A Type Overdrive, Part III - Reassembly

By Nelson Riedel, nriedel@nextek.net

Draft 8-20-01

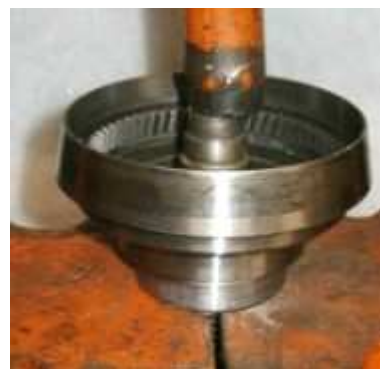
Installing Annulus Head Bearing: The annulus head bearing (or OD middle bearing) was pressed onto the annulus shaft until it was snug against the shoulder. A hydraulic press as shown in the photo on right was used.

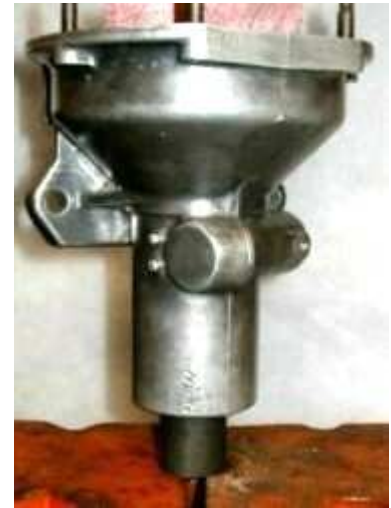
gearbox) was placed over the end of shaft and against the side of the bearing and a pipe coupling spacer was slid over the shaft as shown in the photo on the right. This is the same as the previous setup except the annulus is being pressed into the tail bearing instead of the rear casting. The press force was limited to that necessary to get the bearing seated.

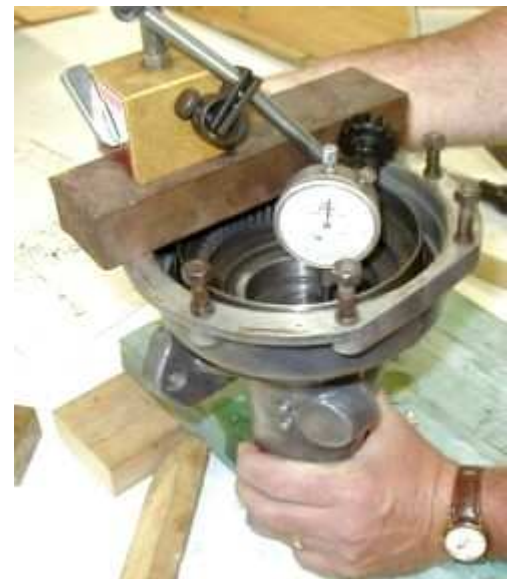
Measuring Annulus End Float: The annulus end float was measured again using the same procedure described in Part II. The dial indicator tip was positioned against the annulus. The casting was then pushed down and a first reading taken. A second reading was taken after the casting had been pulled up by placing our hands on each side of the casting and pushing down on the annulus with our thumbs. The difference between the two readings is the end float. The end float was within the .005 to .010 inch specification before the unit was disassembled so it was expected to be within specifications after reassembly, even with new bearings. In this case it was. If it were not, one of the bearings might not be seated. The first thing I'd try is to use a punch to drive the tail bearing outer race a little further into the rear casting. The next most likely problem is that the head bearing inner race isn't seated against the annulus shoulder. One might have to go back to the first step above to make sure the head bearing is seated properly. Another possibility is that the old bearings were worn and sloppy. If the bearings are seated properly and the end float is still out of specs, read on.

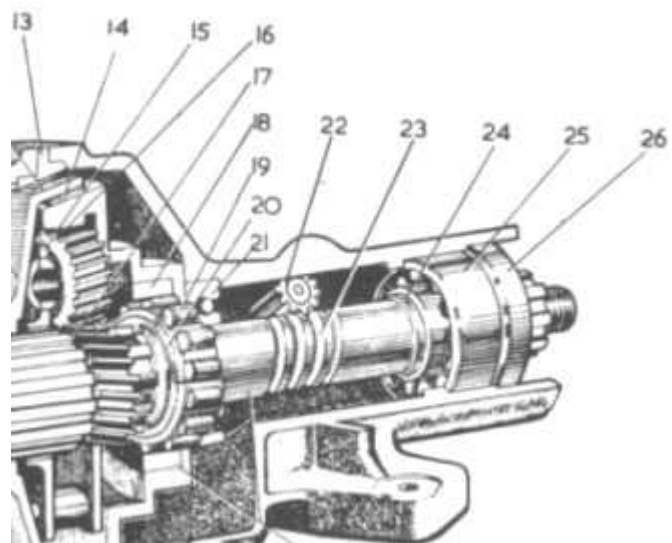
Annulus End Float Out of Specifications: The sectional view on the right is part of a diagram in the Service Instruction Manual mentioned in Part I. Component 14 is the Annulus, 21 and 25 are the head and tail bearings, 24 is the adjustment washer and 26 is the rear seal.

New head and tail bearings have some end float between the inner and outer races. I don't have specifications on the bearings but expect it is about .010 inch. Note from the sketch above that the outer races on the two bearings are pressed against shoulders in the rear casting. The inner races are squeezed together by the annulus head and the rear flange. The adjustment washer (24) rests against a shoulder on the shaft and keeps the inner races apart

If everything is perfect, the distance between the two outer races is exactly equal to the distance between the two inner races and the annulus end float will be equal to the lesser of the two bearing end floats. On the other hand, if the distances between the two inner races and the two outer races are different, the end

float will be less. In the extreme, if the difference in these two measurements is too large, there will be no annulus end float and the bearings may have a pre load ---- a lateral force applied to the bearings. Pre load will likely lead to early bearing failure.

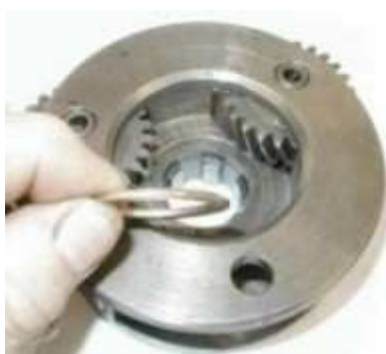
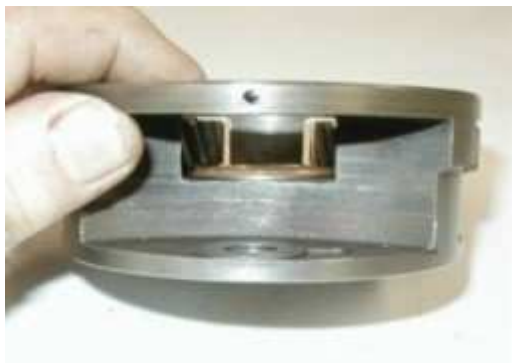
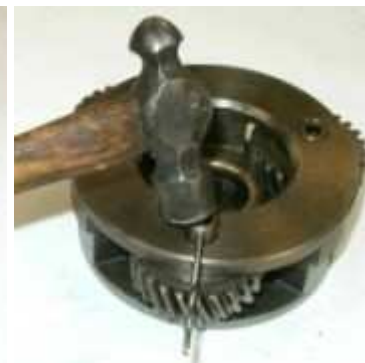
Planet Carrier: Each of the planet gears was rotated to make sure the bearings were smooth. Normally there will be no problem and nothing else need be done to the planet carrier. In this case the mainshaft thrust washer retained in the center of the planet carrier was destroyed and the new washer couldn't be installed without removing one of the gears. The photo on the right shows a gear, the little shaft and associated tabbed thrust washer. There is a hole in the top of the shaft. A 3/32 mild steel pin is driven through a matching hole in the carrier and into this hole to retain the shaft. The pin was drilled out using a 5/64 bit.

The thrust washer was positioned in the recess in the center of the carrier. The top of the washer is beveled to provide clearance for the planet gear teeth. (If the top of washer isn't beveled, one can try turning it over.) The planet gear thrust washer was then positioned with the tab in the hole, the gear slid into position and the shaft tapped home using a small hammer. The photo on the right shows a drill bit in the hole in the shaft to help keep it visually aligned with the hole in the carrier. A 3/32 steel retaining pin didn't seem tight enough so a 3/4 inch long 3/32 expansion pin was ground down to a length of ~.6 inches and used instead. The expansion pin is tempered and will likely ruin a drill bit if one tries to drill it out. However, if the shaft is pressed out, the pin will shear off and the pieces can then be tapped out with a small punch. (I tried it to make sure it works.)

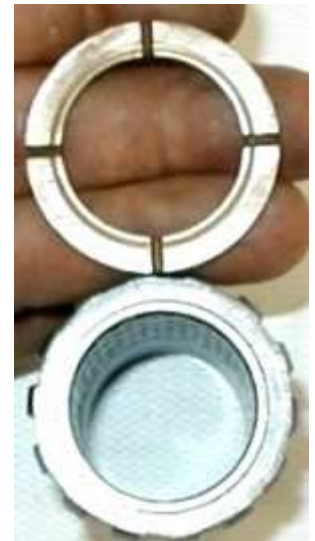
No End Float! When the end float was measured with the dial indicator there was none. That was the same result I got using the extra washer method --- but the problems mentioned earlier caused variations of about .010 inch so I didn't know for sure. A problem was suspected because the thrust washer had a groove worn in it. Also, remember that the thrust washer between the sun gear and planet carrier had been destroyed.

Closer examination of the trust washer and sun gear revealed that the bushing pressed into the sun gear was not flush with the top of the gear --- it stuck up at least .010 inches. This bushing has a steel outside and brass or bronze inside. The steel outside part had cut a groove in the thrust washer as shown in photo on right. An attempt was made to press the bushing in further --- wouldn't budge. The protruding part was then filed off smooth. (Photo is after it was filed.) The thrust washer groove was positioned away from the sun gear in the earlier measurements, which explains the lack of end float.

After filing off that ridge, everything was put together to measure the end float again ---- it was about .012 inches this time. Still a little short. There was no hurry this time (I was waiting for a motor to arrive for a test stand --- see next part) so the next size smaller adjustment washer was ordered. A replacement for the damaged thrust washer had been purchased when parts were ordered parts earlier. Unfortunately, I couldn't find the damn thing. Maybe the workshop cats ate it -- or the mice carried it off. The rough edge around the groove in the old washer was filed smooth and the washer was positioned with the groove against the adjustment washer --- should work fine. That new washer was found later and installed when other problems were encountered necessitating disassembly again as discussed Part IV.

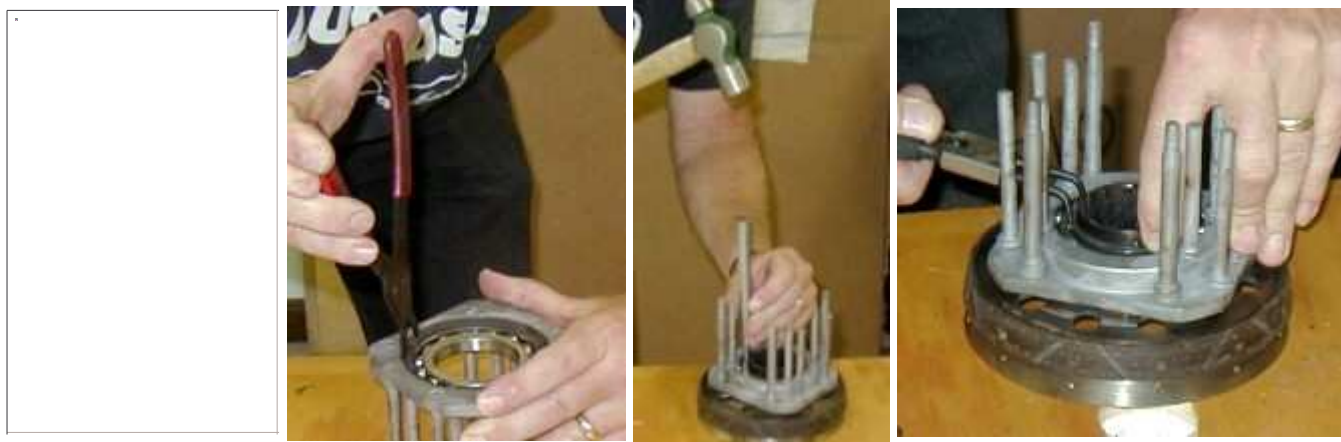
Assembling the Sliding Clutch: This job as illustrated in the photos below was fairly straightforward. The outer race was driven into the thrust ring and then the circlip installed. This circlip is a biggie and takes a lot of force to compress to get it into position. We made sure the circlip was fully seated. Next,

the thrust ring with bearing was placed over the clutch sliding member and the inner race driven onto the sliding member. The final step was to install the inner race circlip. Fred Thomas (the young man who helped me get started powder coating) had his TR3 OD quit and when disassembled the only problem found was that the circlip had come out. It was reinstalled and the OD tested and found to work fine. Message: **make sure the circlips are seated!**
