A Type Overdrive, Part III - Reassembly

By Nelson Riedel, nriedel@nextek.net

Draft 8-20-01

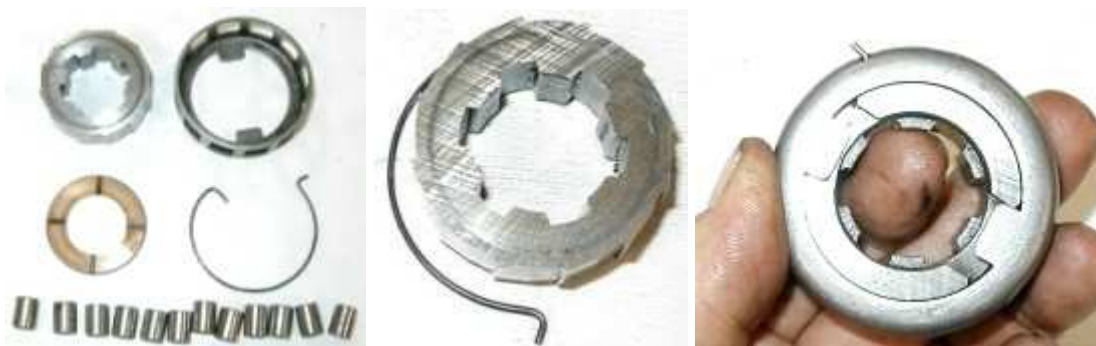
Assembling the Unidirectional Clutch: The parts of the unidirectional clutch in the left photo below are inner member (upper left), cage, spring, thrust washer and rollers. The spring was connected to the inner member first as shown in the middle photo. There are two ways to connect the spring, only one is correct. Next, the other end of the spring was slipped into the hole in the cage, followed by the inner member. The inner member was then rotated against the spring and locked into place by the cage tabs

shown in the right photo. The end of the spring can be seen sticking out of the cage in the right photo.

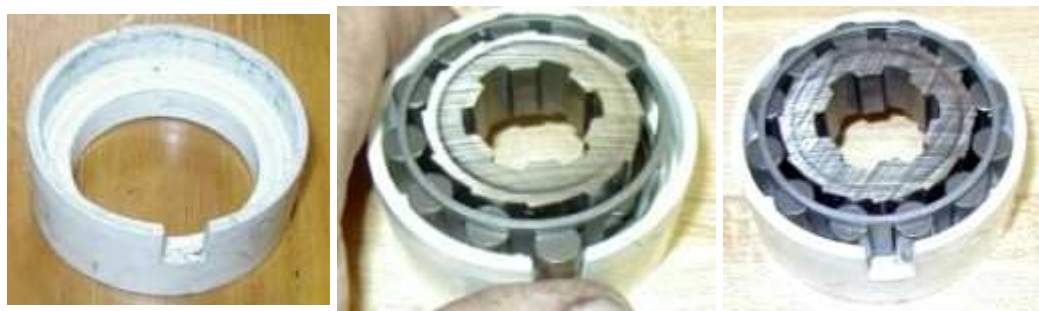
The 12 rollers must be inserted into the cage next. One way to do this is to wrap a heavy rubber band around the cage and then lift it and feed the rollers into position one at a time. The manuals show photos of a Churchill tool to help assemble the clutch. A similar tool was fabricated using a plastic pipe coupling and bushing as shown in left photo below. The inside was turned to a diameter just less than the inner diameter of the recess for the clutch in the annulus and to a depth slightly less than the clutch thickness. The slot in the side is just wide enough for a roller to pass. The cage with inner member is placed in the tool as shown in the middle photo and the rollers fed into the cage. The inner member is rotated clockwise after each roller is inserted. If an attempt is made to turn the inner member counterclockwise, the clutch will lock. (If it doesn't lock, then the ramps are probably not positioned as shown in photo and it must be taken apart and reassembled, making sure the spring is installed in the correct direction.) The assembled clutch is shown in the right photo.

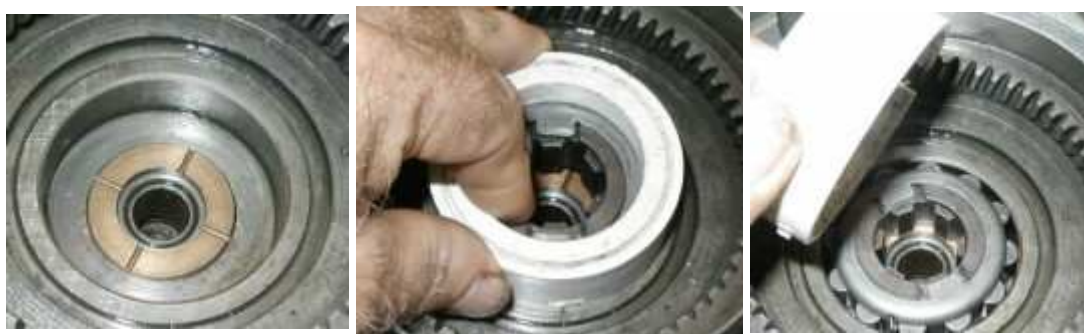
Installing the unidirectional Clutch: The rear casting was still mounted to the OD stand. The thrust washer was positioned (left photo), the tool with clutch inside was placed over the recess and the clutch pushed into the recess (center photo), and the tool lifted away (right photo). If one used rubber bands to assemble the clutch, then the procedure is the same and the rubber band would slip off as the clutch was pushed into the recess.

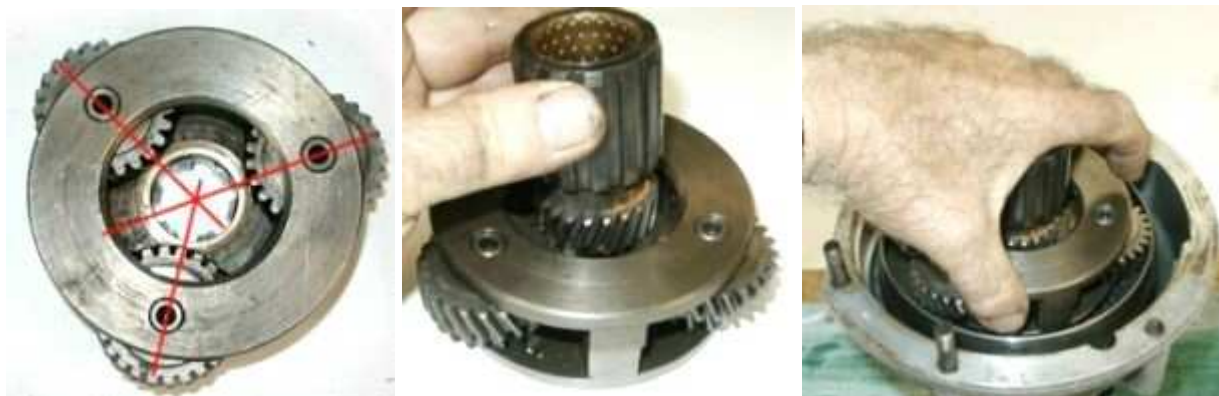
carrier and the unidirectional clutch. There are indexing dots stamped into the top of each of the planet gears. Each gear was turned so that the dot is on the outside and a line through the dot and the center of the planet gear shaft also passed through the center of the planet carrier as show in the left photo below. The sun gear was inserted with the planet gears aligned as indicated. The dot alignment was verified after the sun gear was in position. The three dots didn't line up as indicated, so I did it over and got it right. The planet carrier with sun gear was then inserted into the annulus. The sun gear was rotated back and forth slightly to get the gears to mesh properly so that the planet carrier would drop into the annulus..

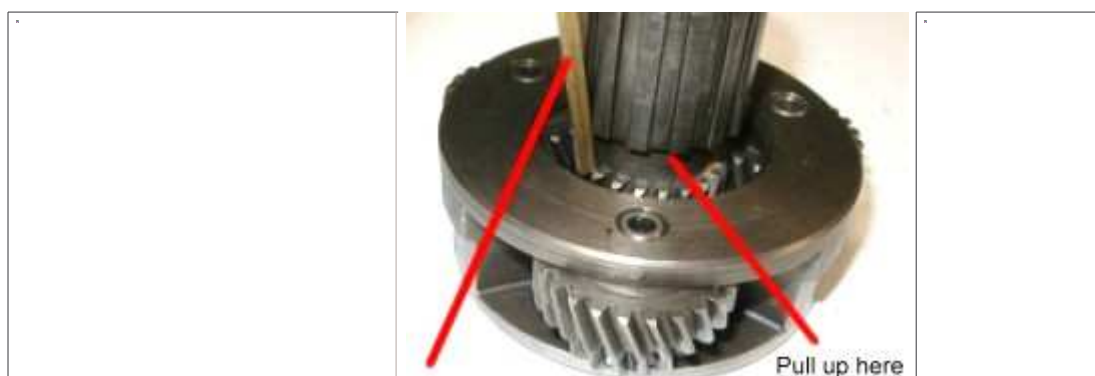
Rod to dial indicator

Measuring Sun Gear End Float: A thrust washer and adjustment washer fit between the sun gear and the bushing in the rear of the main casting (left photo below). When everything is put together, the sun gear must have an end float of between .014 and .020 inches. The books tell you to put an extra washer (thickness over .025 inches) on the mainshaft, pound the brake ring in the main casting and slide the main casting into position. Because of the extra washer, there will be a gap between the brake ring and the rear casting. Measure that gap with feeler gauges and subtract the measured value from the size of the extra washer to determine the end float. For example if the gap is .025 inch and the washer is .040, the end float is .015 inch. I was unable to get a repeatable measurement using this method --- the brake ring was on crooked, slid down from the main casting, or main casting tilted, etc.

The method used to measure the annulus end float with the dial indicator worked well so a way was found to do something similar here. Unfortunately, it's six inches or so between the only surface on the sun gear one can position the indicator point and the body of the indicator. Point extenders are available, but not in this workshop. Instead, a piece of square brass tube (available at hobby stores) was used as an extension. The scheme was to install the two washers (no extra washer this time) and then slide the main casting with brake ring into position. The two castings went together with the brake ring in-between. Nuts were tightened on a couple studs on opposite sides of the case to make sure everything was seated. I was able to reach through the gap in the main casting and feel the sun gear shaft, rotate it and try to feel some end play -- but found none. Next, one end of the brass tube was positioned on one of the sun gear teeth and the other end slipped under the dial indicator point. A couple hooked tools were then used to lift the sun gear up. The change in the indicator reading was the end float. The center photo below shows where the rod and hooked tools were positioned and the right photo shows the lifting tools; a scribe and a screwdriver with a bent tip (also used to install door top weather seal clips).

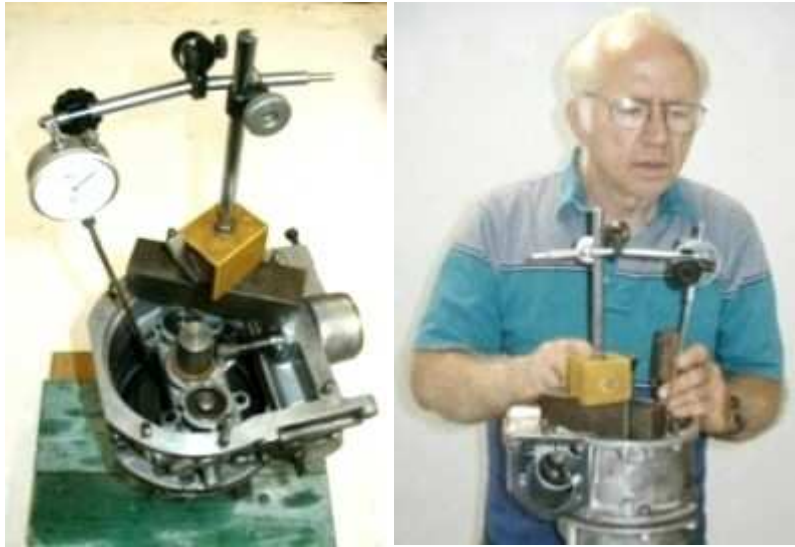
The left photo below shows the actual setup. A fairly large steel bar was used to secure the indicator magnetic base and provide stability. The right photo shows a young LBC mechanic wannabe at work.

No End Float! When the end float was measured with the dial indicator there was none. That was the same result I got using the extra washer method --- but the problems mentioned earlier caused variations of about .010 inch so I didn't know for sure. A problem was suspected because the thrust washer had a groove worn in it. Also, remember that the thrust washer between the sun gear and planet carrier had been destroyed.

Closer examination of the trust washer and sun gear revealed that the bushing pressed into the sun gear was not flush with the top of the gear --- it stuck up at least .010 inches. This bushing has a steel outside and brass or bronze inside. The steel outside part had cut a groove in the thrust washer as shown in photo on right. An attempt was made to press the bushing in further --- wouldn't budge. The protruding part was then filed off smooth. (Photo is after it was filed.) The thrust washer groove was positioned away from the sun gear in the earlier measurements, which explains the lack of end float.

After filing off that ridge, everything was put together to measure the end float again ---- it was about .012 inches this time. Still a little short. There was no hurry this time (I was waiting for a motor to arrive for a test stand --- see next part) so the next size smaller adjustment washer was ordered. A replacement for the damaged thrust washer had been purchased when parts were ordered parts earlier. Unfortunately, I couldn't find the damn thing. Maybe the workshop cats ate it -- or the mice carried it off. The rough edge around the groove in the old washer was filed smooth and the washer was positioned with the groove against the adjustment washer --- should work fine. That new washer was found later and installed when other problems were encountered necessitating disassembly again as discussed Part IV.

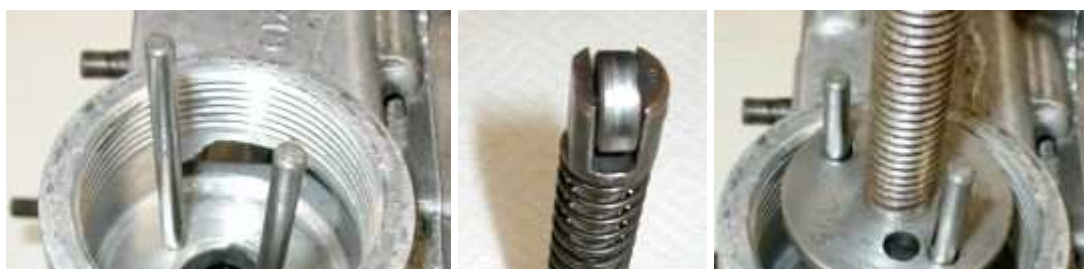
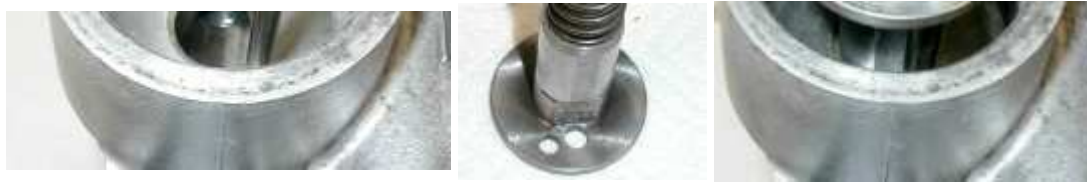
Installing the pump: The next step was to press the pump into the main case. The ends of two 2 inch long 3/16 steel rods were threaded 12-32. These rods were then screwed into the pump retaining screw holes to guide the pump housing into the correct position (left photo below). The rod used to extract the pump was then screwed back into the pump. Both the inside and outside of the pump body were lubricated, the spring slipped on the piston and the piston with spring slipped into the pump body. The end of the piston is asymmetric as seen in the middle photo. The thin side is positioned next to and slides beside the steel pin in the main casting. The pump with piston was slid into position over the pins. Before pressing the body in, the thin side of the top was verified to be next to that pin and the hole in the pump body was on the correct side to match up with the hole for the non-return valve. After everything was positioned correctly, the pump home was driven home using a hammer on the end of the threaded rod. The large threaded rod and two smaller rods were then removed. A little oil was poured into the pump housing and then the plug was installed followed by the two small screws. The screen filter was installed next, and then the drain plug with a new washer/gasket. This OD didn't have the magnets under the filter that are used on the later ODs.

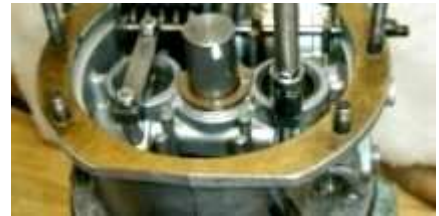
Mating the two castings: The sliding clutch was positioned over the sun gear shaft on the rear casting that was still mounted to the OD stand. A small amount of sealer was spread on the surface of the brake ring that mates with the rear casting and the ring was driven home with a hammer and punch (left photo below). A small amount of sealer was then spread on the surface of the brake ring that mates with the main casting. The dummy mainshaft was still in place and the thrust washer and adjustment washer in front of the sun gear were still in position. The main casting was then positioned on the rear casting/brake ring with the four threaded end thrust ring rods going though the holes in the main casting. The main casting was tapped into position (wood block & hammer) and drawn tight with six nuts and lock washers on the studs. The center photo below shows the two castings in position. Some sealer may ooze out after everything is tightened. The Hylomar sealer stays sticky for weeks and makes a big mess. The excess was removed using a paper towel dampened with mineral spirits. The last thing was to position the two bridge pieces on the thrust ring rods and secured them with nyloc nuts (right photo).

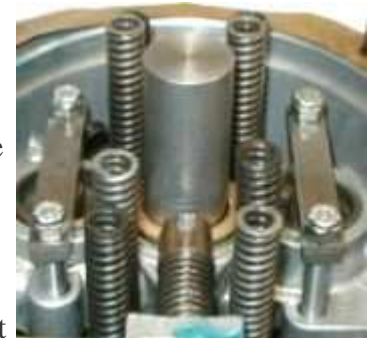
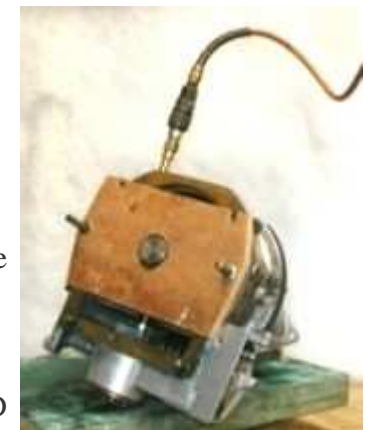
Next, the eight springs were installed over the rods on the the thrust ring as shown in the middle photo. The long springs go on the outside and the short ones on the inside. A couple holes were drilled in a plywood scrap and it was bolted it to the front of the OD to simulated the adaptor plate, compressing the 8 springs in the process (bottom photo). The air line was connected and the lever below the operating valve plug was pushed down. There was an audible clunk as the clutch shifted into OD and a slow air escaping sound when it returned to direct drive.

In direct drive, the output flange rotated easily in either direction. In OD, the 1:1.2 step up between the input and output was observed for clockwise rotation (as viewed from the front). The output couldn't be rotated in the counterclockwise rotation as expected. This is the easiest way to tell that the OD is engaged --- it wouldn't rotate counterclockwise (recall that the OD must not be engaged in reverse).
