A Tasmanian Supra gearbox conversion

100 TECHNICAL CD-ROM

INTRODUCTION

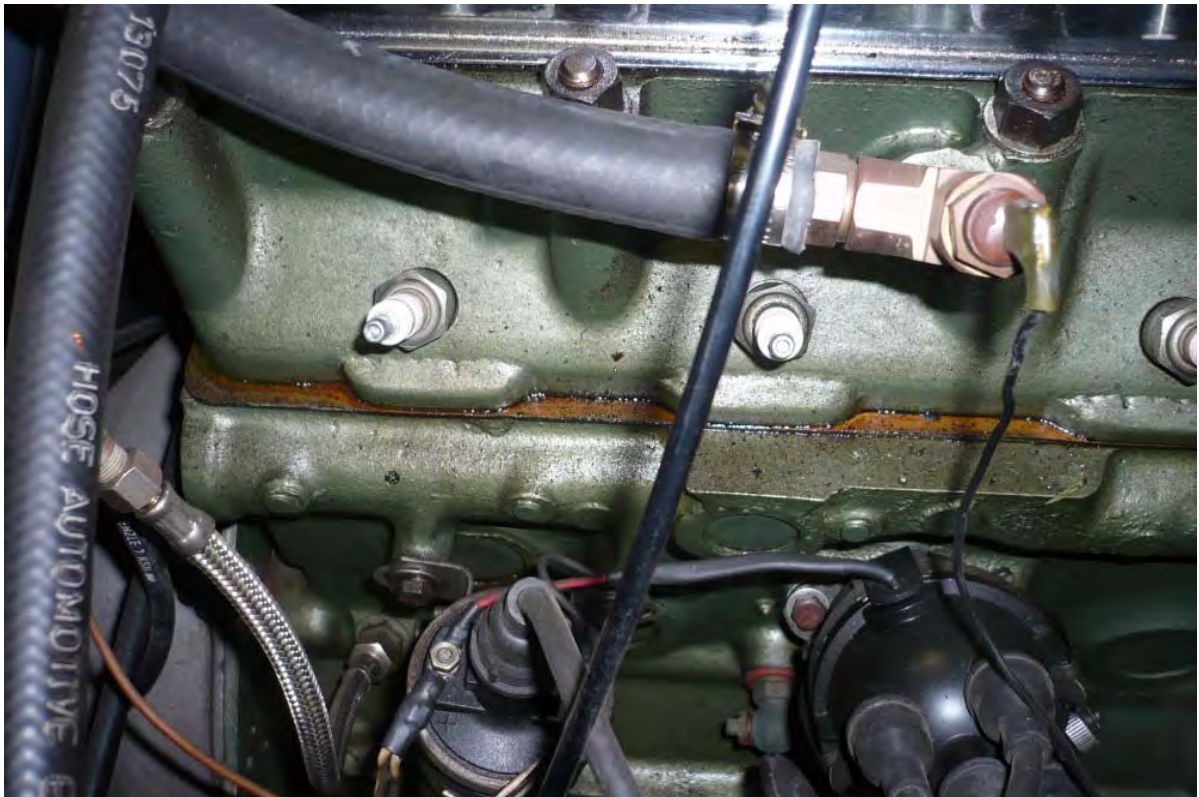
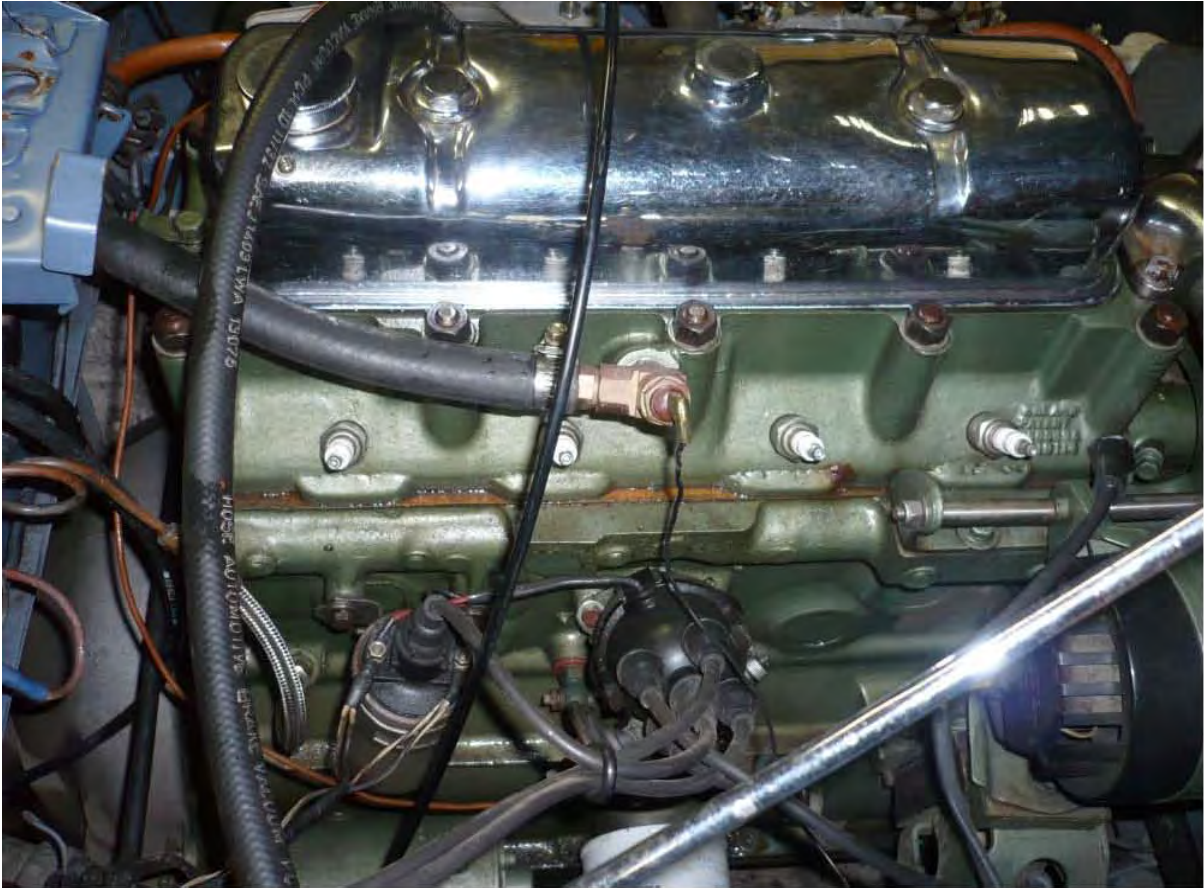
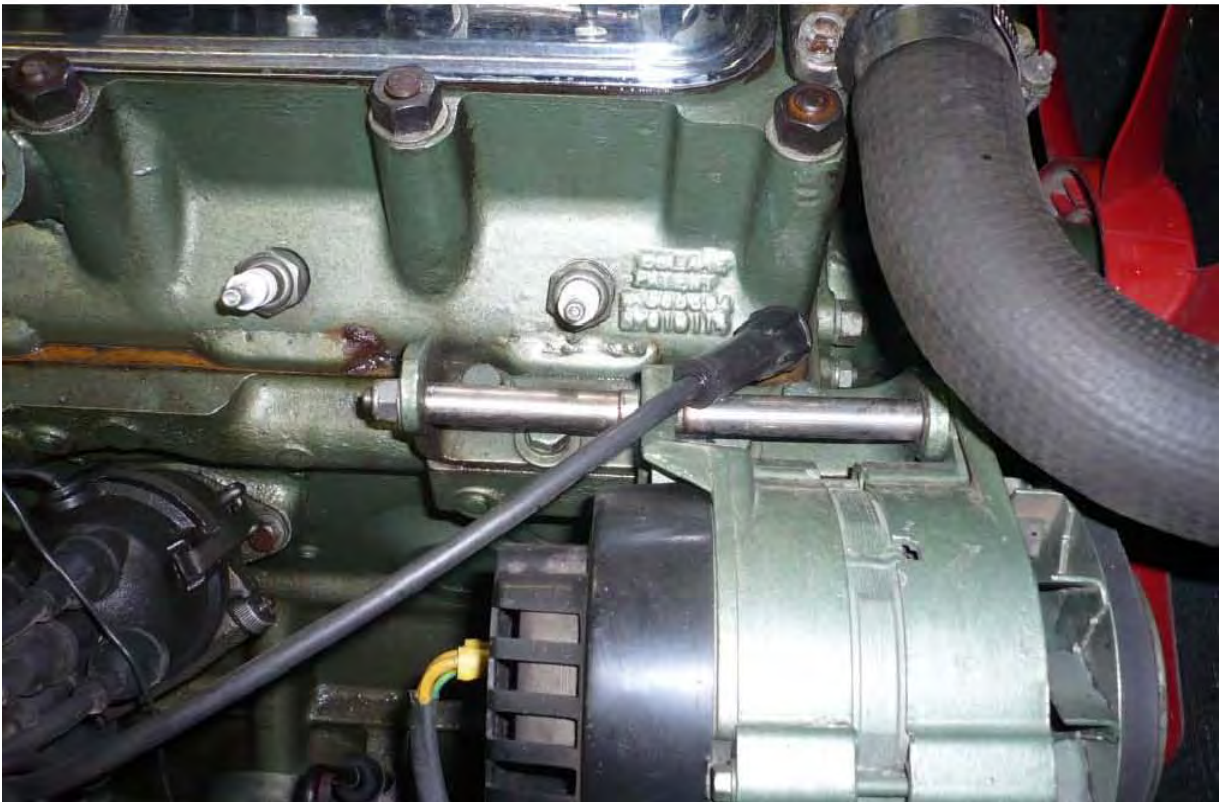
At No 4 cylinder a crack developed and I had it fixed by MG Metalock a company at Bankstown, who drill holes along the crack and fit threaded plugs (no welding). No 2 Cylinder has now got a similar crack (you can see the rust in the 3rd picture) and I will soon have to get that fixed.

The modified A70 head has now done abt 50,000 miles and the repair was done abt 30,000 miles ago when the engine was rebuilt, hardened exhaust valve seats and Chev valves fitted for unleaded petrol.

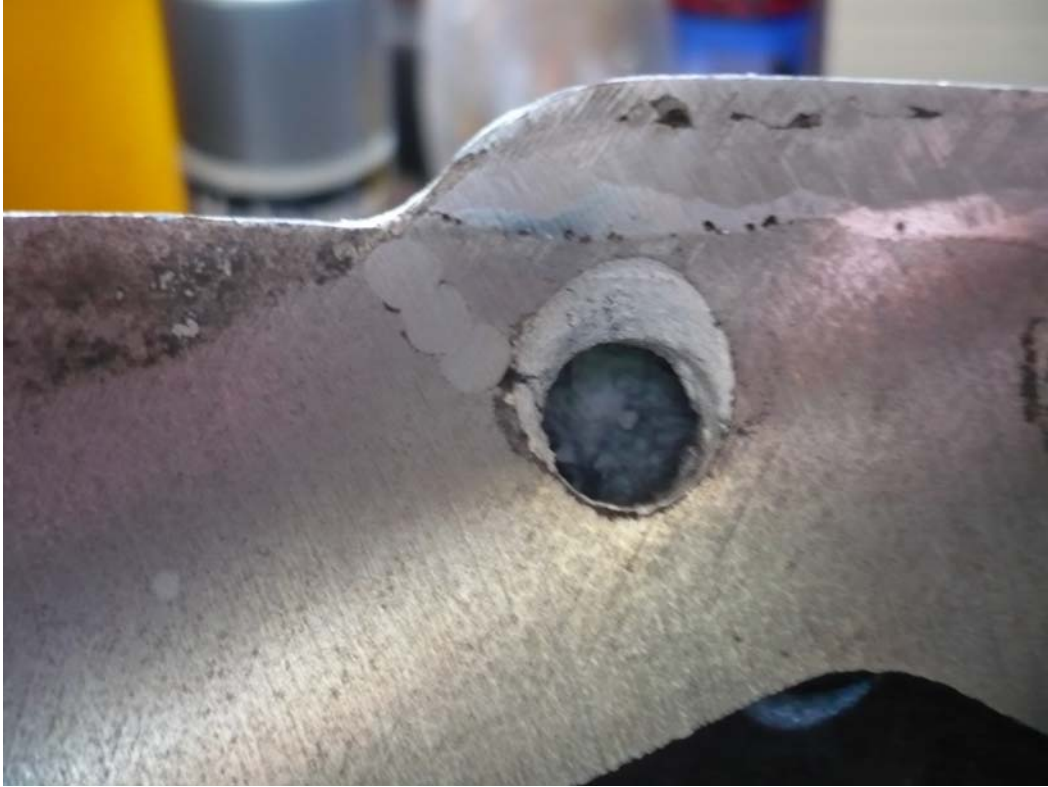
First crack repaired 1999

After 14 ½ years and 58,509 miles after the welding, the second was repaired by Metalock Australia at Ingleburn, the pictures below shows how. (D.H. 31/10/2009)

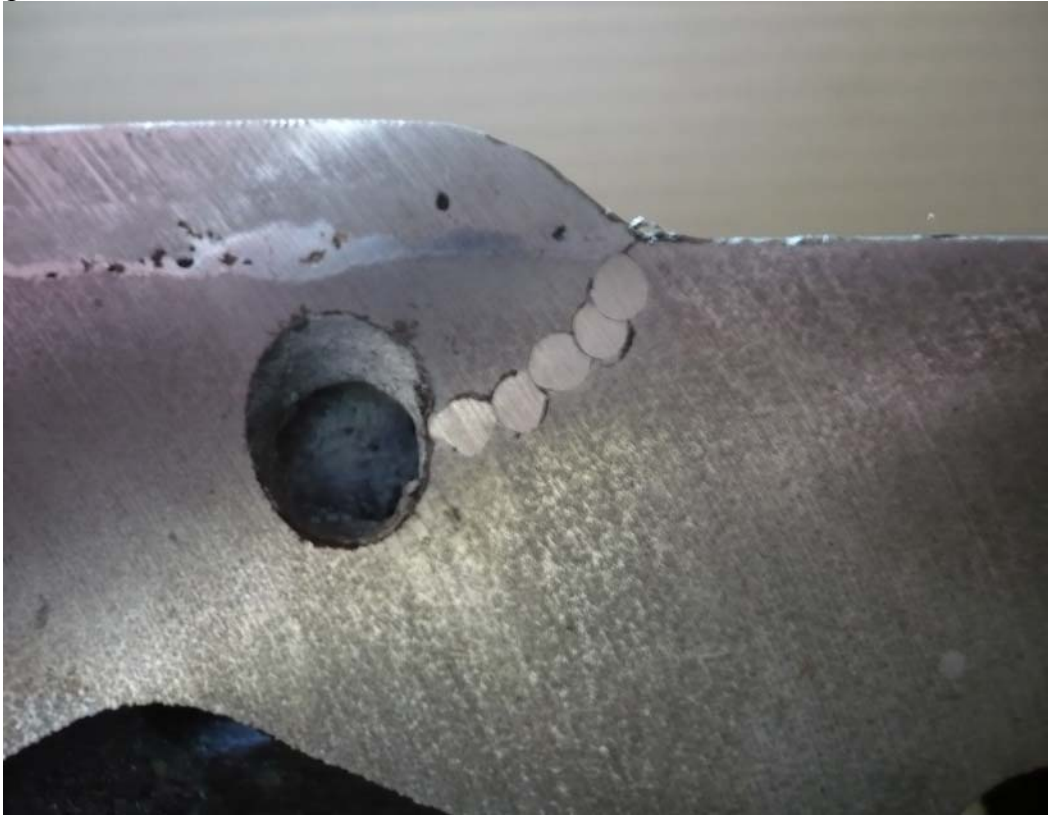
Second crack repaired 2009

You can see how the water holes had to be extended to match up with the Head Gasket, which would have a source of a leak, as the original Healey head was prone to leaking at these points with full coverage out to the edge of the gasket.

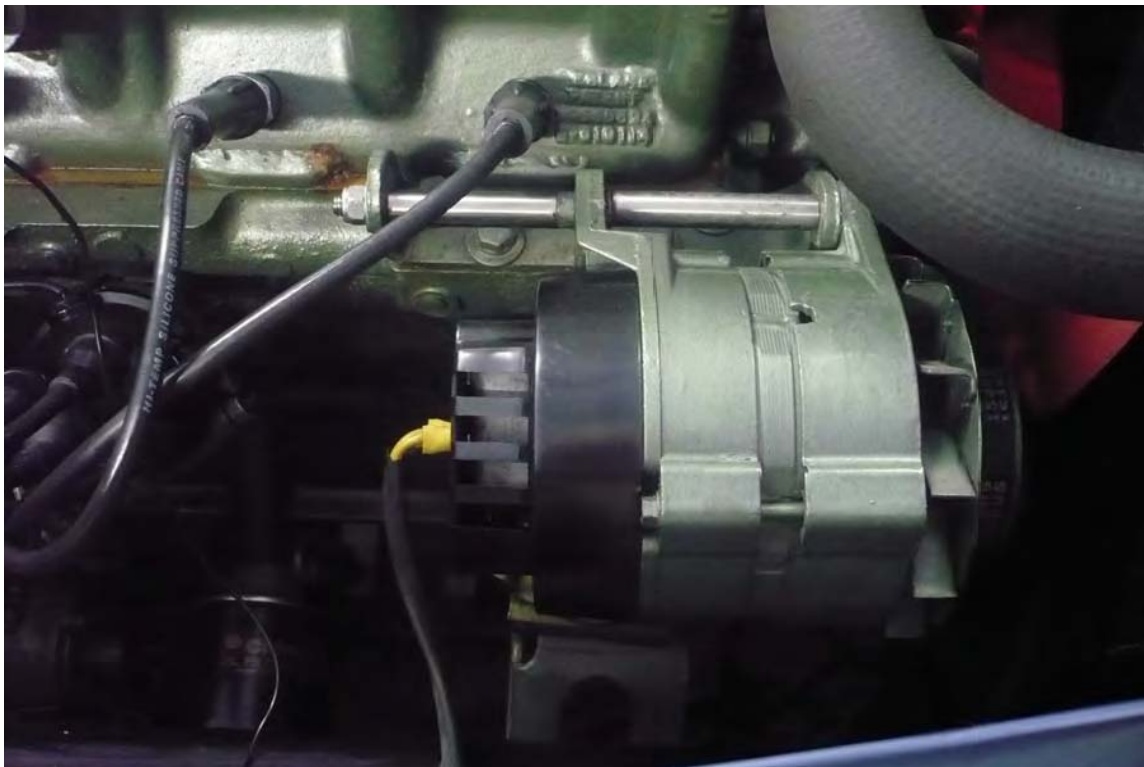
The fitting a narrow fan belt had already been done (see relevant article) and a 45amp Lucas 18ACR, with built in regulator, was purchased from my friendly Wrecker (sorry - Auto Parts Recycler) and painted engine green. The stiffener strip welded across the generator bracket had to be removed, but with less strain and vibration from the narrow belt it is figured that this should be ok, but it will be closely watched for any problem. The alternator was secured to the bracket by a 7 1/2" length of 5/16" threaded rod and two pieces of 5/16" ID stainless steel tube of suitable length. The original adjusting linkage was used and with the fan belt fitted and everything tightened, SURPRISE, the pulleys lined up exactly.

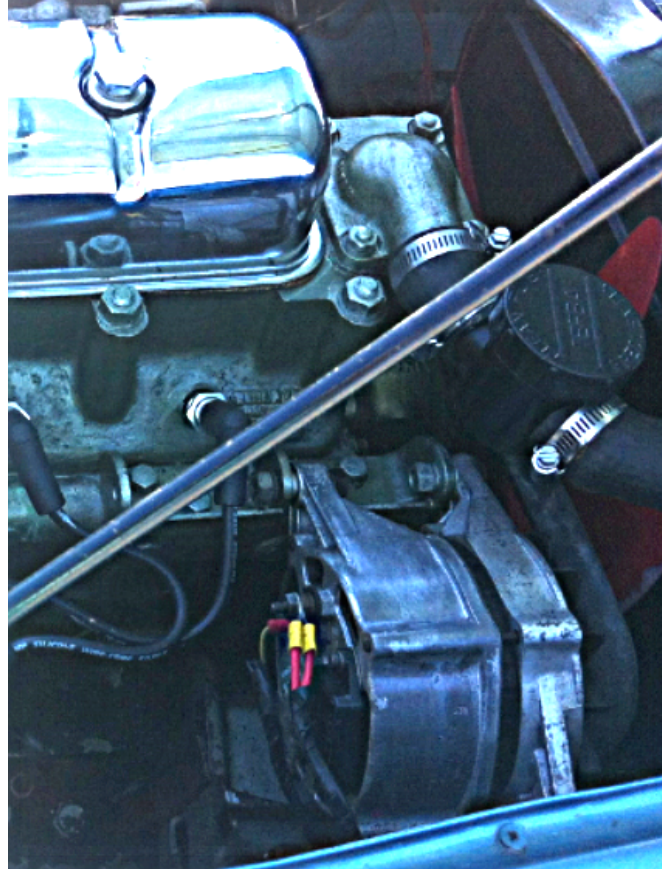
Another way is to weld a piece of steel onto the generator bracket as shown below.

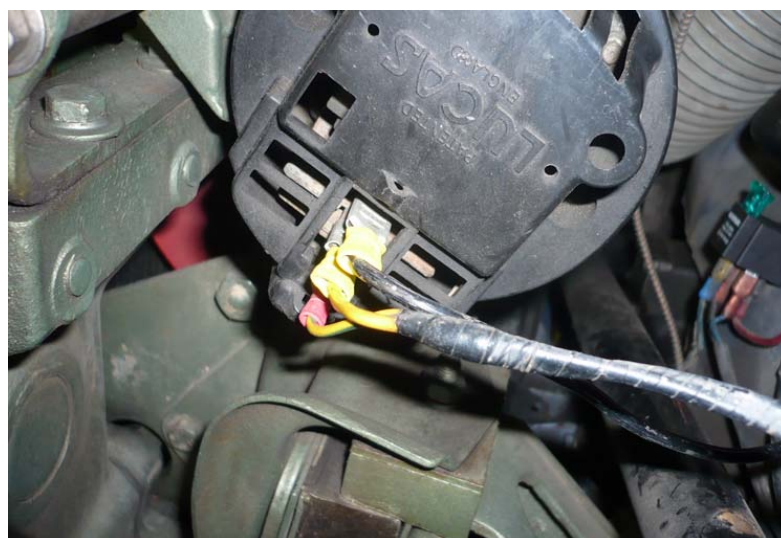
The way I first wired up the alternator in 1996 was rather clumsy so I changed it. The existing generator wires are now connected to the alternator, the yellow to one of the large spade terminals and the yellow/green to the small lower spade terminal, I connected another wire from the other large spade terminal to the headlight relays mounted on the right hand inner guard. The relays originally had a wire up to the regulator, and I left it connected, so there are now two wires supplying current to the regulator, which is now only used as a junction box.

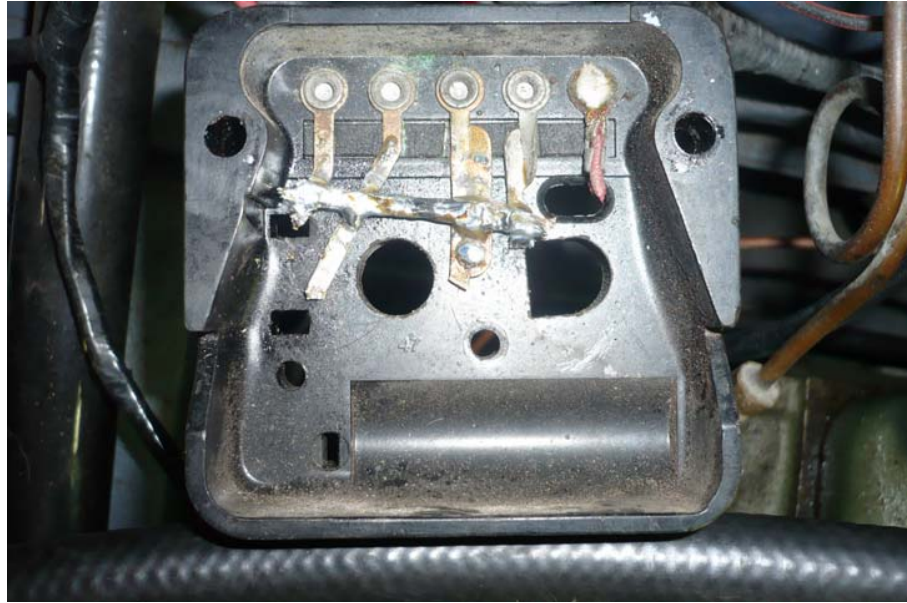
There was an old regulator in the “precious spares” bin, so all its innards were removed leaving the copper and steel strips underneath intact and two pieces of 20 amp wire stripped of their insulation were soldered across them all, except the earth terminal (the one on the right of the photo below).

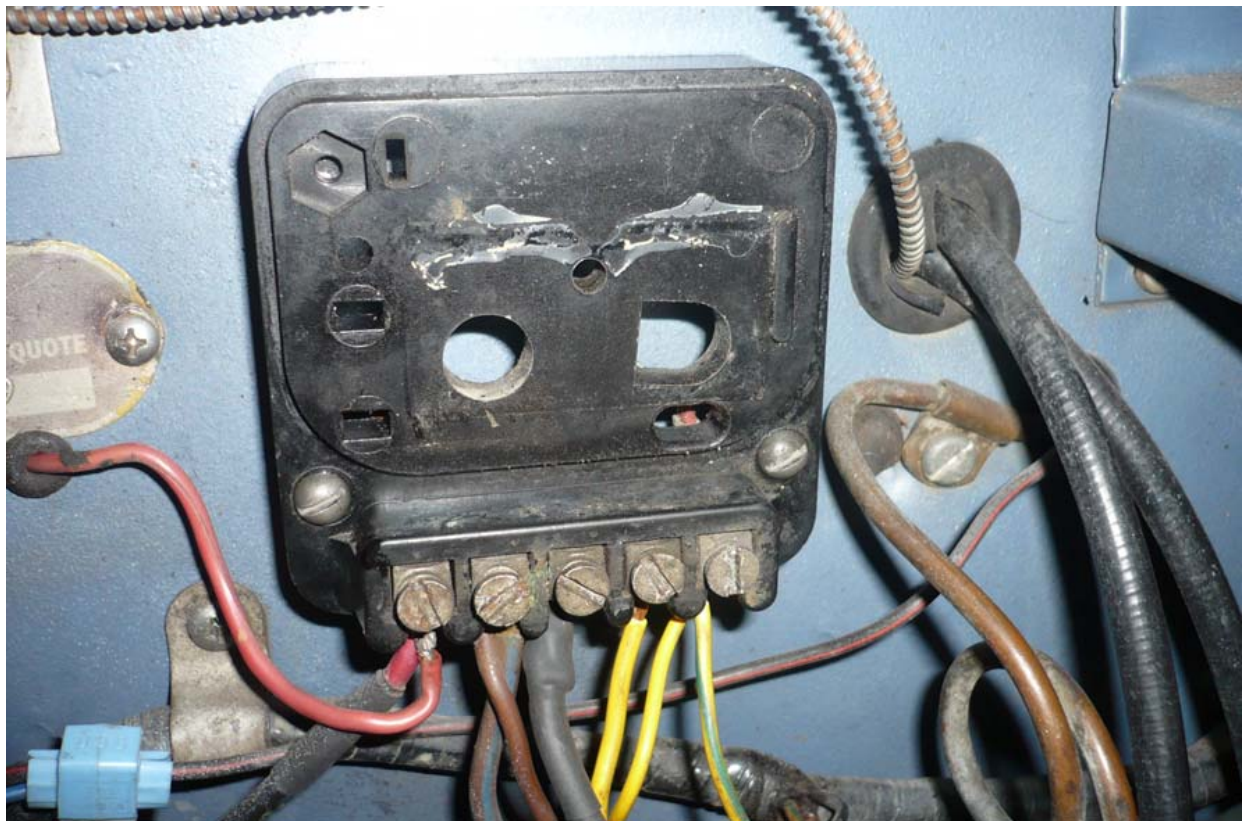
This was then mounted in place of the original and all the wires connected to the four left hand terminals, except the yellow/green and small yellow (the ignition light wires), which were both connected to the right hand one (the old earth one).

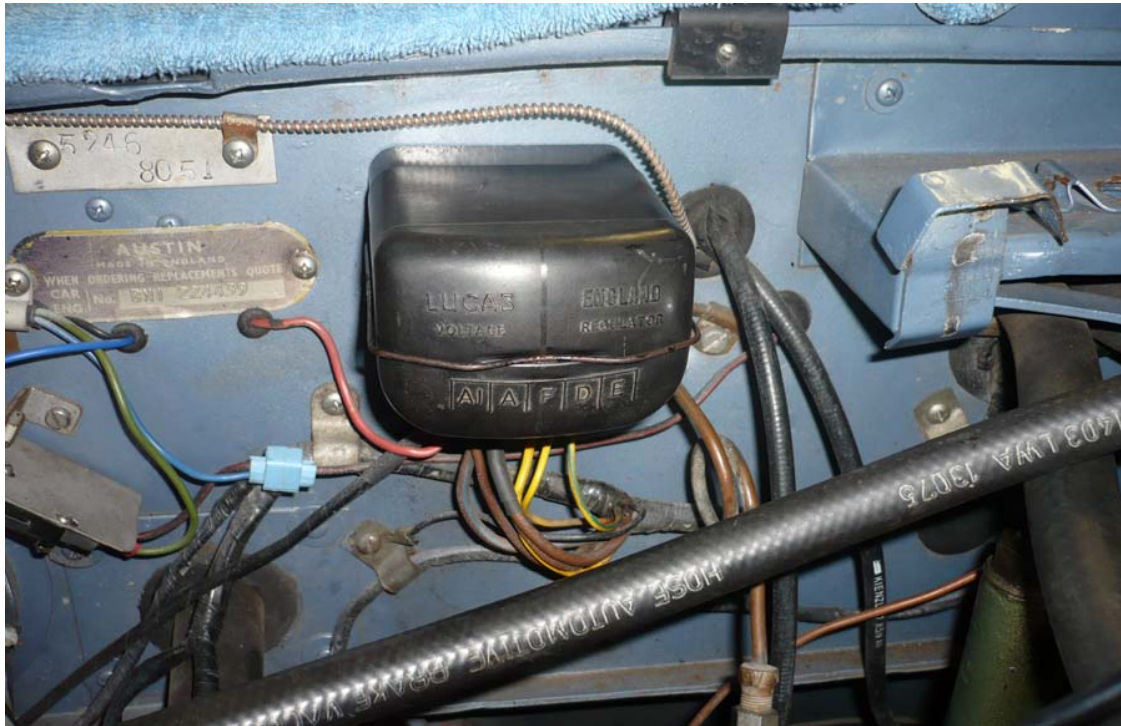
From above the regulator box is still there and the changes in the wiring are hard to see.

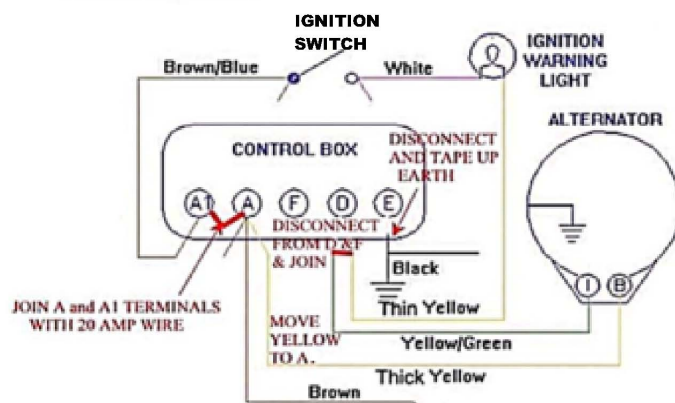
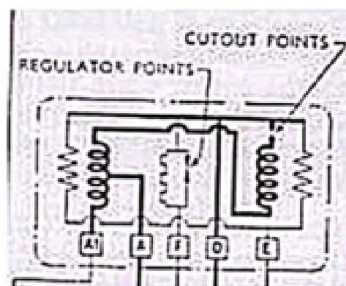
By removing the earth, joining the thin yellow and yellow/green together, and bridging A and A1, the innards of the regulator are no longer used as they are no longer needed, because the alternator has a built in regulator.

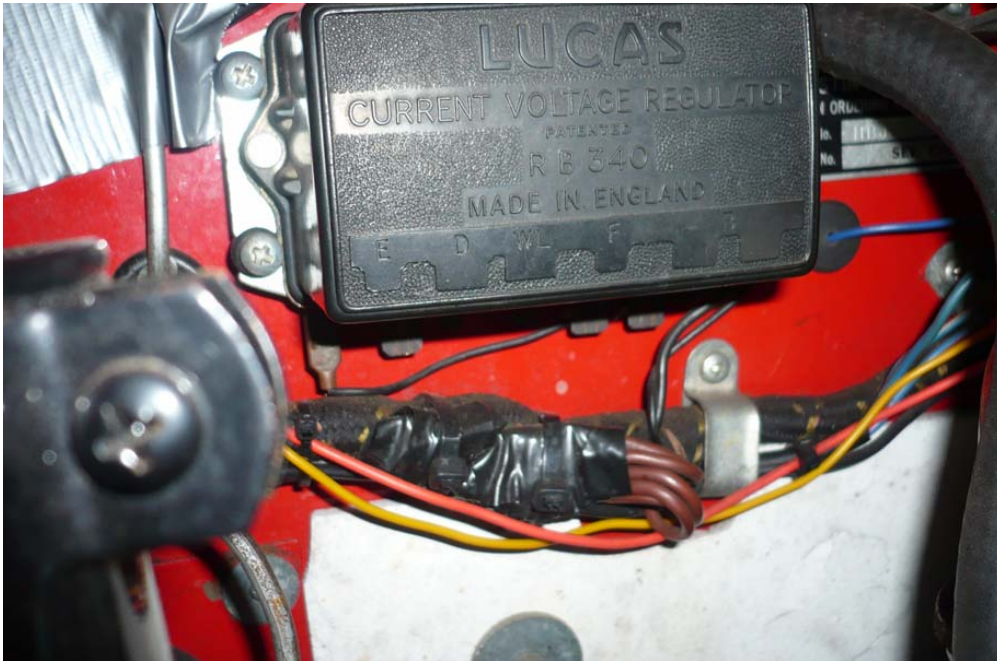
Another way of doing it, the wires are joined with electrical connectors, wrapped in electrical tape and secured with plastic ties.

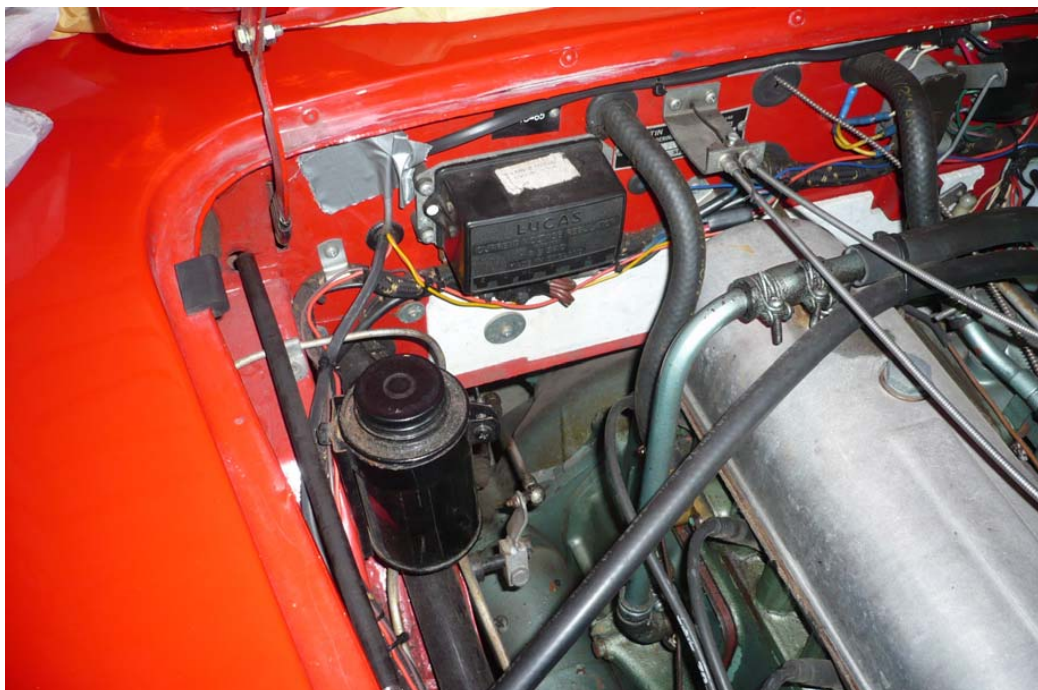
From above the regulator box is still there and the changes in the wiring are hard to see.

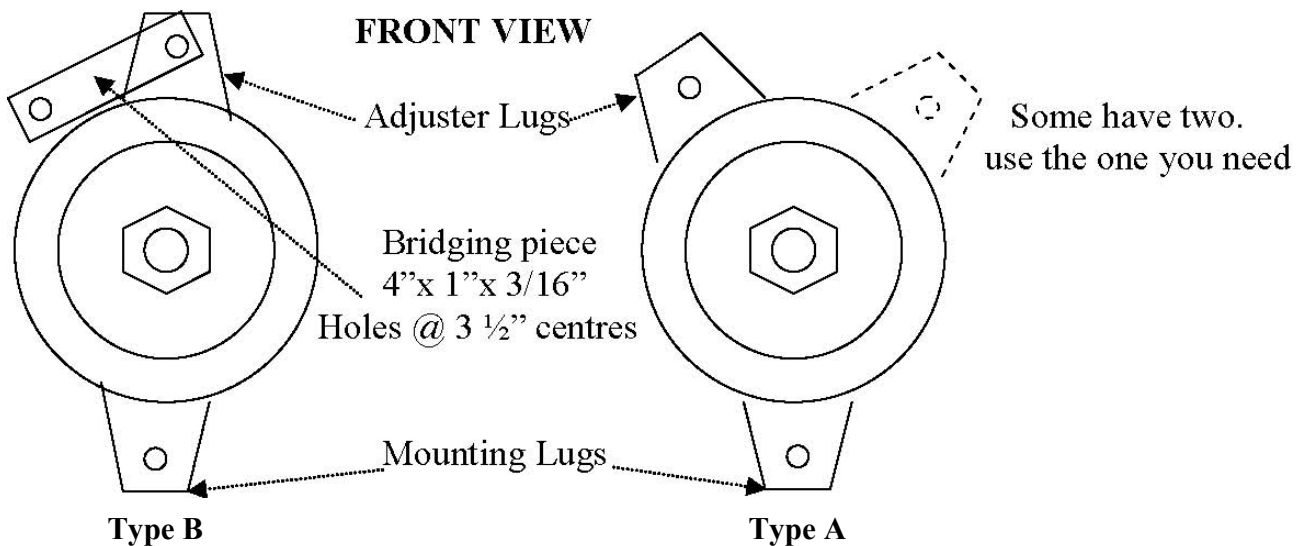
Mounting and adjusting lugs are of a couple of different types the front views are shown below –

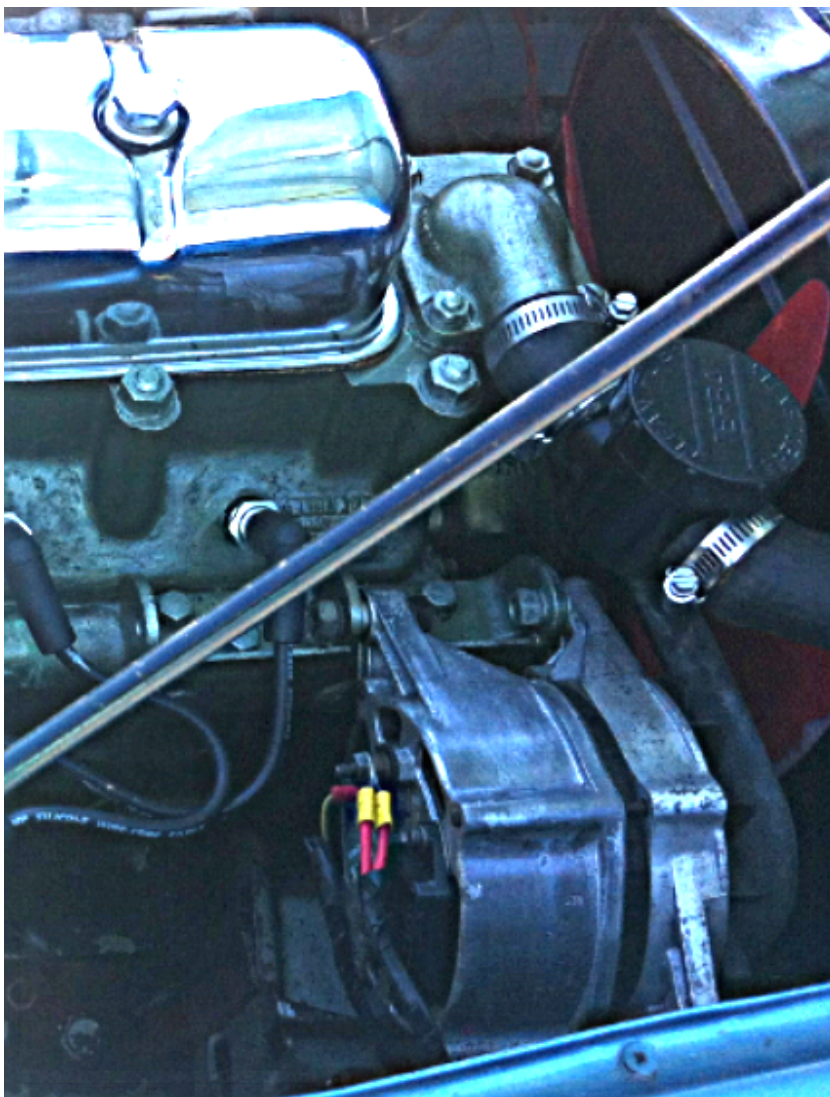
Remove the stiffener strip welded across the generator bracket. Secure the alternator to the bracket by a 7 1/2" length of 5/16" threaded rod and two pieces of 5/16" ID stainless steel tube of suitable length.

Another way is to weld a piece of steel to the generator bracket as shown below.

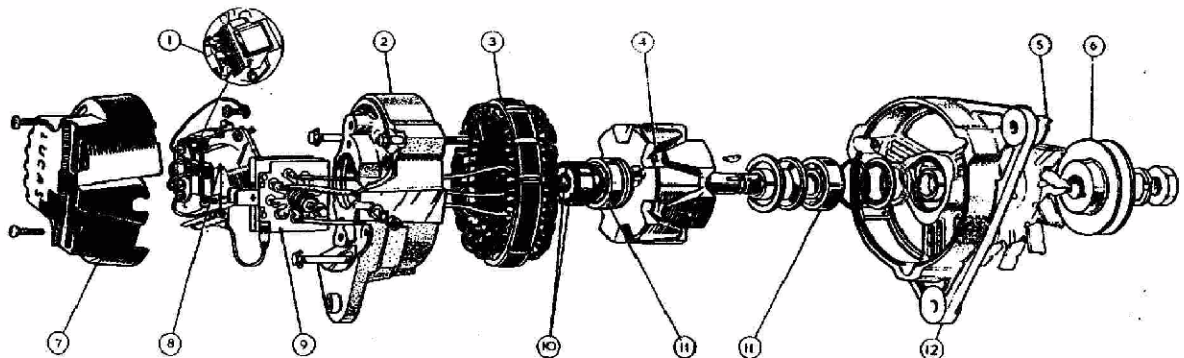
Fig. 1 Alternator Models 15ACR, 16ACR and 17ACR, dismantled

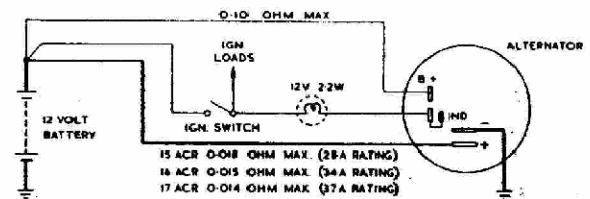
Fig. 2 The charging circuit

The additional 'field' diodes enable a simple charge-indicator warning light to be used (Fig. 2). When the ignition is switched on, the warning light is connected to the battery, the circuit being completed by way of the alternator field winding and the regulator. The bulb is then lit fully. This small current, flowing in the field winding, sets up a flux which supplements the residual flux in the rotor and aids the initial build-up of stator voltage as the rotor begins to rotate when the engine is started.

As rotor speed and generated voltage increase, the field current supplied by the stator winding through the 'field' diodes increases correspondingly until the alternator becomes fully self-excited. During the rise in stator generated voltage (reflected at terminal IND) the brilliance of the warning light is gradually reduced. At approximately the speed at which the alternator commences to charge, the voltage at the IND terminal equals that at the battery side of the warning light, and the latter is extinguished. Thus, illumination of the warning light under normal running conditions indicates that the alternator is not functioning correctly.

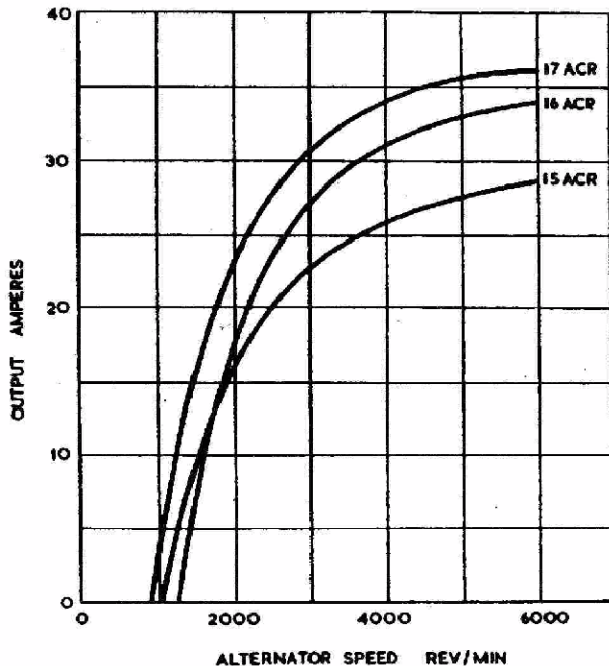
Fig. 3 Typical performance curve (alternator hot)

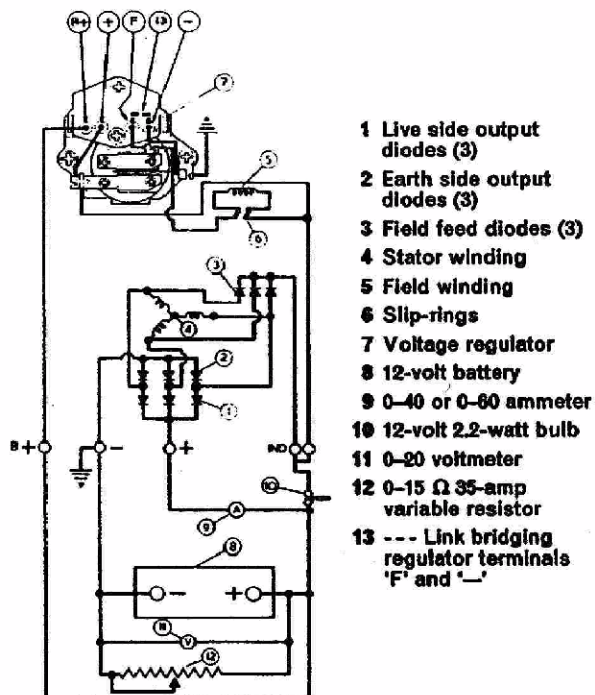
- 1 Live side output diodes (3)
- 2 Earth side output diodes (3)
- 3 Field feed diodes (3)
- 4 Stator winding
- 5 Field winding
- 6 Slip-rings
- 7 Voltage regulator
- 8 12-volt battery
- 9 0-40 or 0-60 ammeter
- 10 12-volt 2.2-watt bulb
- 11 0-20 voltmeter
- 12 0-15 Ω 35-amp variable resistor
- 13 --- Link bridging regulator terminals 'F' and '-'

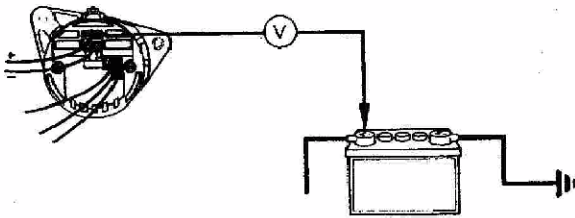
Fig. 5 Charging circuit voltage drop testing — insulated side

Now connect a low-range voltmeter (Fig. 5) between the positive terminal of the alternator (the moulded terminal connector is open-ended to facilitate this) and the positive terminal of the battery. Switch on the headlamps, start the engine and increase speed until the alternator runs at approximately 6,000 rev/min. Note the voltmeter reading.

If the reading exceeds 0.5 volt on the positive side or 0.25 volt on the negative side there is a high resistance in the charging circuit which must be traced and remedied.

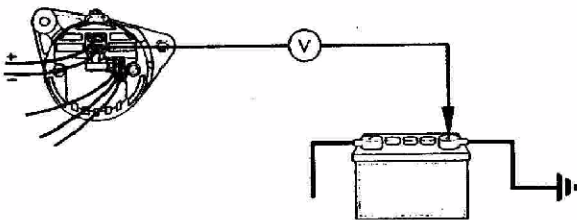
Fig. 6 Charging circuit voltage drop testing — earth side

Transfer the voltmeter connections to the negative terminals (Fig. 6) of alternator and battery, and again note the meter reading.

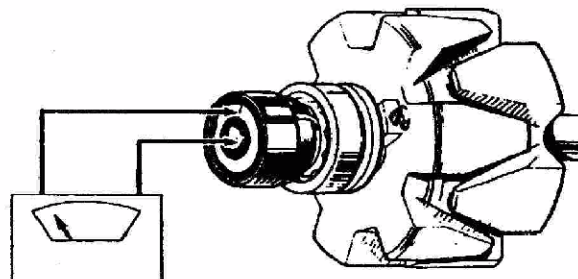
Fig. 7 Measuring rotor winding resistance with ohmmeter

Test the rotor winding by connecting either an ohmmeter (Fig. 7) or a 12-volt battery and ammeter

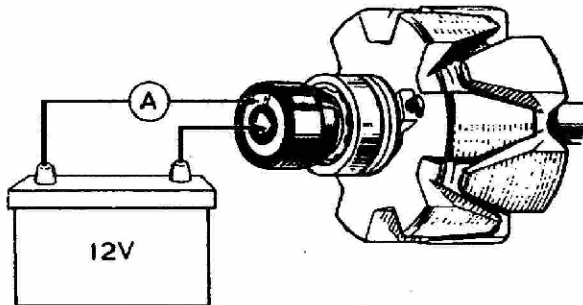
Fig. 8 Measuring rotor winding resistance with battery and ammeter

(Fig. 8) between the slip-rings. The resistance should be as given in 'Technical Data' or the value of current approximately 3 amperes.

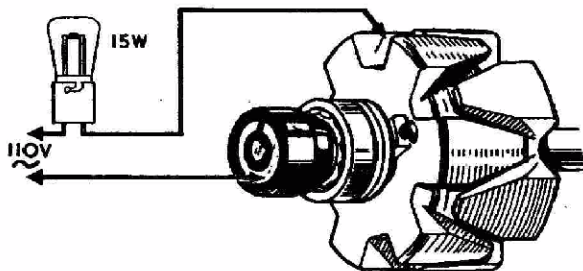
Fig. 9 Insulation test of rotor winding

Test for defective insulation between one of the slip-rings and one of the rotor poles using a 110-volt a.c. mains supply and a 15-watt test lamp (Fig. 9). If the lamp lights, the coil is earthed to the rotor core and a replacement rotor/slip-ring assembly must be fitted.

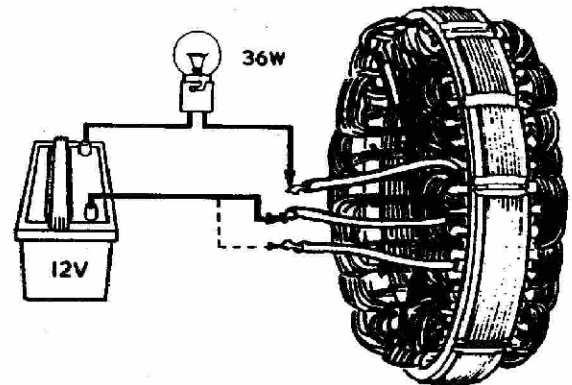
Fig. 10 Stator winding continuity test

Check the continuity of the stator windings by first connecting any two of the three stator cables in series with a 12-volt battery and test lamp of not less than 36-watts (Fig. 10). Repeat the test, replacing one of the two cables by the third cable. Failure of the test lamp to light on either occasion means that part of the stator winding is open-circuit and a replacement stator must be fitted.

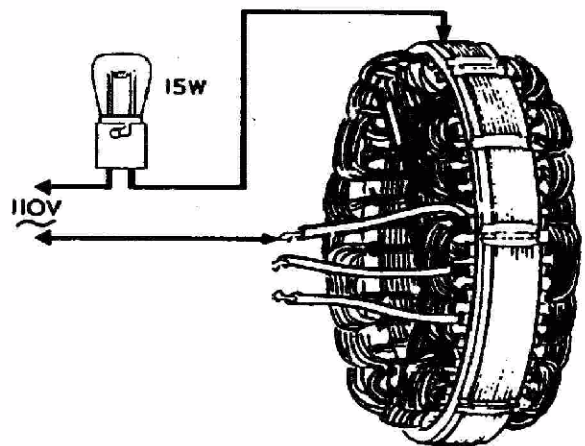
Fig. 11 Insulation test of stator windings

Test for defective insulation between stator coils and the lamination pack with the mains test lamp (Fig. 11). Connect the test probes between any one of the three cable ends and the lamination pack. If the lamp lights, the stator coils are earthing and a replacement stator must be fitted.

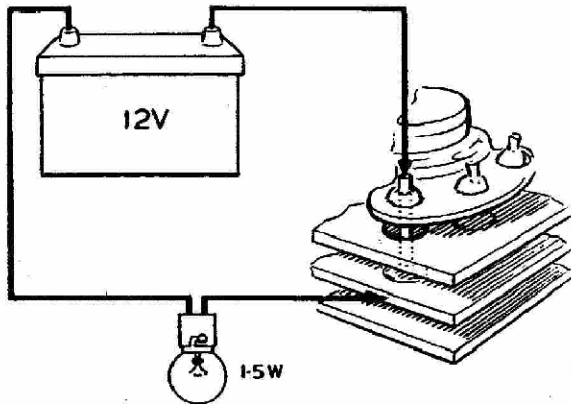
Fig. 12 Simple test for diodes

Connect each of the nine diode pins in turn in series with a 1.5 watt test bulb and one terminal of a 12-volt battery (Fig. 12). Connect the other battery terminal to the particular heat sink on the rectifier pack into which the diode under test is soldered. Next, reverse the connections to diode pin and heat sink. The bulb should light in one direction only. Should the bulb light in both tests, or not light in either, the diode is defective and a new rectifier pack must be fitted.

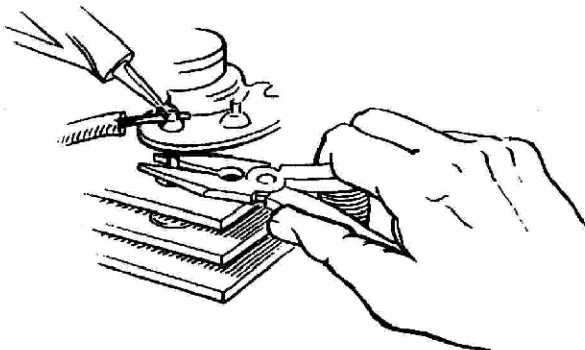
Fig. 13 Use of thermal shunt when soldering diode connections

When re-soldering the stator cables to the diode pins use only 'M' grade 45-55 tin-lead solder. Take great care to avoid overheating the diodes or bending the diode pins. The diode pins should be lightly

gripped with a pair of long-nosed pliers (which act as a thermal shunt) and soldering must be carried out as quickly as possible. The operation is shown in Fig. 13.

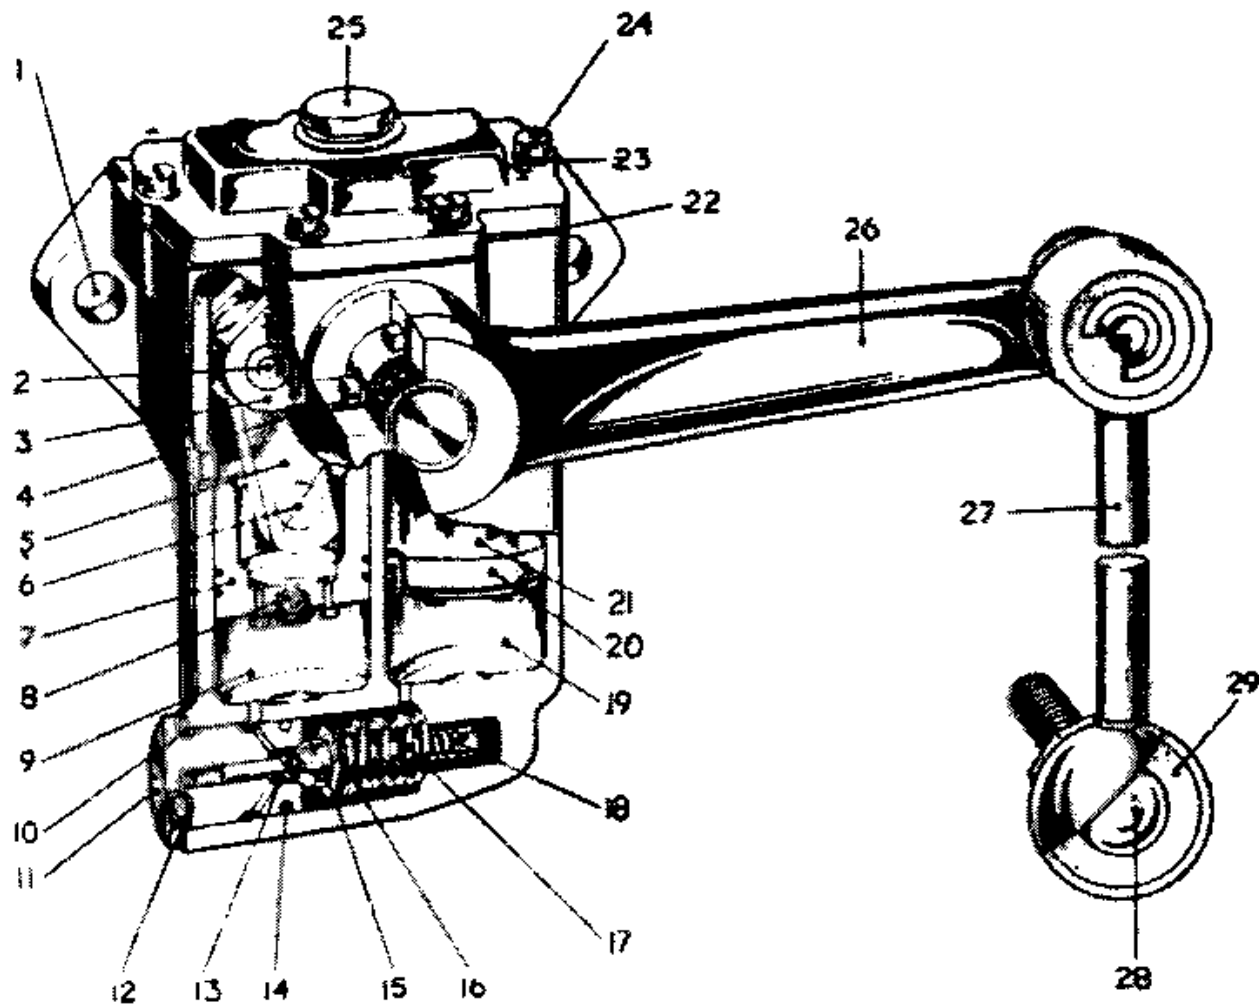
Fig. 11.15. REAR SHOCK ABSORBER COMPONENTS

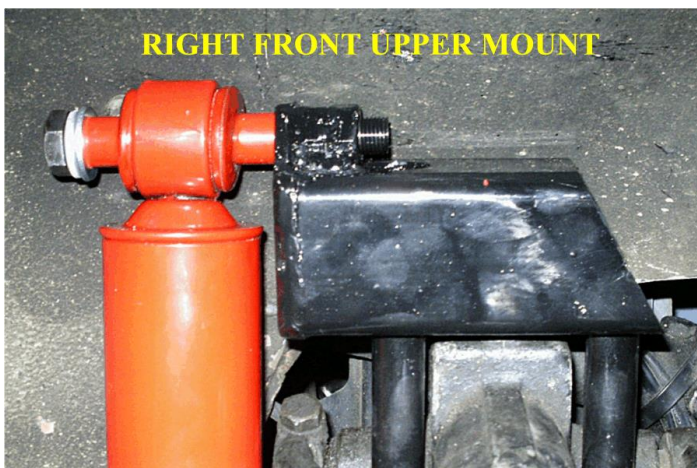
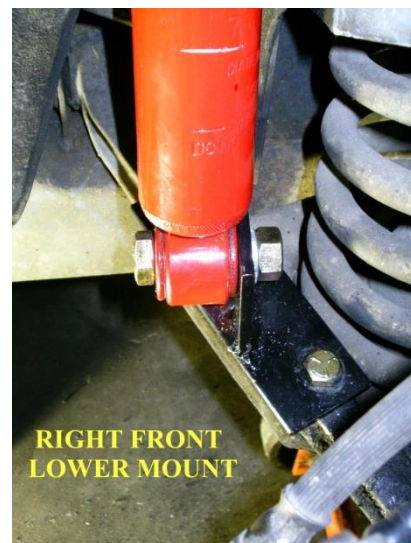
FRONT UPPER RIGHT BRACKET FOR GABRIEL 81464 SHOCK ABSORBER THE LEFT BRACKET IS A MIRROR IMAGE

I made and fitted the fronts and the ride was defiantly better, the front dipped slightly under braking which never happened with the lever arm shocks. So then the rears were made and fitted, as the weight distribution is 50/50 I used the Hyundai - GABRIEL GUARDIAN GAS 81464 – ones again and was pleased with the result.

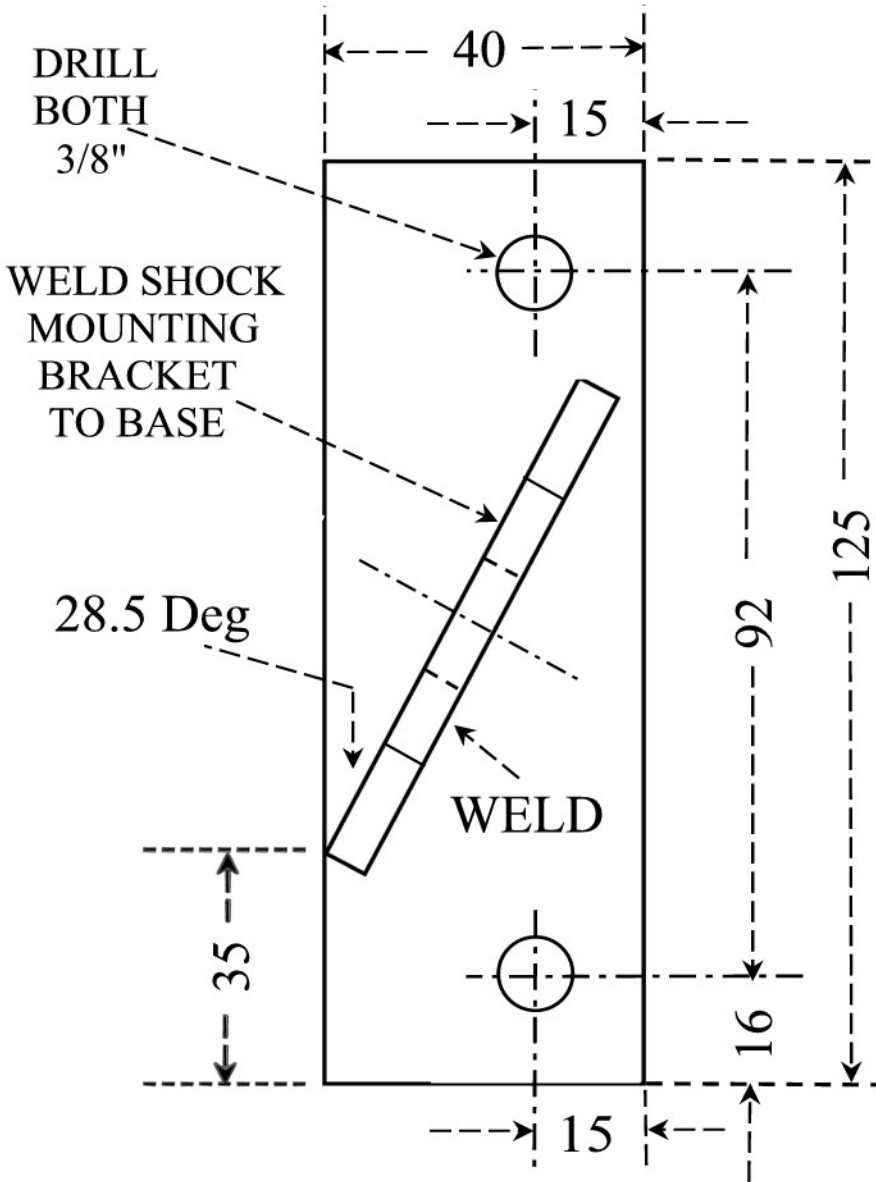
FOR GABRIEL 81464 SHOCKABSORBER

LEFT BRACKET IS A MIRROR IMAGE

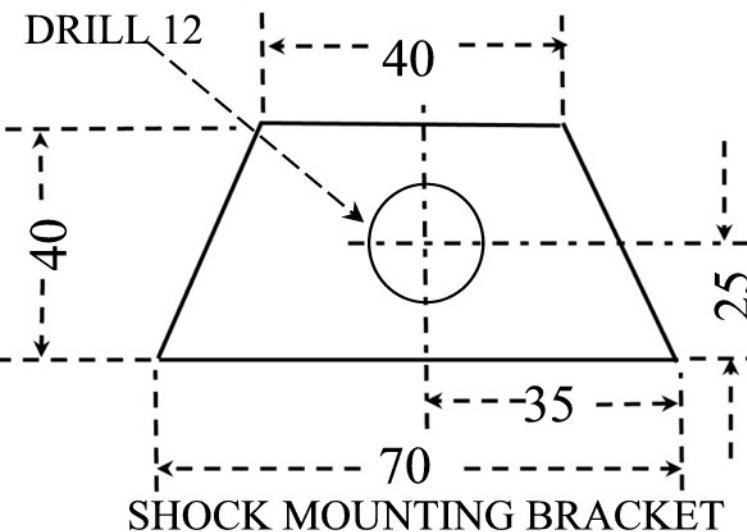
TACK THE SHOCK
MOUNTING BRACKET
IN PLACE AND THEN
CHECK TO MAKE SURE
ITS AT RIGHT ANGLES
TO THE CHASSIS
BEFORE THE FINAL WELD
