A Tasmanian Supra gearbox conversion

100 TECHNICAL CD-ROM

INTRODUCTION

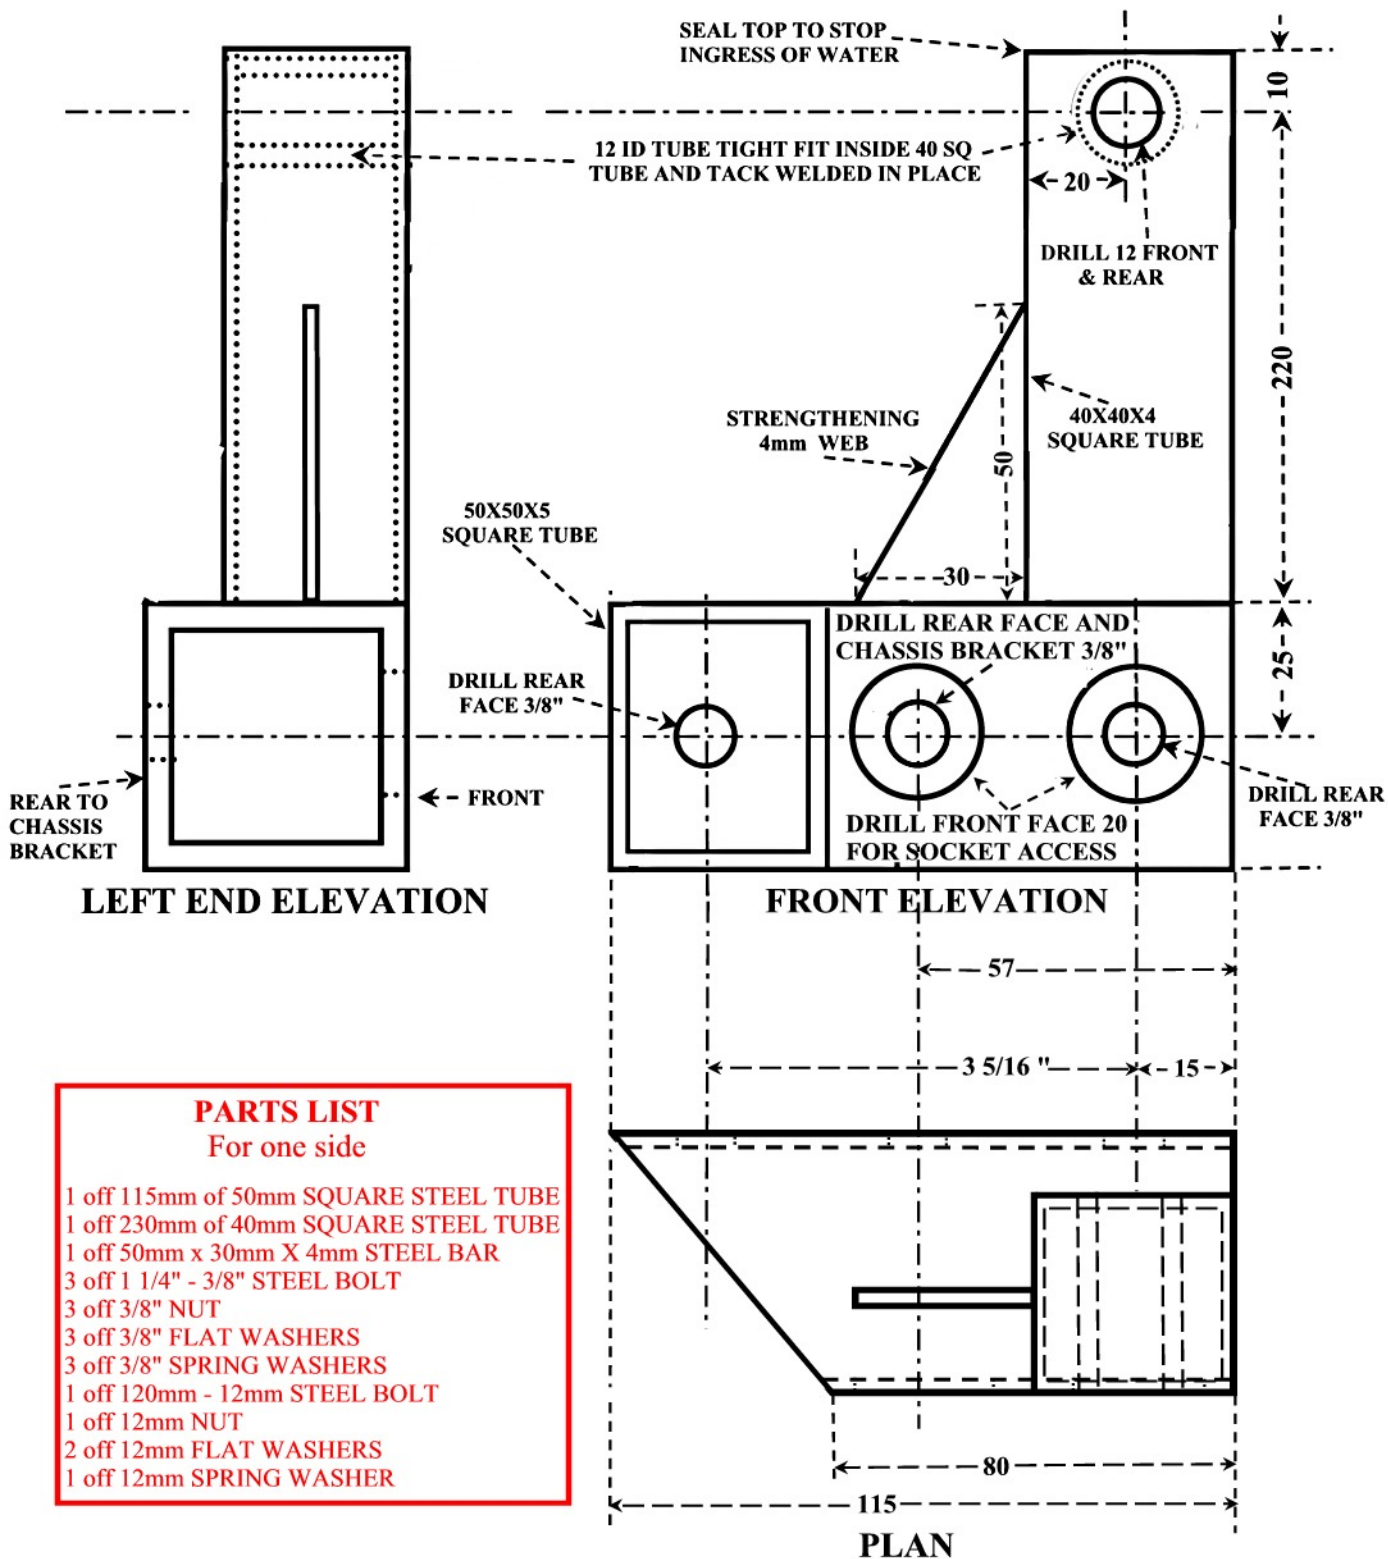
REAR CHASSIS MOUNTING FOR GABRIEL 81464 SHOCKABSORBER (To replace lever arm shockabsorber) RIGHT HAND

Mirror reverse for Left Hand

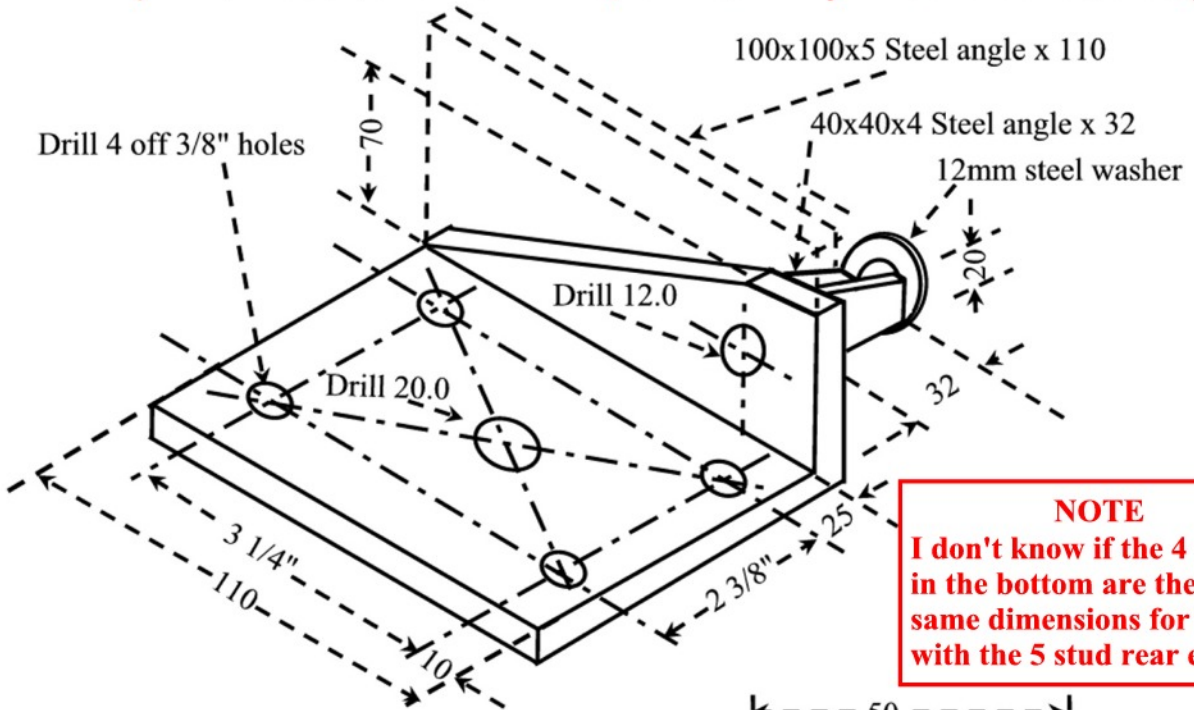
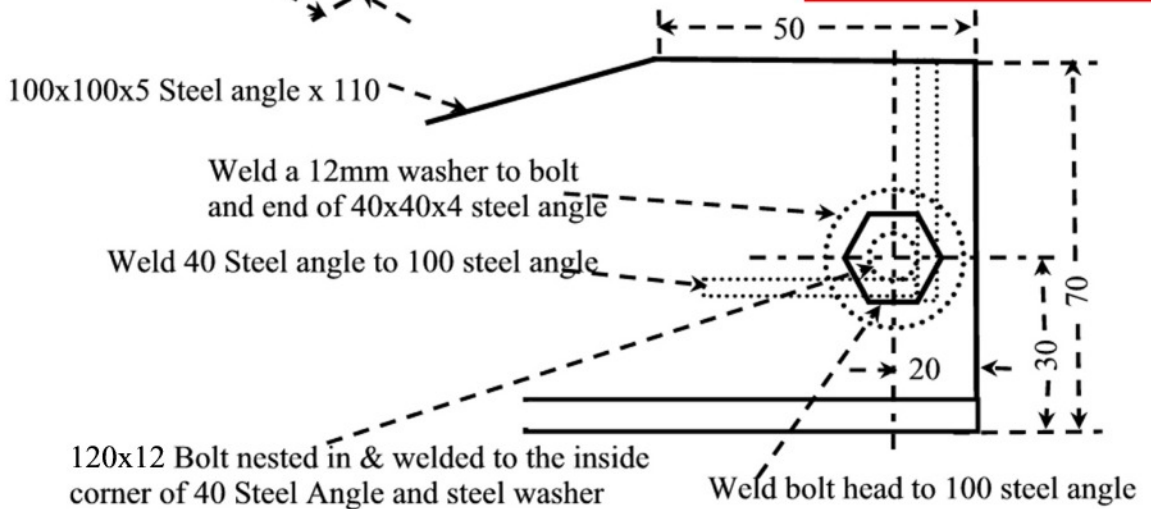
REAR LOWER MOUNTING FOR GABRIEL 81464 SHOCKABSORBER (To replace lower spring mounting plate)

(Mirror reverse for left hand, exhaust may have to be lowered)

DETAIL OF 12mm BOLT POSITION

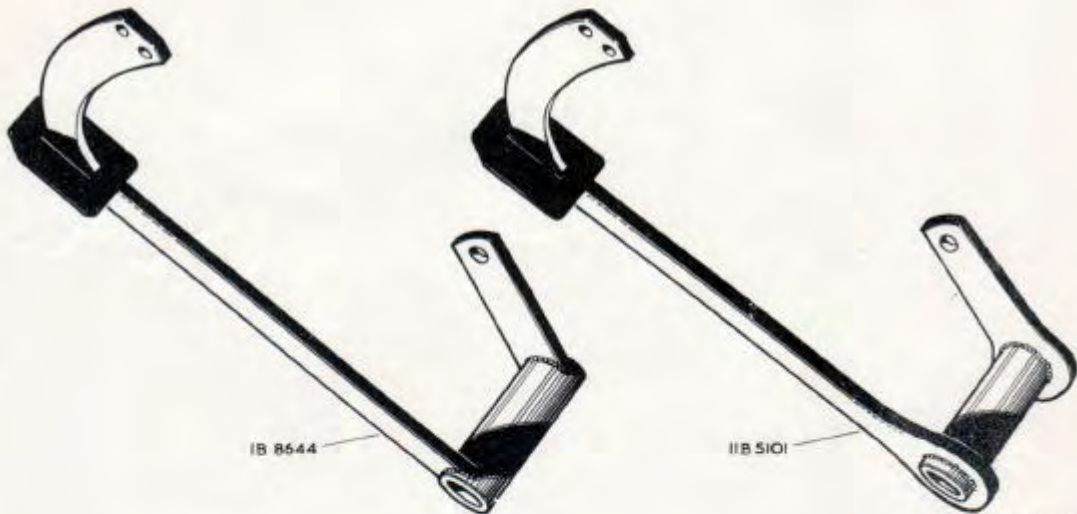
The new brake pedal lever will be supplied for replacements when stocks of the old ones are exhausted.

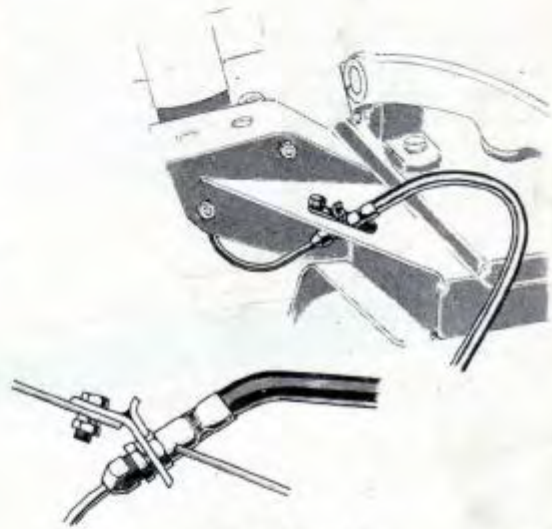
STR 1685

New arrangement.

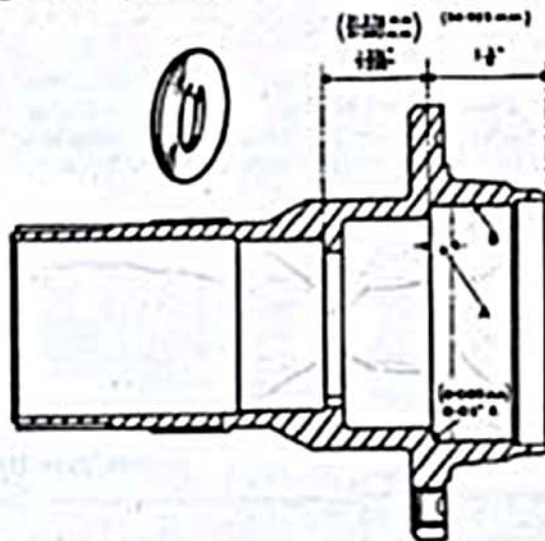
STR 1718

When machining the extra depth A care should be taken not to touch the original surface B.

The special front hubs, taper roller bearings and washer for nut can be fitted together to replace the original ones on cars in the following chassis number range:—138031-228046 except 227505, 227511, 227514, 227536, 227542, 228008, 228026.

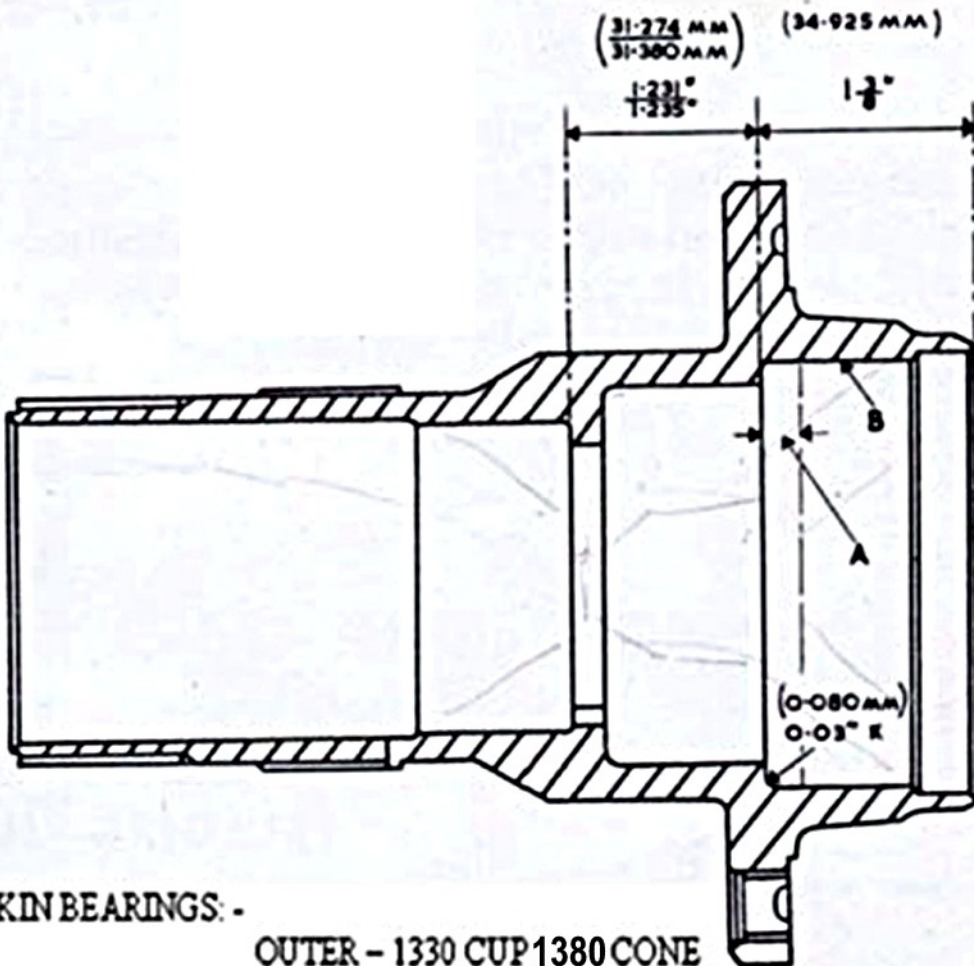
TIMKIN BEARINGS: -

OUTER - 1330 CUP 1380 CONE

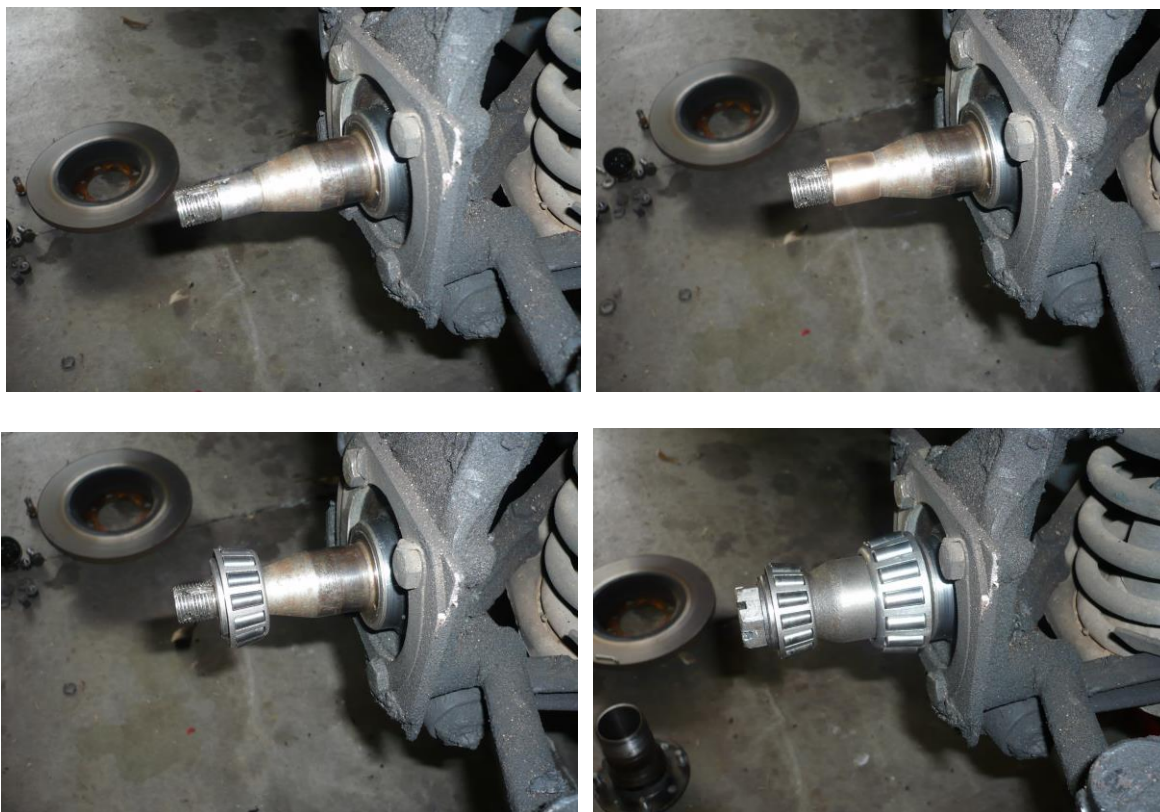
HEALEY HUB DIMENSIONS

TIMKEN BEARINGS
 INNER 2523 CUP 2582 CONE
 OUTER 1330 CUP 1380 CONE

The Austin Service Bulletin quotes the
 outer bearings as 1330 Cup & 1351 Cone

**"A" - Extend 0.267" (6.78mm)
 for wider new bearing**

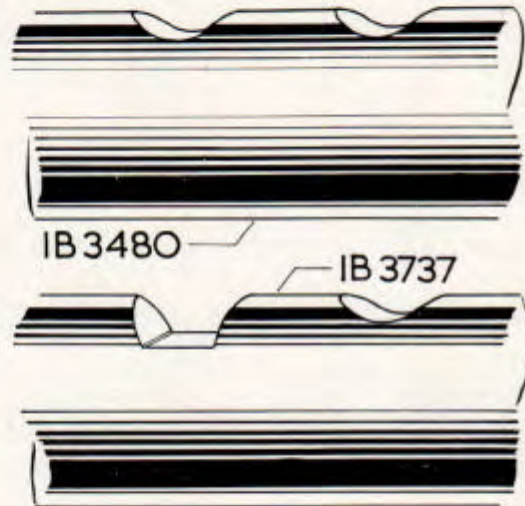
STR 1664

In order to eliminate the possibility of jumping out of reverse gear under exceptionally heavy load conditions, the reverse rod has been modified by deepening the gear engagement groove and altering its shape, see illustration.

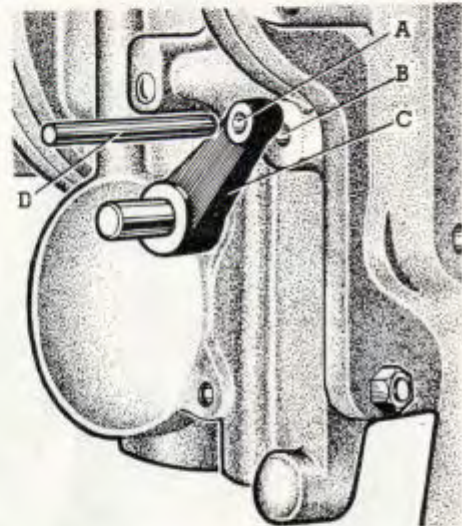
Fig. 1

1. Insert a $\frac{3}{8}$ " pin (D) through the hole (A) in the setting lever (C) into the setting hole (B) on the right hand of the casing. The operating valve in the unit is now held open. Fig. 1.
2. If the solenoid bracket is of the closed type (Fig. 2) remove the cover plate.
3. Loosen the solenoid lever clamping bolt (A). Figs. 2 and 3.
4. Break the snap connector on the solenoid lead and connect through an ammeter to the battery negative, thus energising the solenoid.
5. Check that the current used is about 1.0 amperes. A current of 18-20 amperes indicates that the operating coil is not being open circuited when the plunger is fully home, and that the solenoid is faulty, and must be replaced.

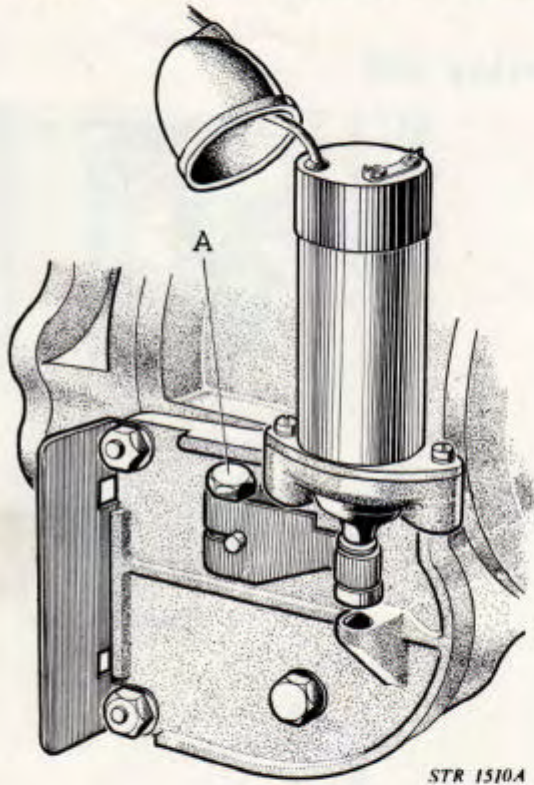
STR 1510A

6. Hold the solenoid lever down against the plunger collar.
7. Retighten the lever clamping bolt, taking care that there is no end play in the cross shaft.
8. Remove the locating pin from the right hand side of the gearbox.
9. Operate the solenoid several times to check the setting and ensure that the current is about 1.0 amperes. If the current is 18-20 amperes, as was previously 1.0 amperes in operation 5, it will be necessary to reset the solenoid lever again.

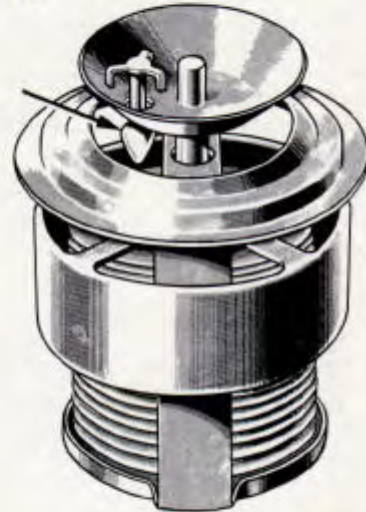
STR 1655

A new thermostat incorporating a 'jiggle-pin' in the vent hole—see illustration, has been introduced. The purpose of the 'jiggle-pin' is to prevent the vent hole from becoming blocked with rust or dirt, and to ensure rapid warming up from cold. When the engine is stopped the pin hangs down under its own weight leaving the vent hole open to ensure that an air lock does not occur when the engine is refilled with water after draining. When the engine is running the pressure of water from the pump forces the pin to rise and seal the vent hole, thus completely closing the waterway until such time as the engine is warm and the thermostat opens.

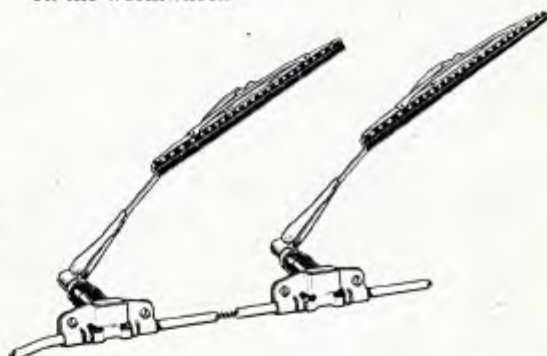
Fig. 1

The wiper is controlled from the instrument panel by a simple "on-off" switch. When this switch is turned to "off", the blades come to rest at the end of a wiping stroke, irrespective of their positions on the windscreen at the instant of switching off. This is arranged by means of

an adjustable limit switch built into the gearbox and connected in parallel with the panel switch, the contacts of the limit switch being opened at a selected point once per revolution by a crank pin on the wormwheel.

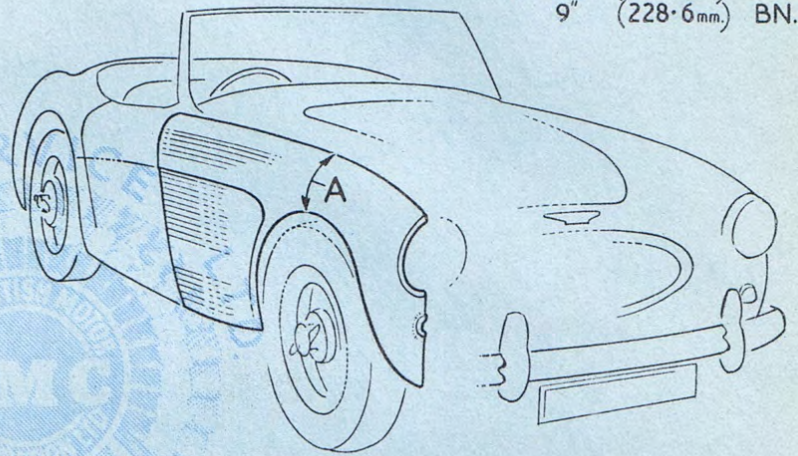
On the Austin-Healey BN 1 model it has been found that, upon rare occasions when either of the front road springs is fully compressed and the steering is on full lock, the tyre has a tendency to foul the front wing panel.

A = 9½" (241.3mm) BN.1
9" (228.6mm) BN.2

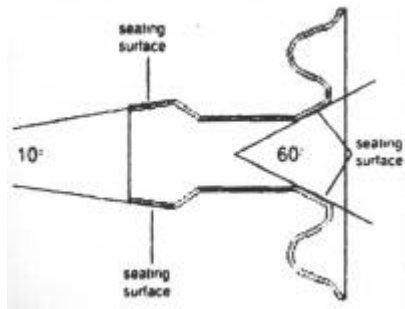
Figure 1

There are many opinions and misconceptions regarding balancing of "spline-drive" or "center-lock" wheels. To properly balance this special type of wheel, it must be centered in exactly the same manner that it is centered on your par. Figure #1 illustrates the two "seating surfaces" (the inside rear bevel, and the outside front bevel) that center the wheel. These two bevels are typically "machined" surfaces -- as opposed to exact surfaces that remain "rough cast". Note that the actual splines drive the wheel but do not center it - in fact, worn splines (on either the wheel or the hub of the car) can negatively affect the centering of the wheel, and cause the wheel to appear out-of true.

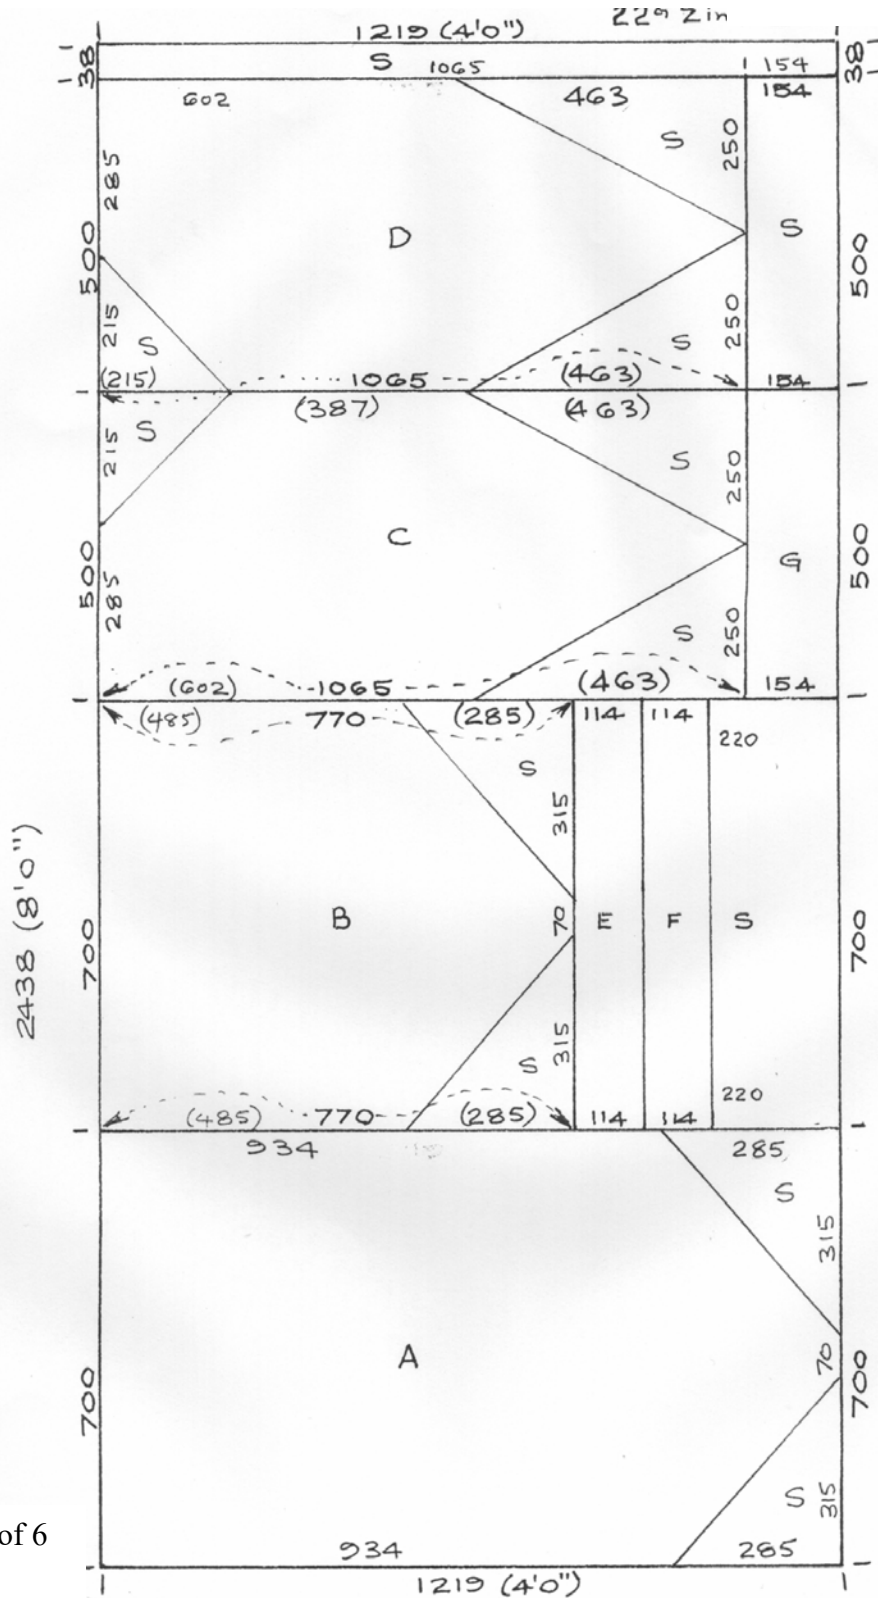
CUTS FOR 8' x 4' 22 Gauge ZINC SHEET

1. "S" Denotes Scrap
2. E & F were used for Light Box.
3. G was used for Vacuum Baffle.

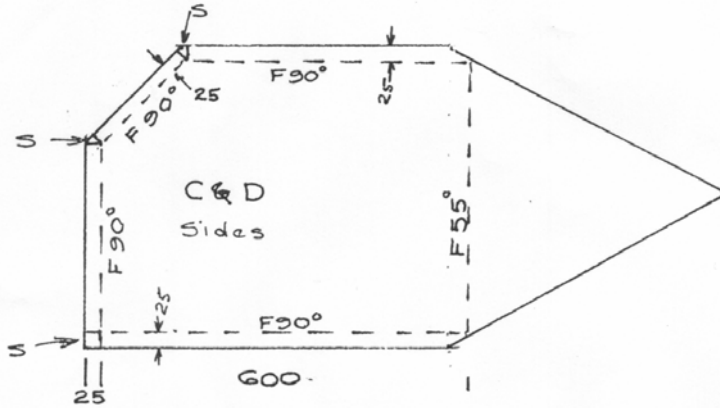
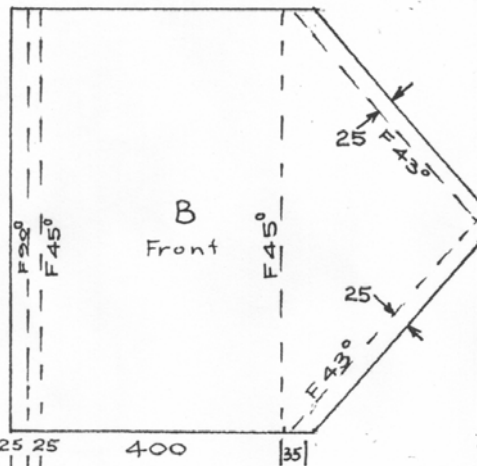
POSITION & ANGLES OF FOLDS

1. "F 45" Denotes fold line & angle.
2. C & D are handed i.e. 1 Right Hand & 1 Left Hand.

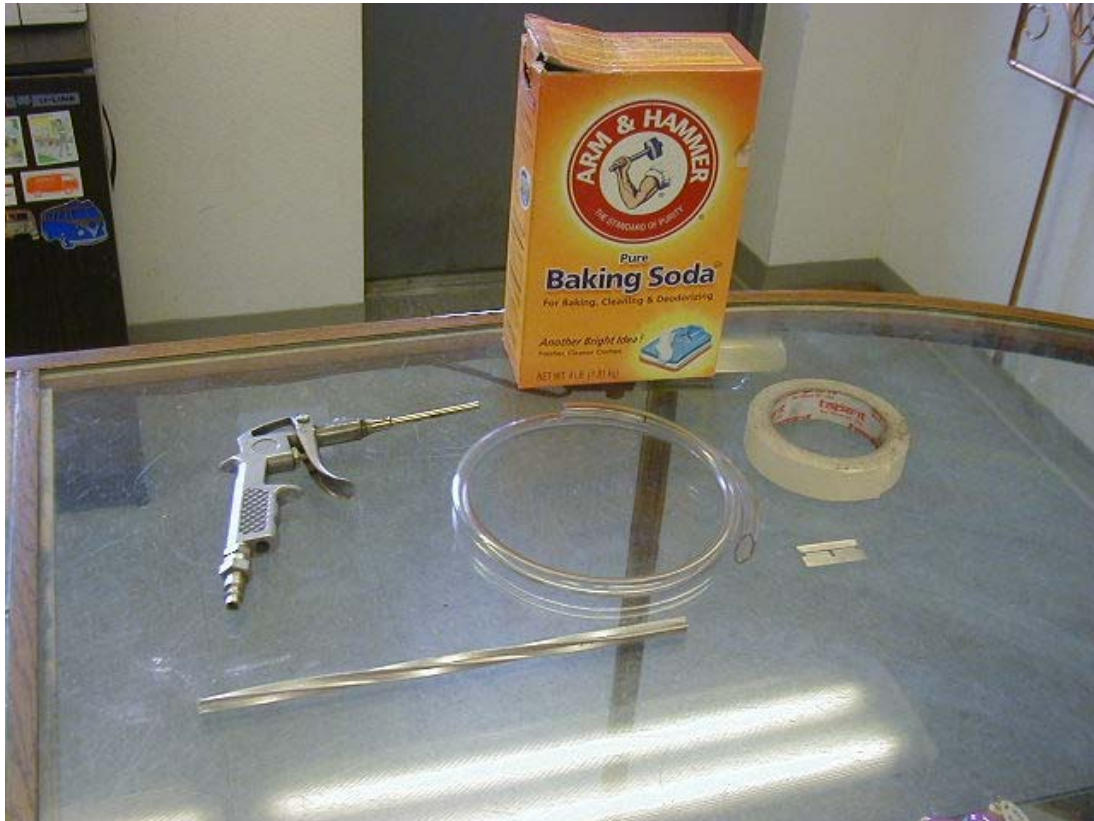
You start by cutting your length of vinyl hose approximately 2-2.5 feet long. Vinyl hose is available at home stores like Home Depot, Lowes, etc. for around \$2.00 for a 10 foot roll. Then measure from one end in about 2" and mark it with a Sharpie.

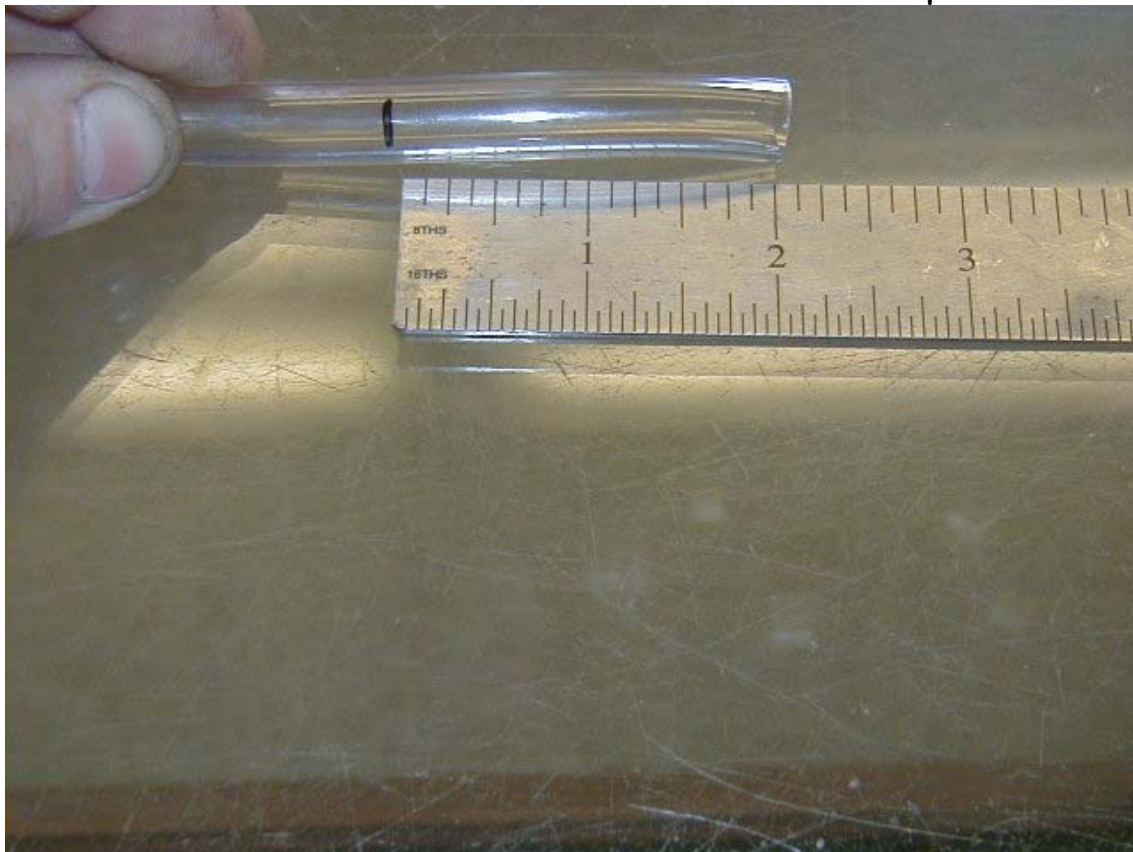
Take your knife or razor blade and make a small cut across the hose ONLY through one side. The cut needs to be just large enough so that the tip of the air wand attachment will stick into the hose. Stick the tip of the air wand into the hose and let it stick in about 1/4" - 1/2".

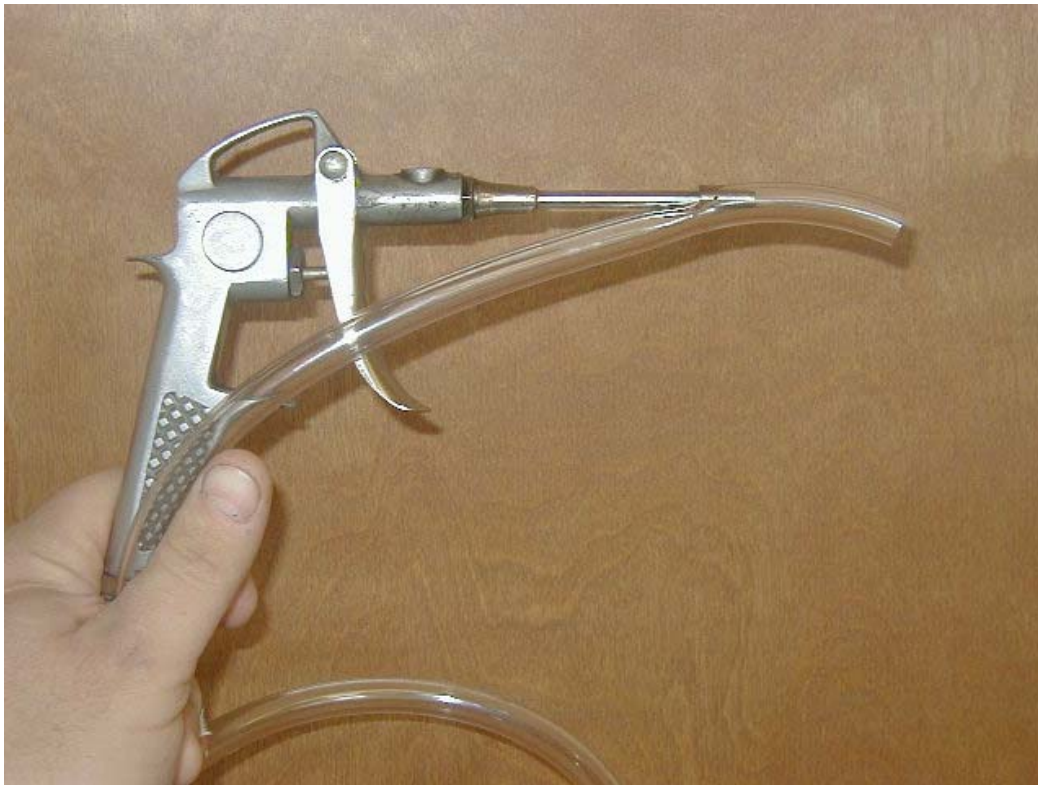
Positioning your wand tip like this will create a venturi effect in the hose causing the soda to be pulled up from the box by low pressure and mixed with the high pressure air from the wand. Use one length of tape to wrap around the end of the air wand and hose. This will keep the hose in the proper position on the wand tip during blasting.

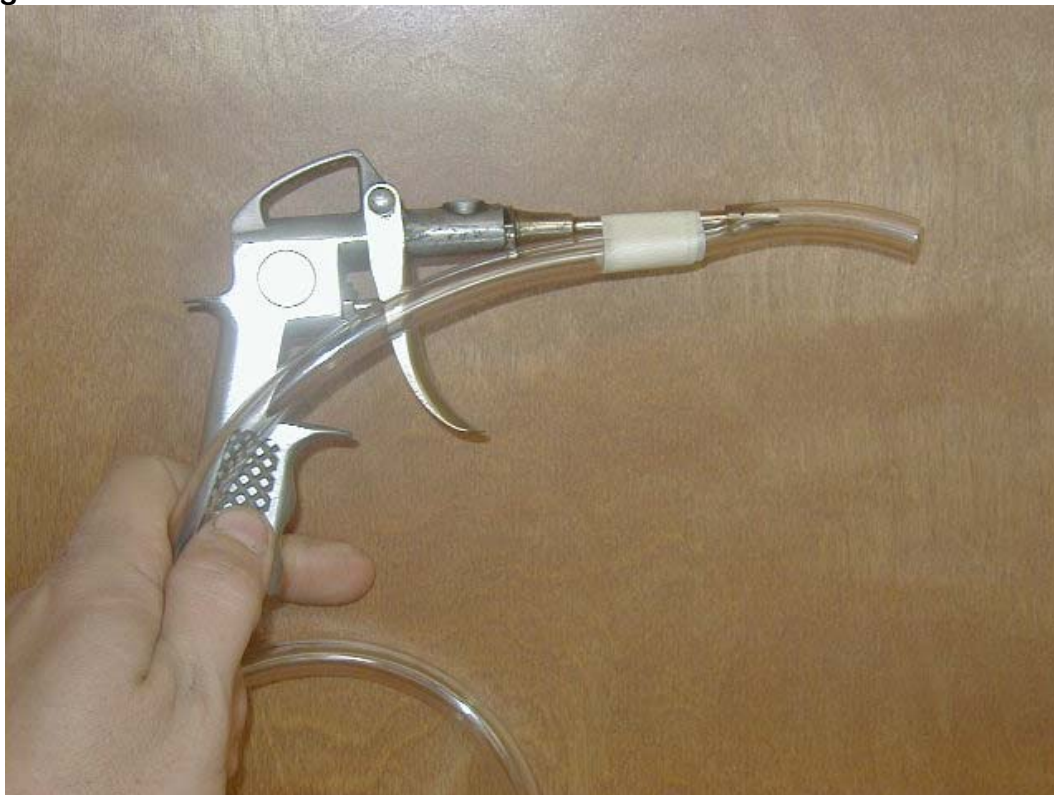
I cut the other end of the vinyl hose at a 45 degree angle to allow better flow of the soda into the hose. Then I tape the piece of dowel, metal rod or wire to the other end of the hose. This will help keep it from curling up in the box of soda and help you keep good flow into the hose. You will need to periodically shake the box to keep the soda flowing nicely.

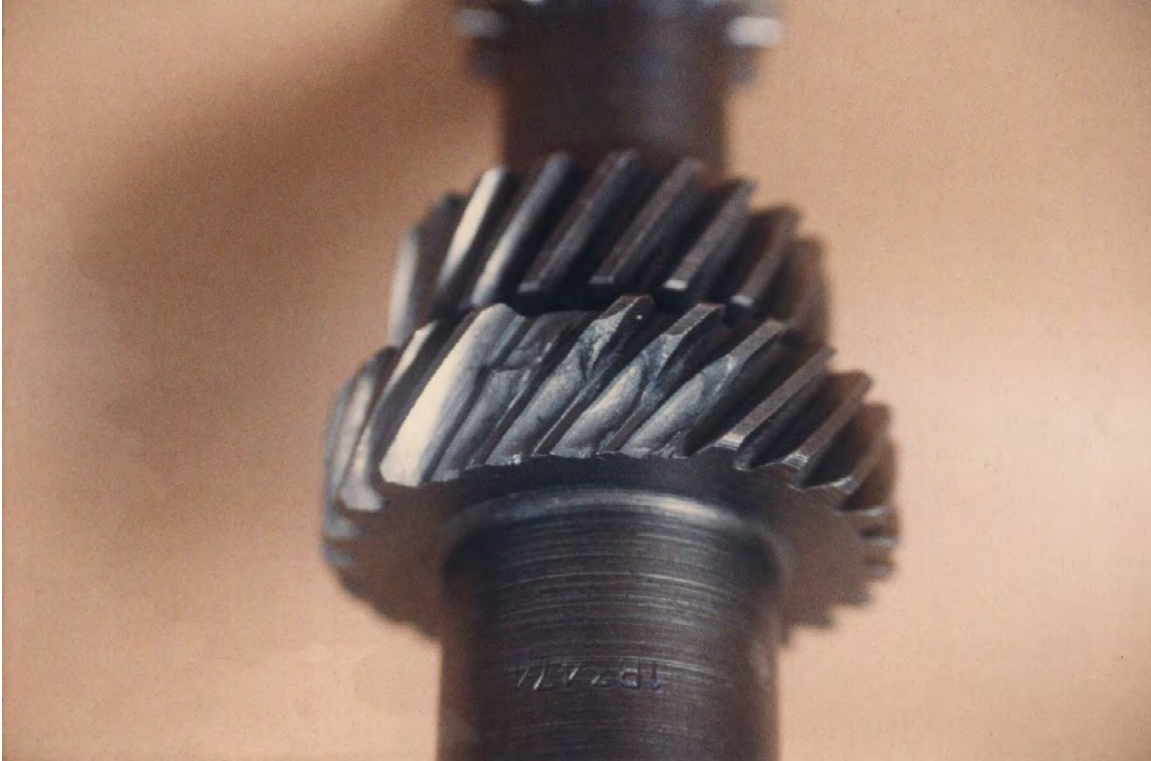
In March 1988 just 6 months after I bought the Healey the gearbox cluster 2nd gear lost one tooth and part of three others.

Club spares had an A70 gearbox, so with a rebuild using the best parts (as the original box had A70 gears) and new bearings we were back on the road fairly quickly.

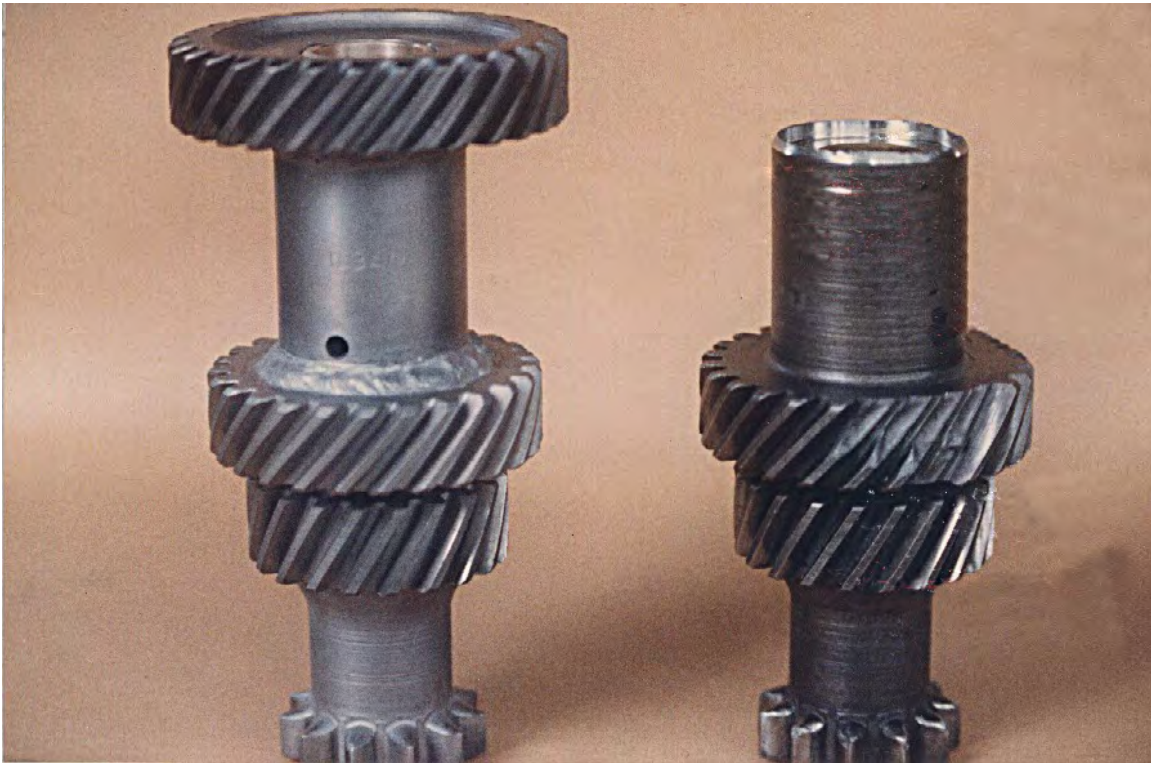
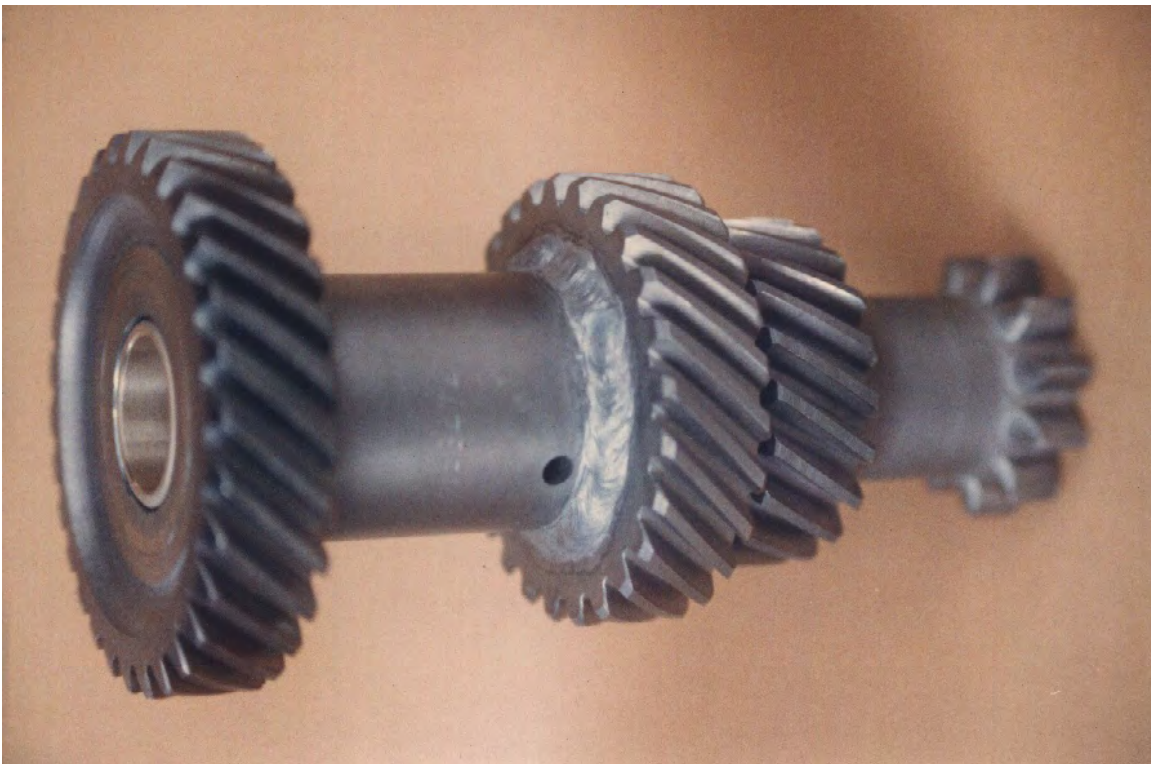
The repaired cluster and the remains of the donor.

The repair has now done 62,984 miles, so hopefully it will go for many more. I must admit I try not to stress 2nd gear with high revs at full throttle.

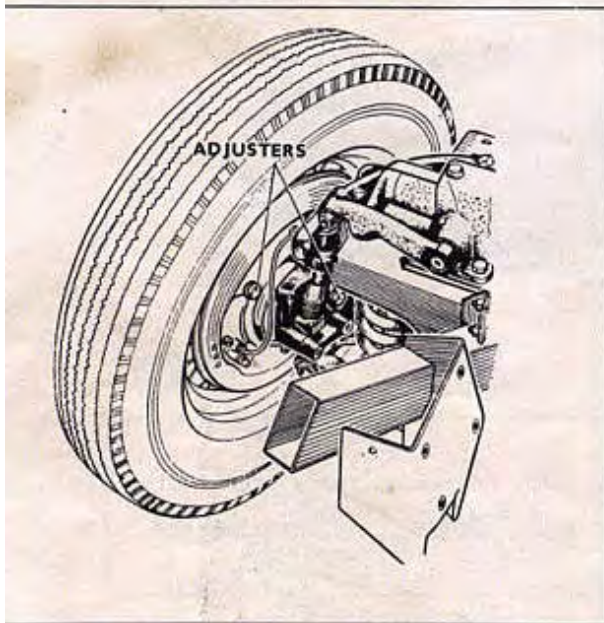
FIG. 1 Front brake adjustment.

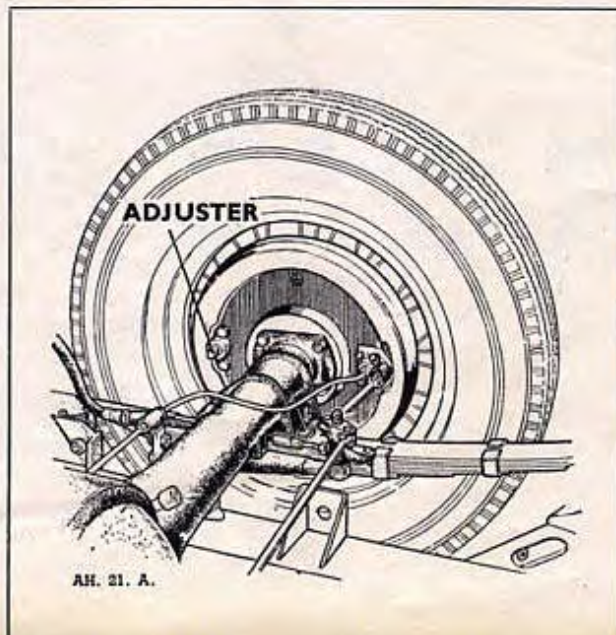
To adjust the rear brakes, first scotch the front wheels, release the handbrake and jack up the rear wheels. Turn the square adjuster stem—protruding through the backplate, in front of the axle—in a clockwise direction until the shoes are locked up in the drum, slack back two "clicks" when wheel should rotate freely, jack down and test.

FIG. 2 Rear brake adjustment (early type).

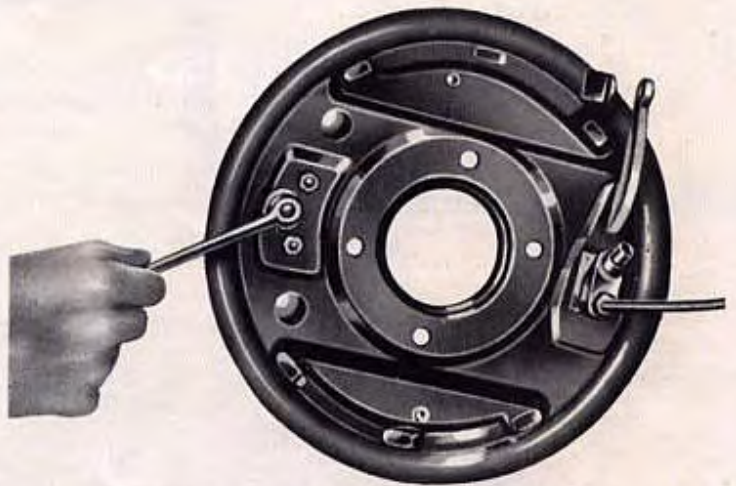
FIG. 3 Rear brake adjustment (later type).

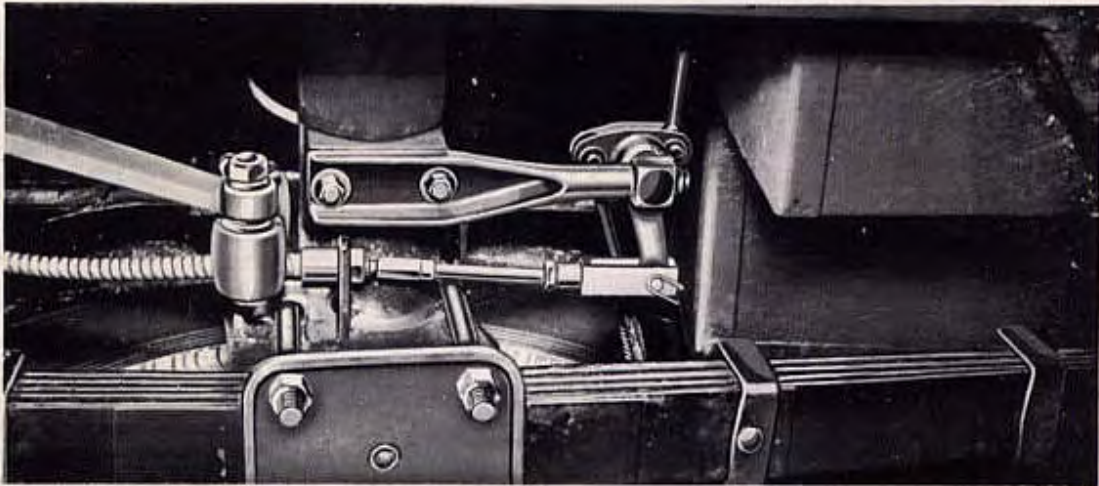
FIG. 4 Hand brake cable adjustment.

If after adjusting the rear brakes there is still excessive free play of the handbrake it may mean that the cable requires adjusting.

To do this, first lock up the shoes in the drum, apply handbrake one notch and take up any slack in the cable by means of the adjuster on the cable, at the compensator end.

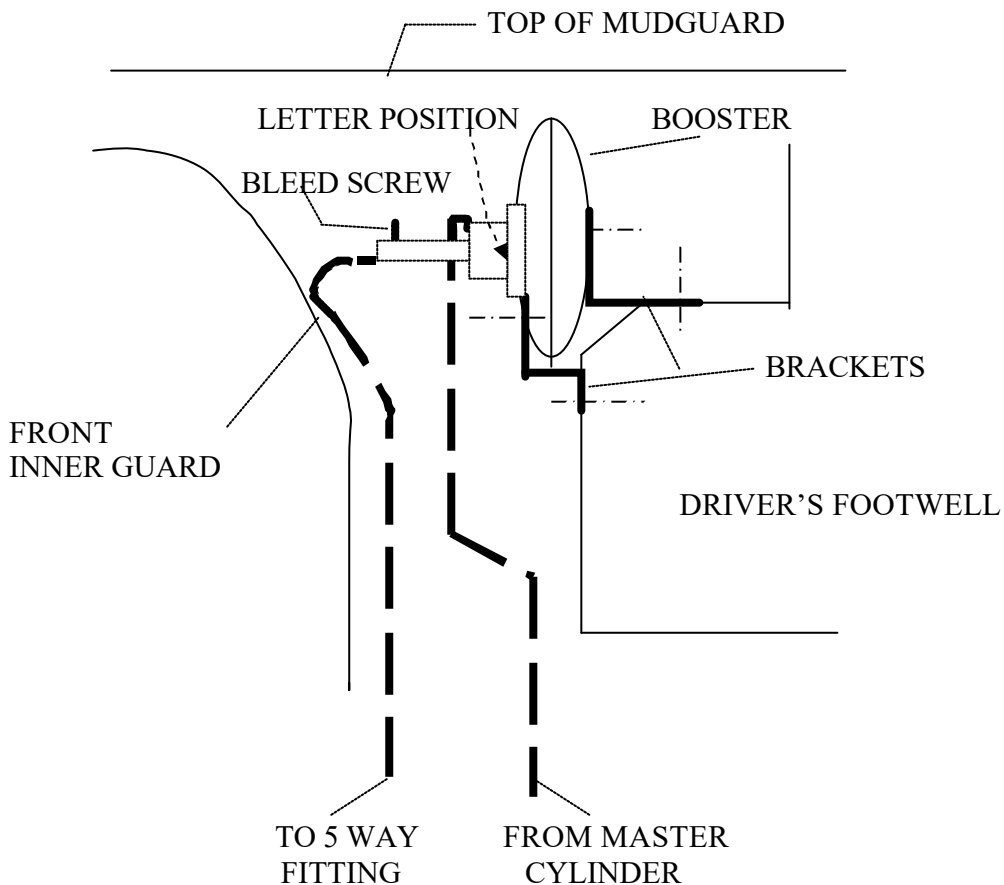
Fig A INSIDE DRIVER'S FOOTWELL

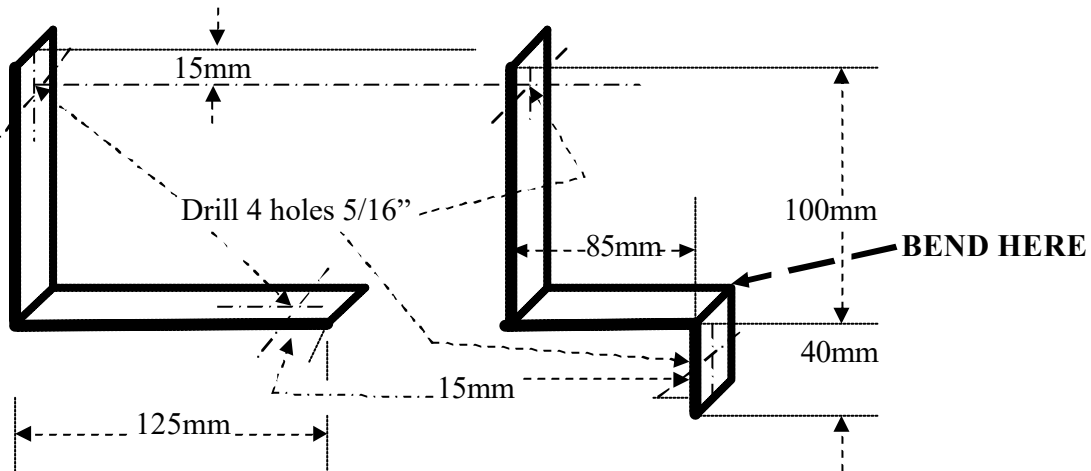
25mm or 125mm depending on which side of the booster the front mounting studs are.

Fig B ANGLE BRACKETS 125 x 100 x 20 x 3

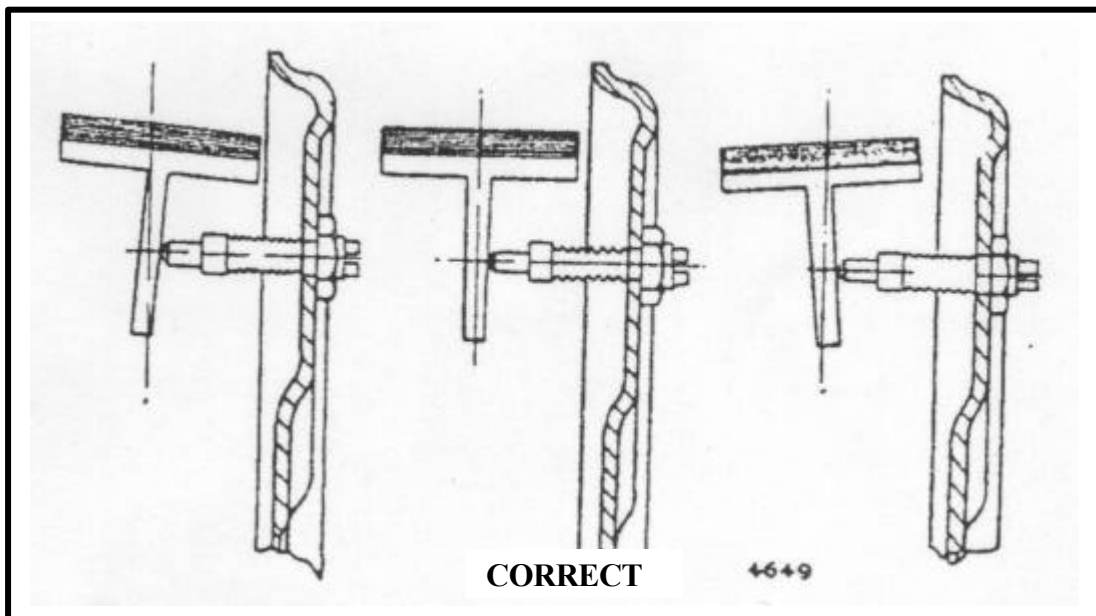
Fig. 1

The steady posts, one for each shoe, are threaded in the back plate and should contact the underside of the brake shoe web. The end of the steady post, accessible at the rear of the back plate, is provided with a screwdriver slot and lock nut (Fig 1). The object of the steady posts is to hold the shoes square with the drum when in the off position. This is important to obviate any loss of travel. The shoes must be ready to contact the drum immediately without tilting and with a minimum of travel.

- A. Loosen lock nut.
- B. Unscrew (screwdriver in slot) the adjustable steady posts two turns (anti-clockwise).
- C. Adjust shoes to the drum with the normal shoe adjusters on the rear, until the drum cannot be turned. The front shoes will require an assistant to apply the foot pedal-holding the brakes on.
- D. Turn the steady post clockwise until it just contacts the shoe. Feel it touching the-shoe, it must not be hard on.
- E. Tighten lock nut.
- F. Adjust shoes by releasing the rear adjusters to give correct clearance between shoe and drum.
