A Tasmanian Supra gearbox conversion

100 TECHNICAL CD-ROM

INTRODUCTION

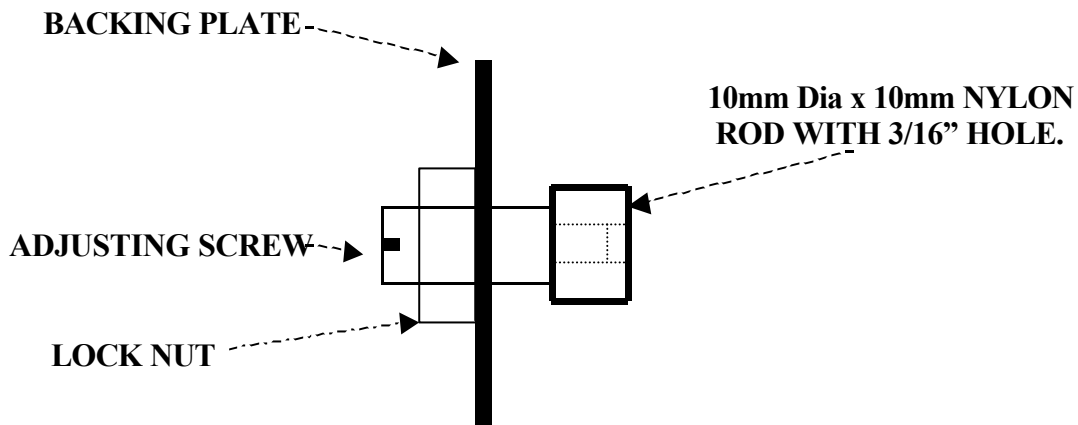
Further to Barry Campbell's Technical Report on Brake Shoe Steady Posts in last months Flat Chat, I have been wearing Nylon End Caps on my Steady Posts successfully for many years (a la Rover 90). The cap is a 10mm length of 10mm dia Nylon rod with a 3/16 inch dia hole down through its middle. It fits over the end of the post, in place of the felt bush, the brake shoe web bears against it and the adjustment is done the same as before. This gives quieter operation (as most felt bushes are long gone), less friction and virtually no wear to the shoe or post. Most shoes are worn where they bear against the post so nothing is to be gained by not taking the hole right through the cap.

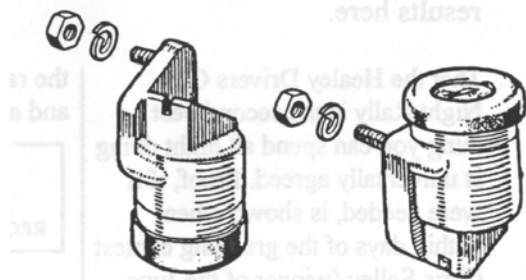
Typical Front Wheel Cylinders

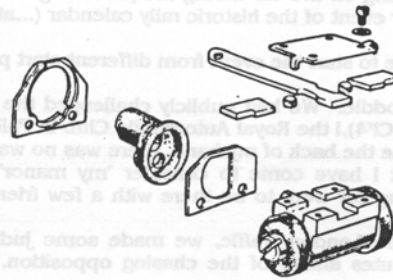
Early Rear Wheel Cylinder (with handbrake mechanism)

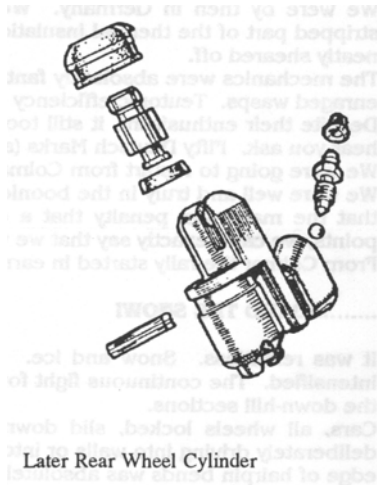
Later Rear Wheel Cylinder

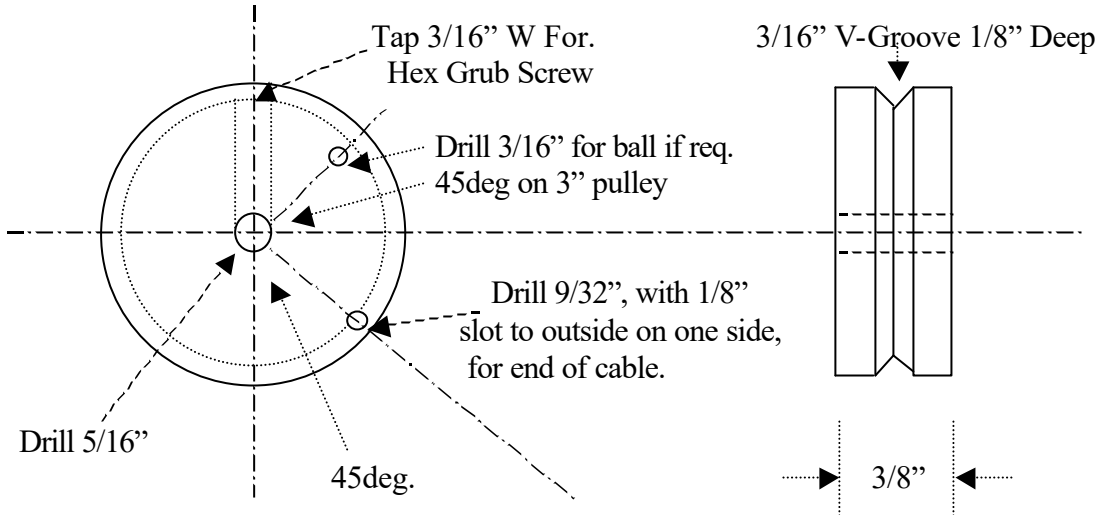
Fig 1 - 2 Pulleys - one 3" Dia. the other 2" Dia.

3" Aluminium pulley	Fig. 1	You will have to get these machined
2" Aluminium pulley.....	Fig. 1	" " " " " " " "
Rear carby bracket.....	Fig 2A & 2B.....	Can be made up in the home workshop if you have a welder.
Outer cable socket	Fig 3	Can be made up in the home workshop
1 off 3/8"W x 3/4" Bolt, spring & flat washers.		
Outer cable socket drilling position.....	Fig 4	
Outer cable adjuster	Fig 5	Pushbike brake one will do nicely.
Inner and outer cable (Abt. 1M Long).....		Rear pushbike brake cable.
1 Cable clamp		Midel -Part No AUE 34
2 Springs (if required).....		Midel -Part No AEC 2075
Spring holding bracket (if required)	Fig 6	Can be made up in the home workshop
2 Spring holding brackets (if required).....	Fig 7	Alternate (" " " " ")

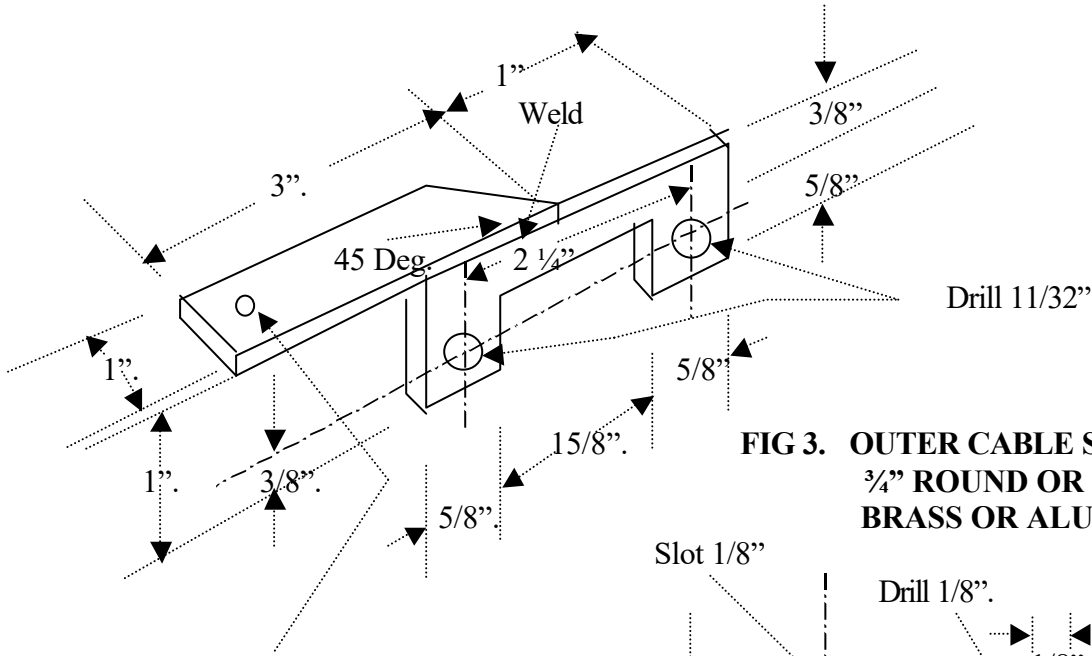
FIG 2A. REAR CARBY BRACKET FOR H 6 & HS 6. 1" X 1/8" STEEL BAR

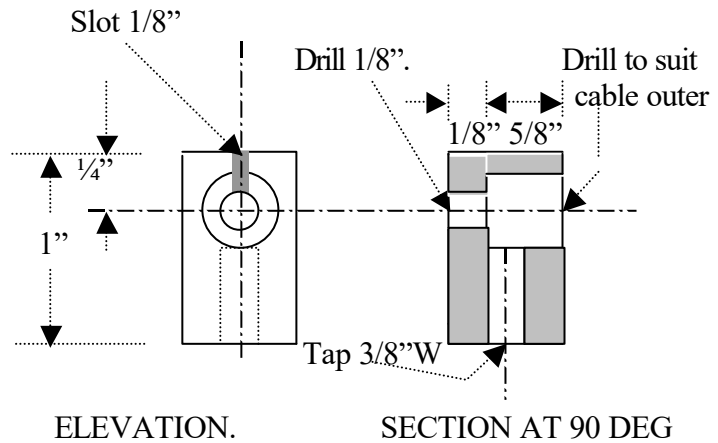
**FIG 3. OUTER CABLE SOCKET
3/4" ROUND OR HEX
BRASS OR ALUMINIUM**

Drill and tap to suit size and position of cable adjuster.

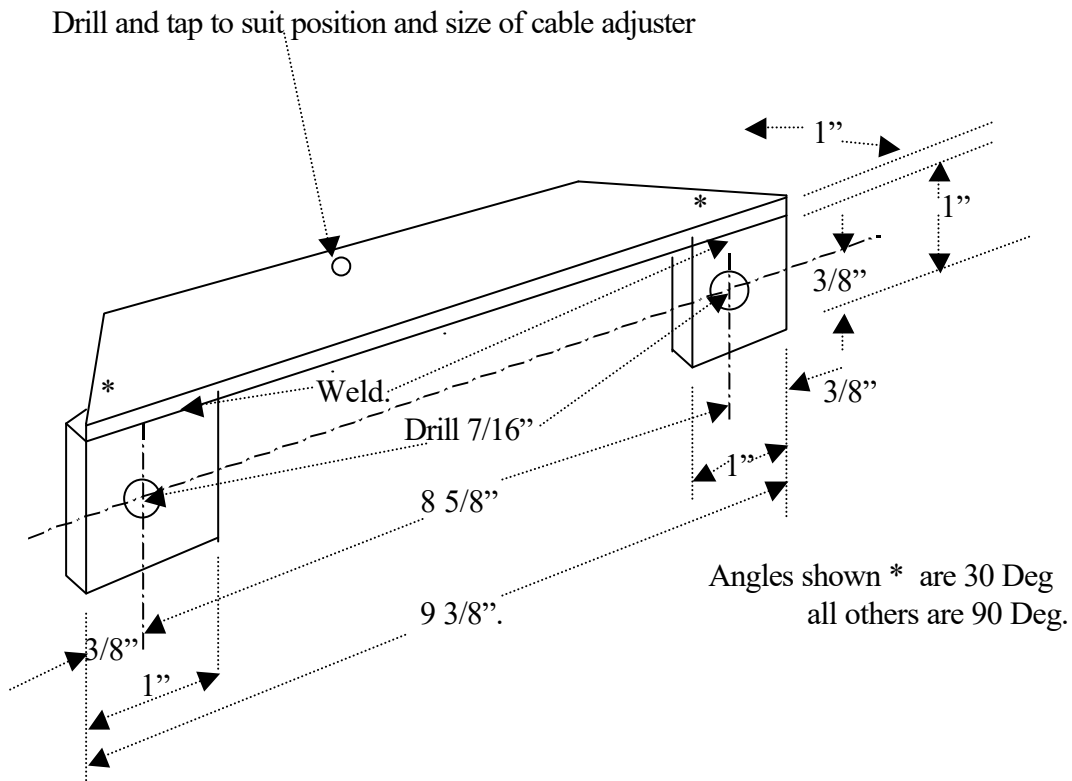
Fig 2B. CARBY BRACKET FOR H4 1" X 1/8" STEEL BAR

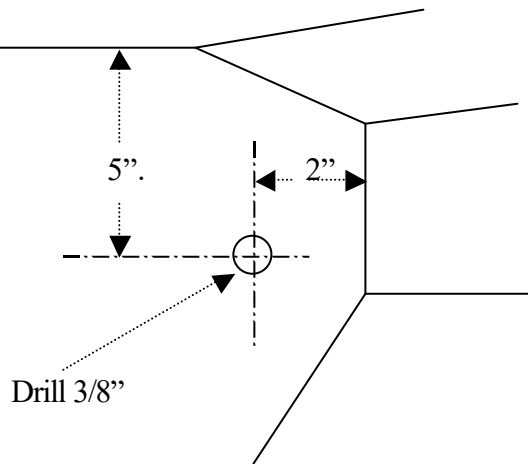
FIG 4. INSIDE LEFT SIDE OF DRIVERS FOOTWELL.

FIT OUTER CABLE SOCKET TO ENGINE BAY SIDE

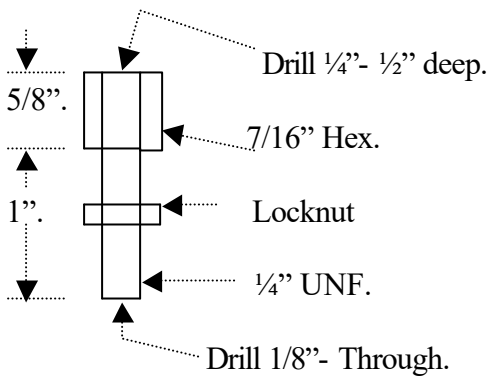
FIG 5 CABLE ADJUSTER

OR PROPRIETARY CYCLE
ONE ABOUT THIS SIZE

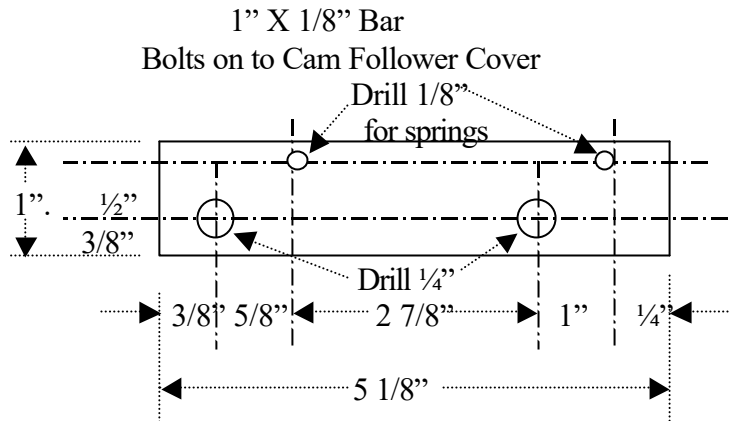
FIG 6 SPRING HOLDING BRACKET

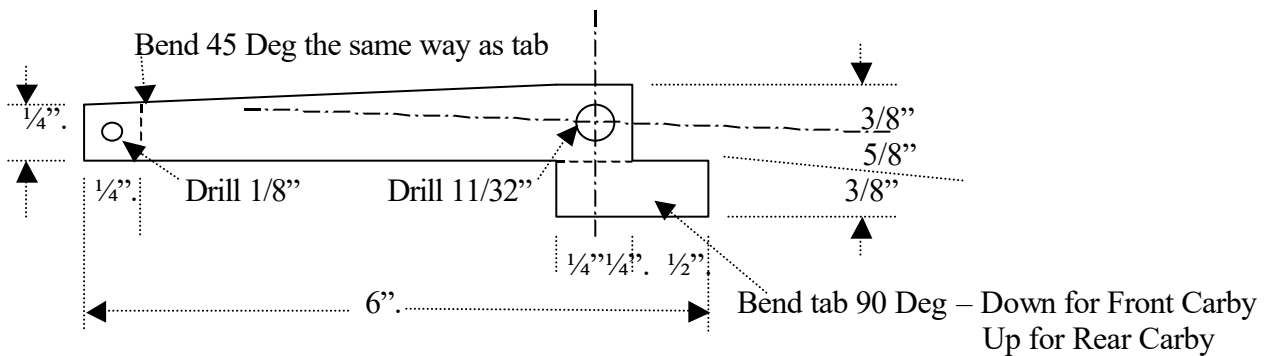
FIG 7. ALTERNATE SPRING BRACKET (HS 6).

Make from 1&3/8" x 1/8" Bar
2 off - Bolt onto lower inner Carby studs.

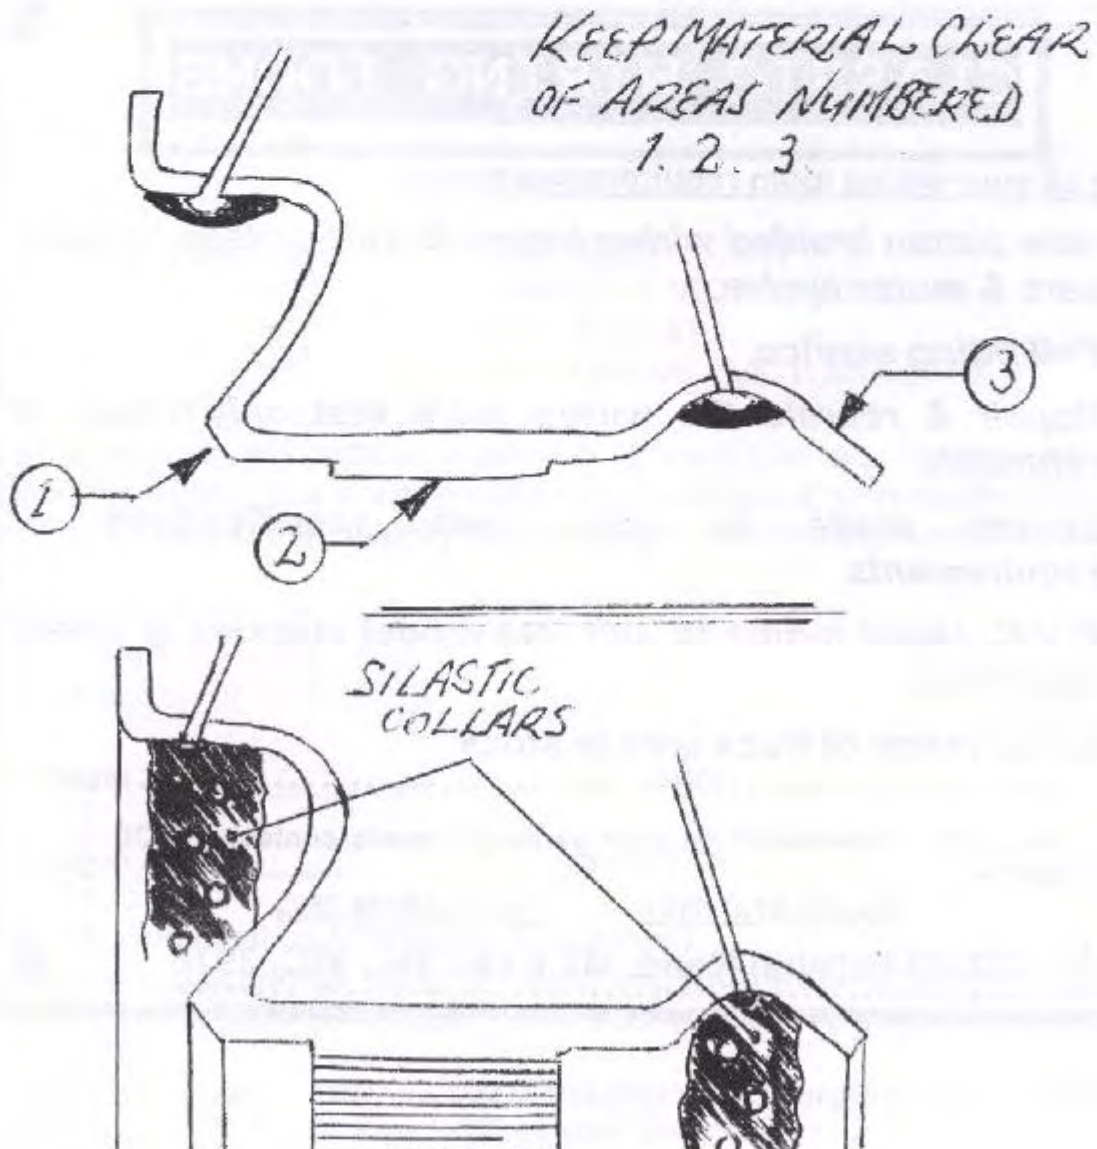
When clean and dry, wipe a liberal amount of SILASTIC (clear) over and around spoke ends, blend material from one spoke to the next to form a collar completely over all ends. A moistened INDEX finger will smooth material for a neat finish.

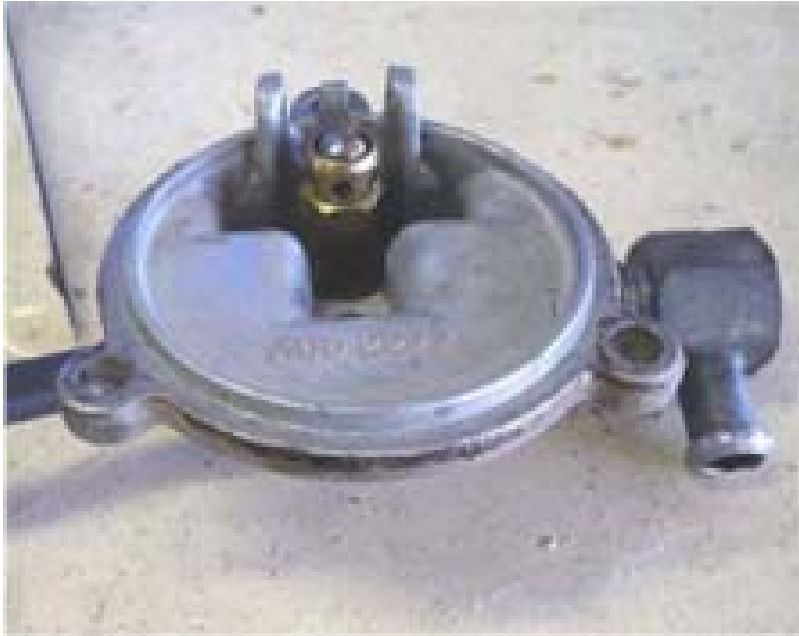
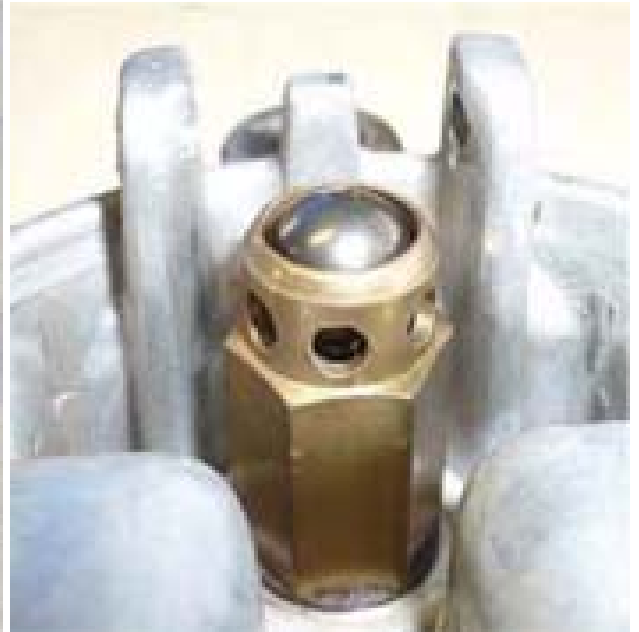
A Grose Jet is simply a valve that uses two balls, the inner one on a circular seat and the outer one is contacted by the float. Unlike a needle valve that can become stuck in its chamber, the balls in a Grose Jet can't. As the float in the petrol chamber rises, it will eventually meet the two pronged fork, as this rises, it will push against the outer ball, which pushes against the small ball, forcing it onto the seat stopping the flow (in the later carbs the float contacts the outer ball). According to the patent, they cope with higher inlet pressures, eject dirt particles, improve high speed running, and don't stick or dribble.

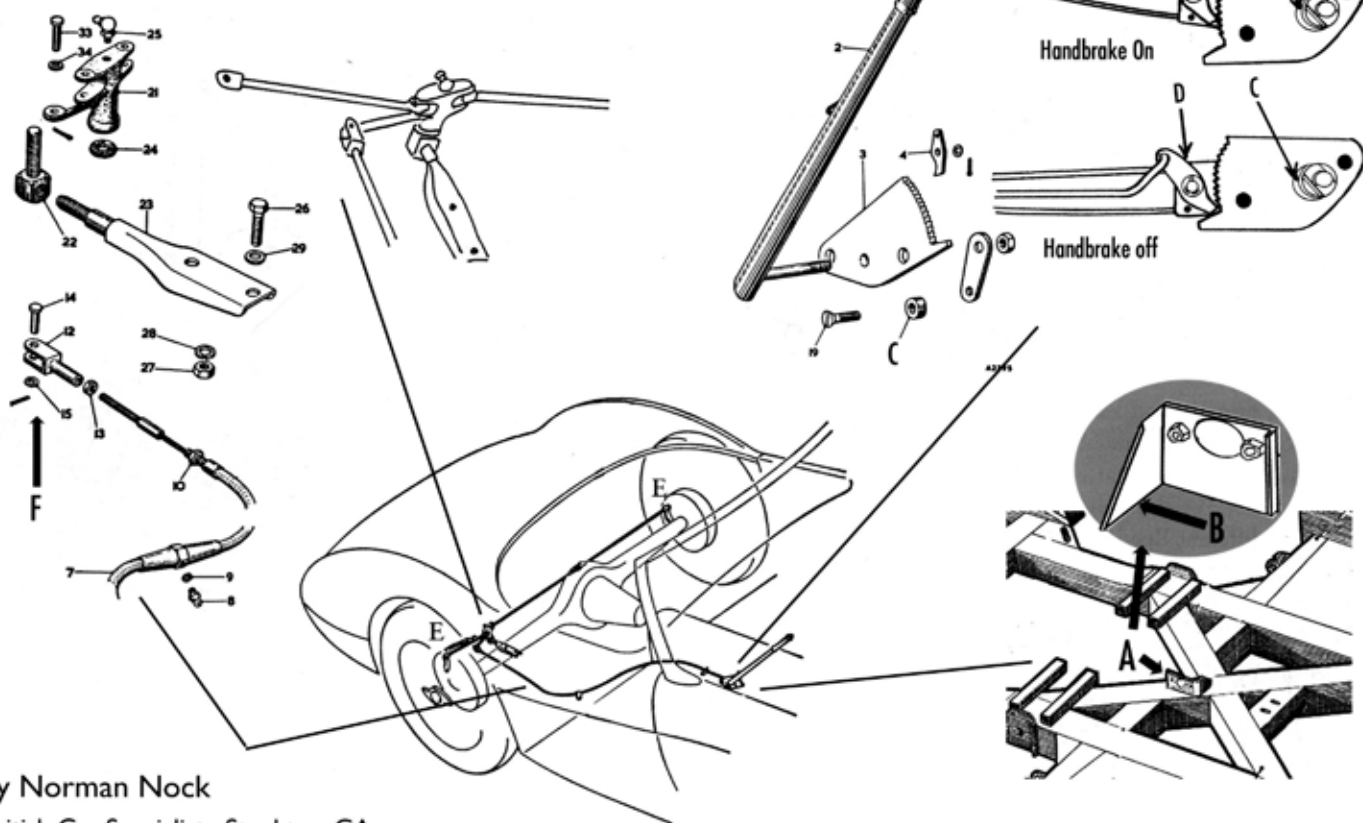
The hand brake lever is, bolted to a bracket (A in the diagram and shown from the opposite side in the inset detail) that is welded to the main chassis rail. Over time if the bushing around the pivot (C in the diagrams) has frozen from rust, and the weld at B was bad, a hard yank on the lever could have broken the weld completely, so that the brake lever moves around in a sloppy fashion.

When the driver pulls the brake lever up, he should press the lever release knob down to release the pawl (D). If the release knob is not pressed then the pawl drags across the teeth causing the pawl to wear, which can eventually prevent the lever from engaging securely with the brakes on. If this is the case the pawl and possibly the hand brake base, might have to be replaced.

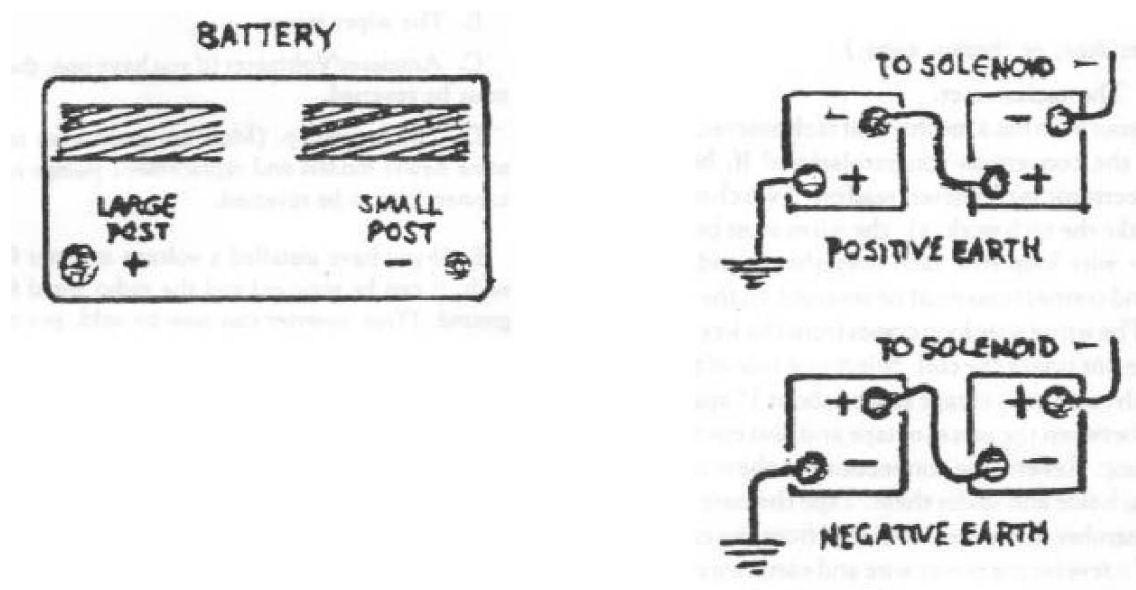
Disconnect your battery and rotate it 180'. You will probably have to change the terminals on the ends of your cables. Now, reconnect your battery the negative post of the battery should now be connected to ground.)

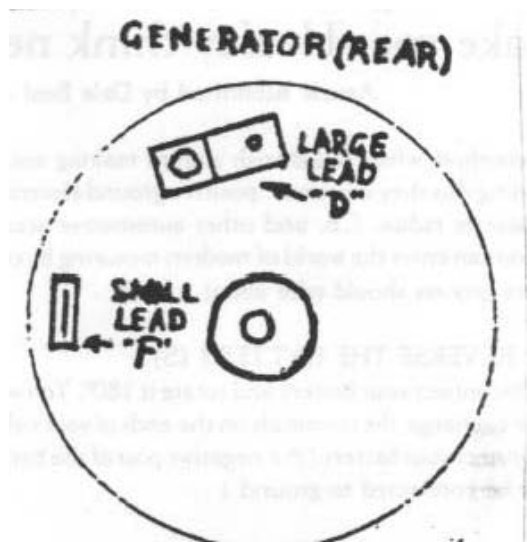
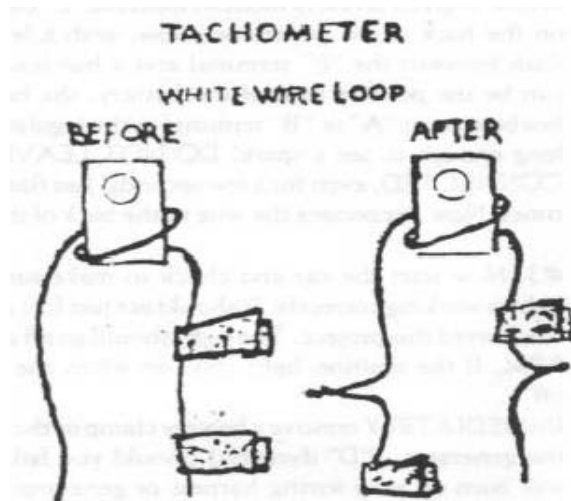
A. – The white wire loop comes from the key switch and travels to the hot side of the coil. Select one side of the wire and tag it with two pieces of tape spaced about 1" apart. Then cut the wire between the pieces of tape and also cut the other side of the loop. Reverse the connections so there is one piece of tape on each side and solder them. Tape the bare sections of wire. (Remember this is the power lead from the coil and is **unfused**.) B --To reverse the power wire and earth wire on the inside of the unit, it is necessary to remove the chrome ring, the glass face and the glare shroud. Then remove the two screws on the back of the unit that hold the internals to the case and allow the internals to drop carefully into your hand. **DO NOT BEND THE NEEDLE!** The spade terminal which carried the green or white wire is the power lead. Next to it is the ground connection. One of the new leads is a resistor (looks like a cigarette filter with a wire at each end). Disconnect the resistor from the lead it is hooked to and solder it to the other lead.

Likewise, disconnect the wire from that lead and connect it where the resistor was connected. In short, reverse the connections. Reassemble the unit (clean the glass)

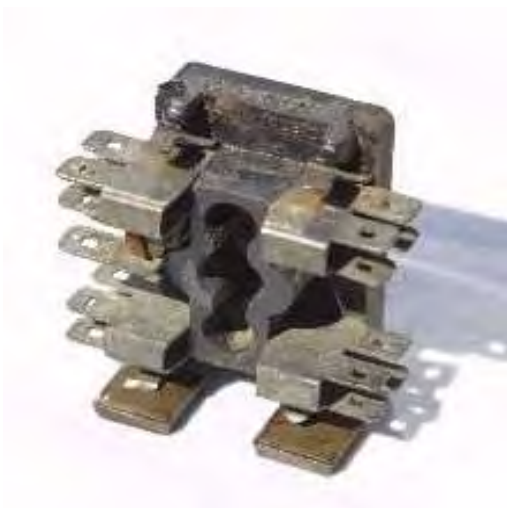
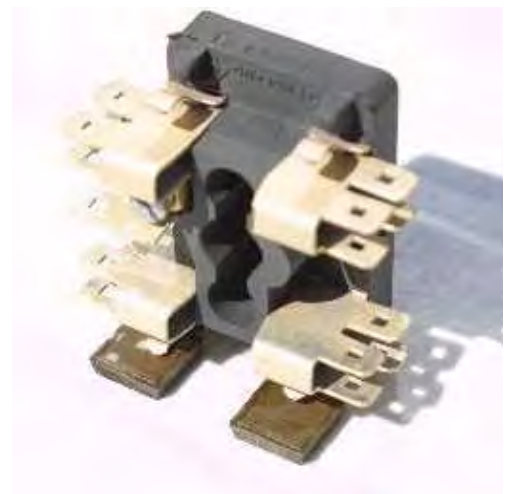
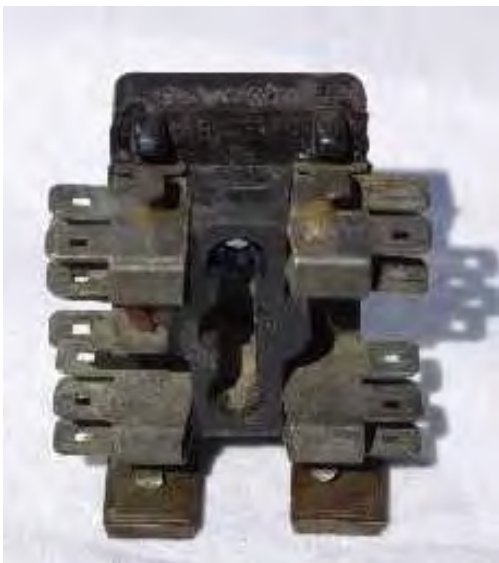
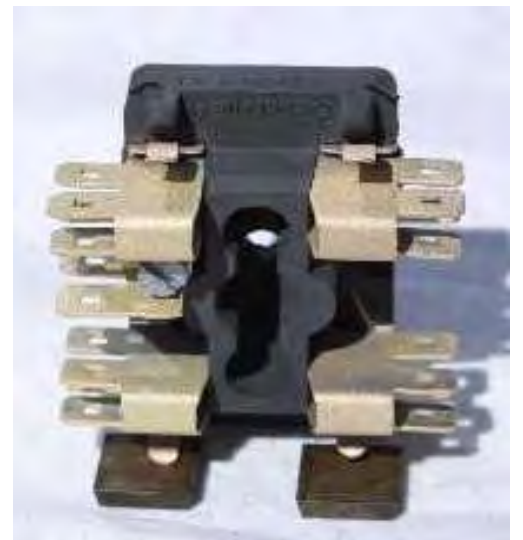
When is the last time you cleaned any of the electrical connectors on your Healey? Well, that's too long. To keep the resistance down from poor contact you should clean the connectors and even the fuse block. Corrosion can lead to resistance at a connector and cause fuse failure. The fuse block shown was lightly glass bead blasted. Other connections can be cleaned with Scotch Brite to provide a good connection. This can make a good winter project.

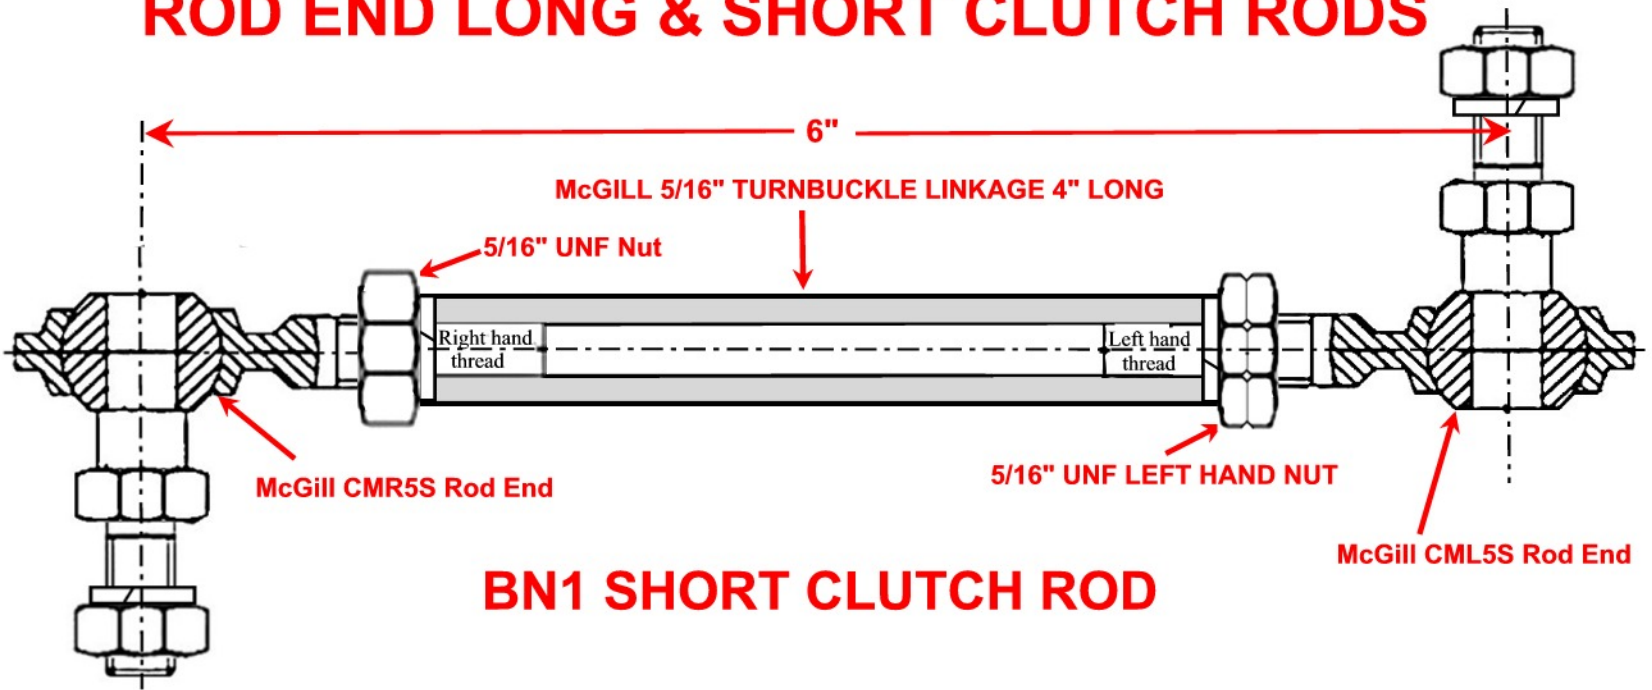
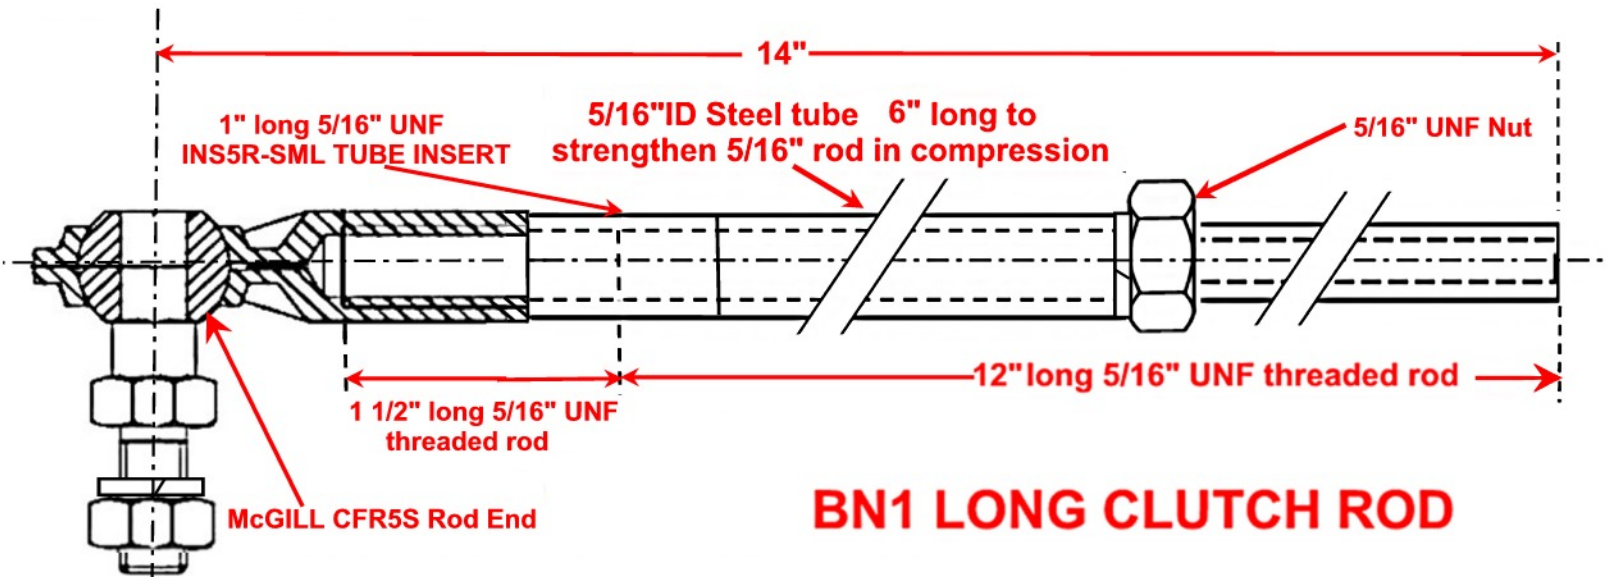
ROD END LONG & SHORT CLUTCH RODS

- PARTS LIST**
- 1 off CMR5S ROD END
 - 1 off CML5S ROD END
 - 1 off CFR5S ROD END
 - 1 off INS5R-SML TUBE INSERT
 - 1 off 5/16" TURNBUCKLE LINKAGE
 - 3 off SEAB1 5/16" RUBBER BOOTS
 - 1 off 12" X 5/16" UNF THREADED ROD
 - 1 off 6" X 5/16" ID STEEL TUBE
 - 5 off 5/16" UNF NUTS
 - 1 off 5/16" UNF LEFT HAND NUT
 - 6 off 5/16" SPRING WASHERS
 - 1 off 5/16" UNF x 1 1/2" SET SCREW AND PERMANENT LOCTITE

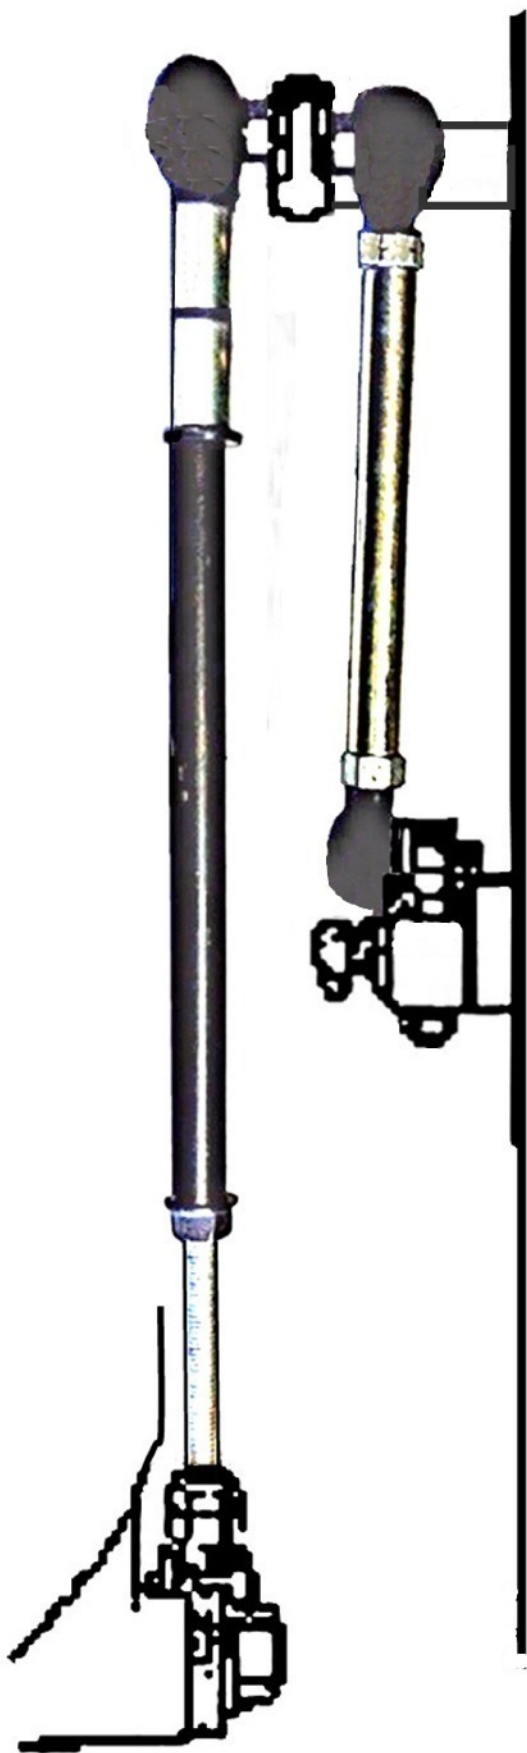
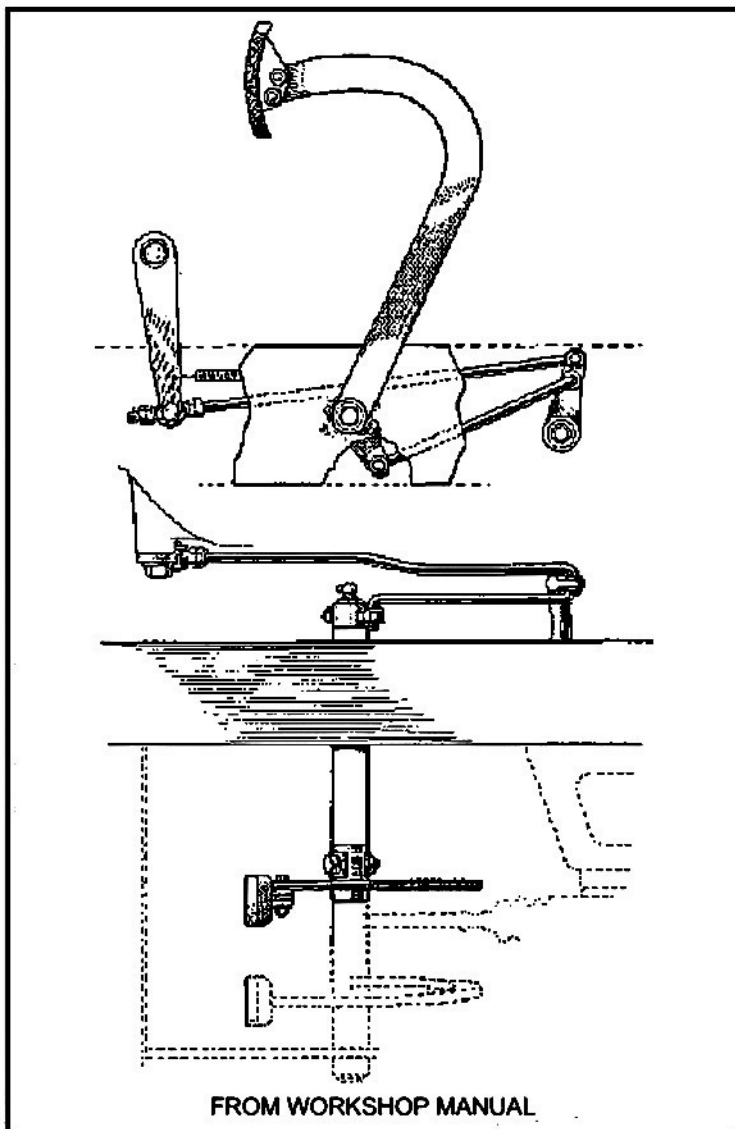
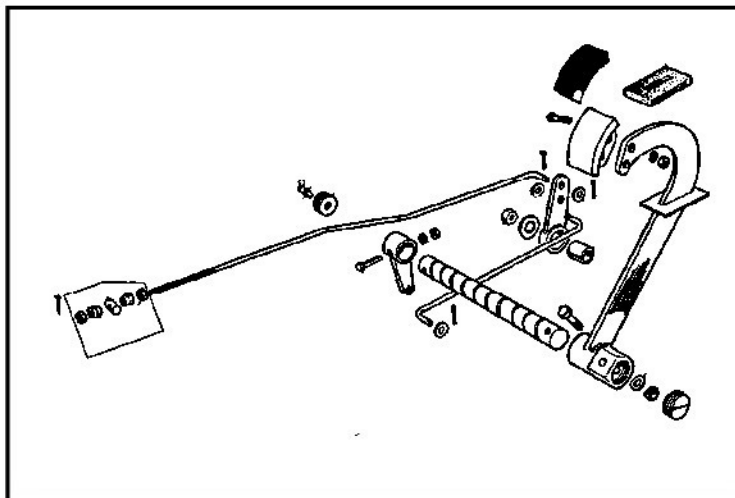
ROD END LONG & SHORT CLUTCH RODS

To those new 100 owners in the club, you probably have yet to experience the broken clutch rod problem, it is quite common with the 100 as the clutch rod often breaks at the right angle bend (near the split pin) it may be first noticed by the clutch seeming to be out of adjustment and difficult to get into first gear. This soon changes to **NO CLUTCH** at all due to the broken link.

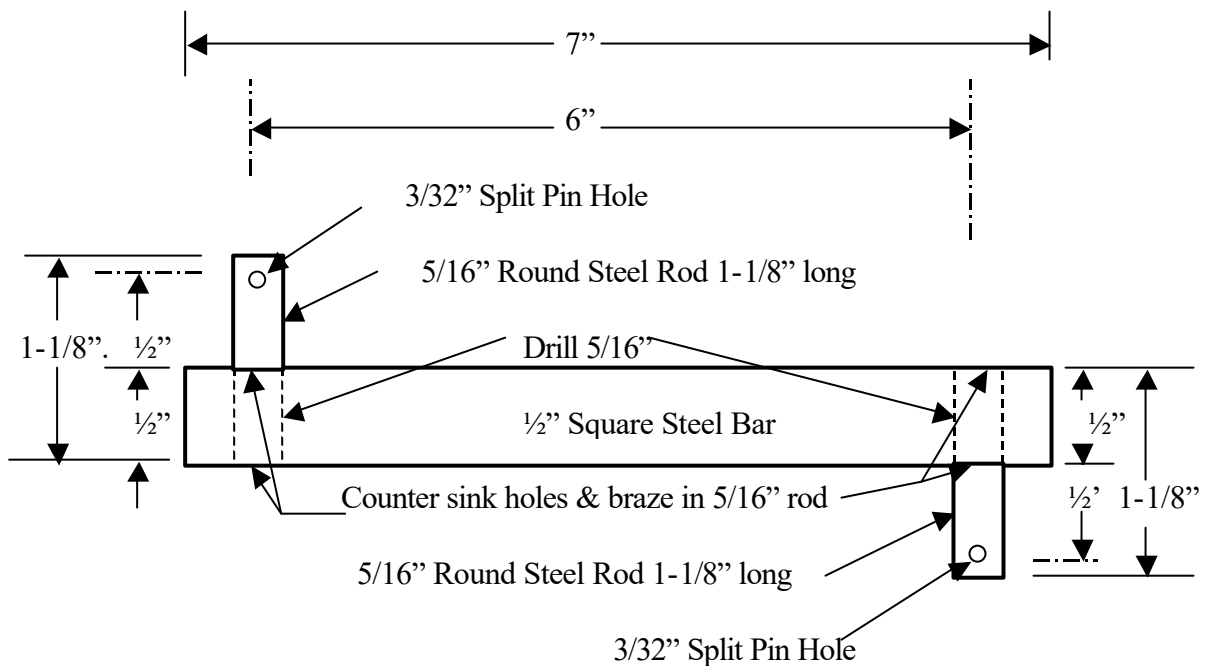
CLUTCH ROD - SHORT

Not much this month due to a garage (house that should be-Don) move, but one thing that came to light when the white board was taken down, was a drawing of a stronger short clutch rod in amongst all the usual gibberish. So it is reproduced below: -

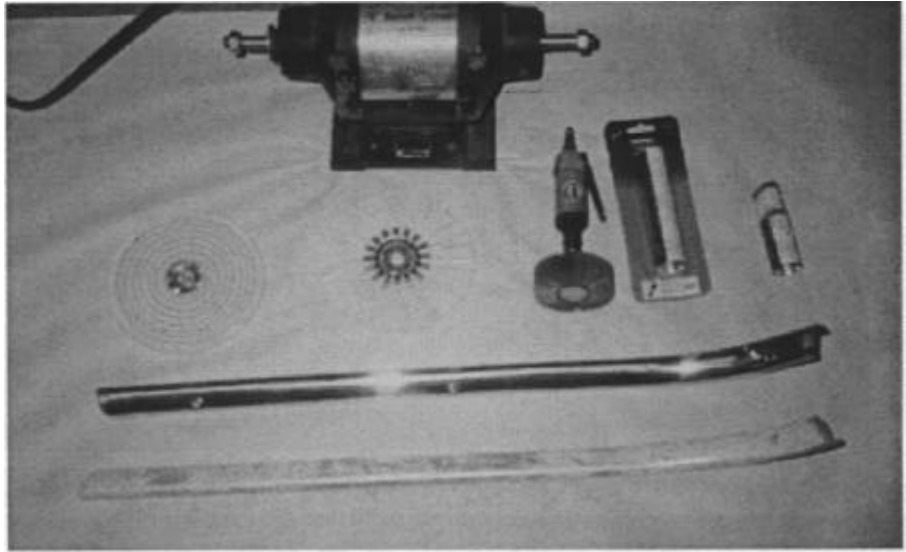
If you have an unrestored roadster, the aluminum cockpit surround has gotten scratched and bruised over the years. I bet you would like it to be bright and shiny again. I asked my local chrome shop what they would charge to remove the scratches and polish the surface of the surround. \$10 per foot says he! I started measuring and came up with \$120-130 for the job. That seemed like a lot of money to me. I figured if my chrome shop guy could do the job, so could I. It's really not that hard. You'll need some equipment, however. The first picture shows what you'll need; a **bench grinder** (Eastwood recommends a motor speed of 3400-3600 RPM) with the guards removed, **buffing pads**, one **closely woven** and one **loosely woven**, a **die grinder** or **drill motor**, **120 grit flapper wheel** (or a powered hand sander) and a stick of **Tripoli** compound for rough polishing and a stick of **White Rouge** compound for finish polishing. All of the required items can be obtained at Sears or Home Depot. If you already have a bench grinder and sander, the rest of the items can be purchased for less than \$20. You'd still save money over having a shop perform the work even if you had to buy all the equipment, including the grinder and sander. Shown in the bottom portion of the picture is a before and after shot of a piece of aluminum door trim. The trim can be brought back to a "chrome like" sheen,

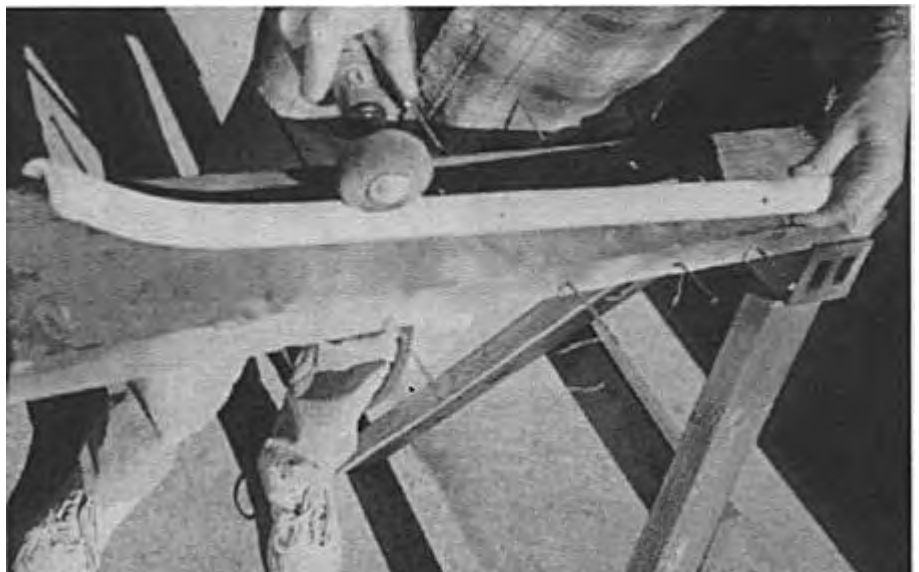
What follows is a step-by-step procedure to make aluminum shine like new. Be sure to wear eye protection during these operations. The picture shows the surface being prepared for polishing. All the coating is being removed and all surface scratches are ground smooth. The finer the grit sand paper, the less polishing that will be required.

Once the surface scratches are removed, we begin the polishing process. The buffing pad used on the left side of the converted grinder has the **closely wound buff**. This pad will be used to **rough polish** the aluminum part. I used 2 pads on the left side to give more surface area to work the piece being polished. Load the buff with **Tripoli** while the grinder is running. Just press the stick against the surface of the buff until a small amount is transferred from the stick to the pad.

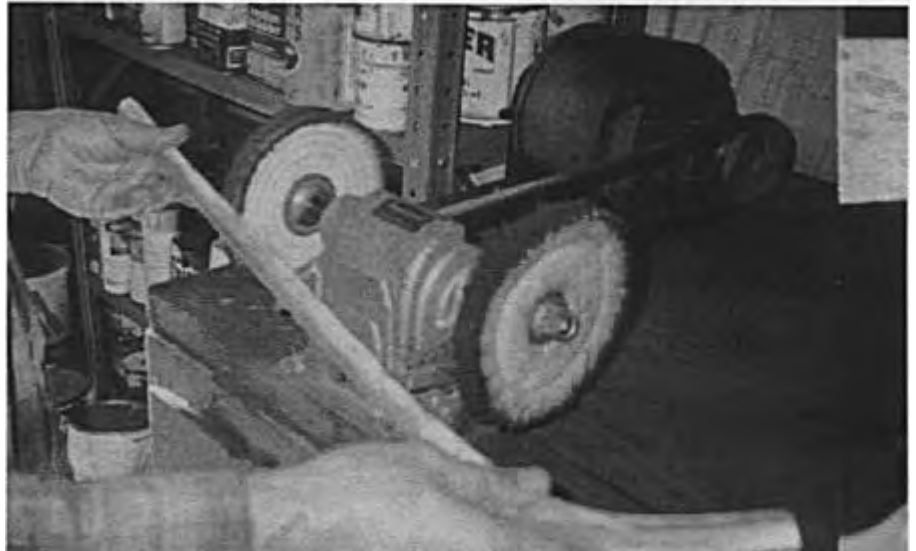
On the right side of the grinder is mounted the **loosely wound buff**. Using the same procedure as before, load the buff with White Rouge. This buff will remove any fine scratches remaining from the rough polish. Eastwood suggests moving the piece you're buffing with the direction of wheel rotation before final inspection. Remove any residue from the part with a soft cloth to expose the shiny surface. With a little practice you'll save yourself some money and learn a new skill.

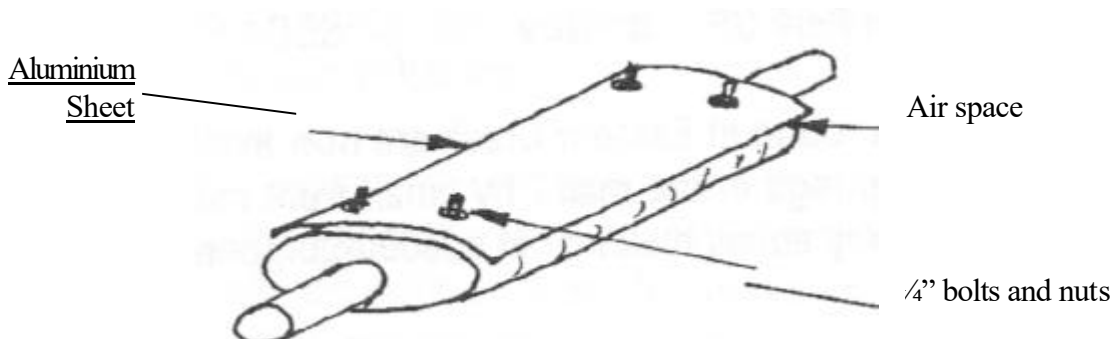
- 5) An additional shield can be fitted above the muffler, by welding four 1/4" bolts to the muffler and bolting on a curved sheet of aluminium, as shown in the sketch.

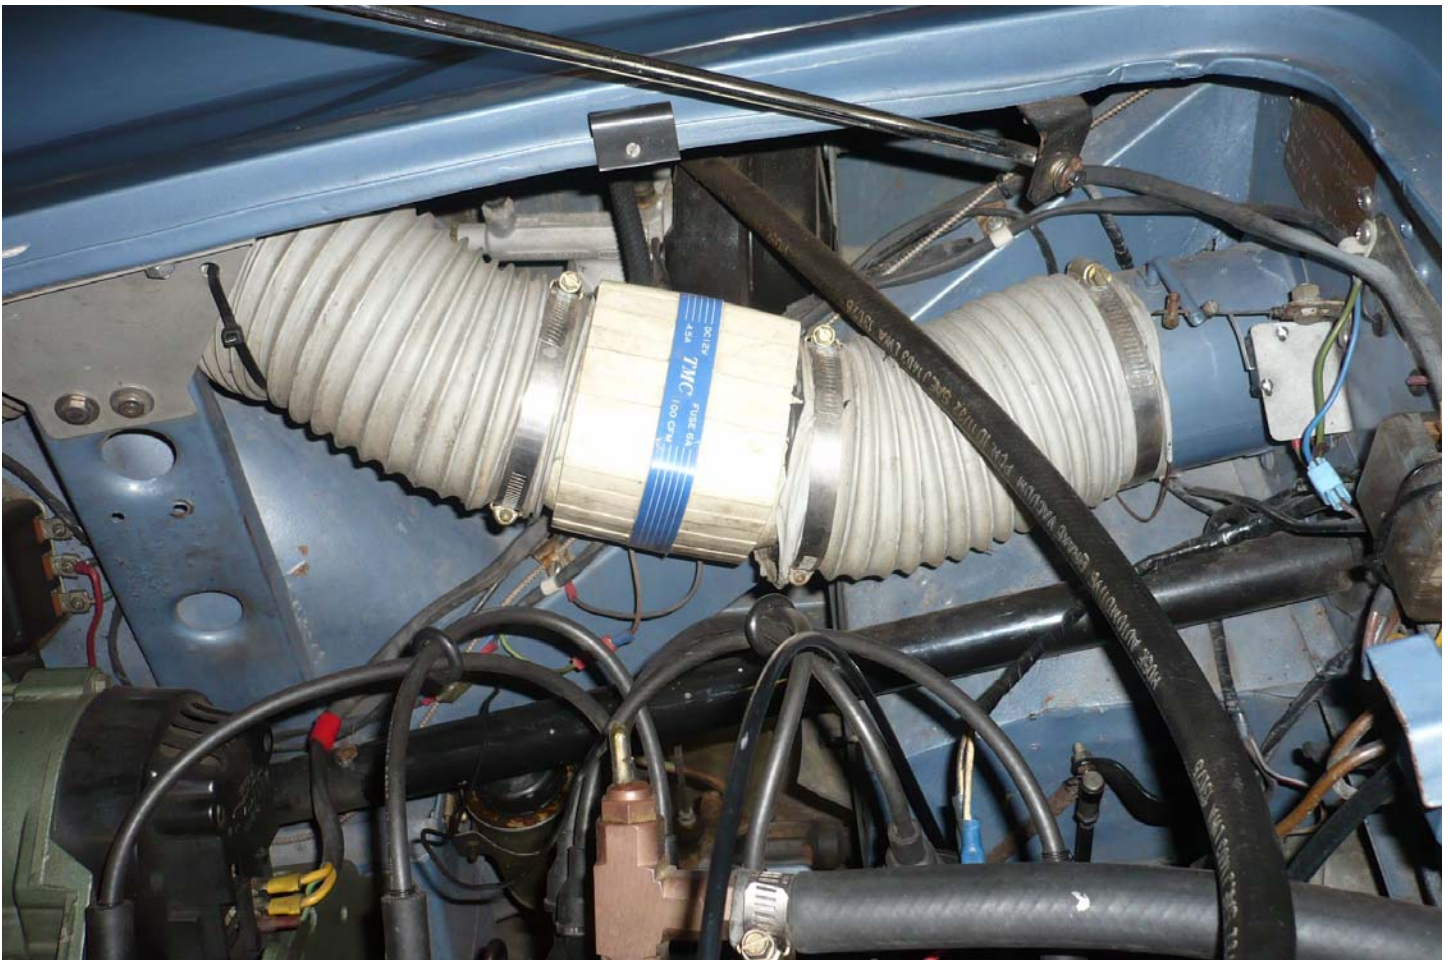
Vent closed.

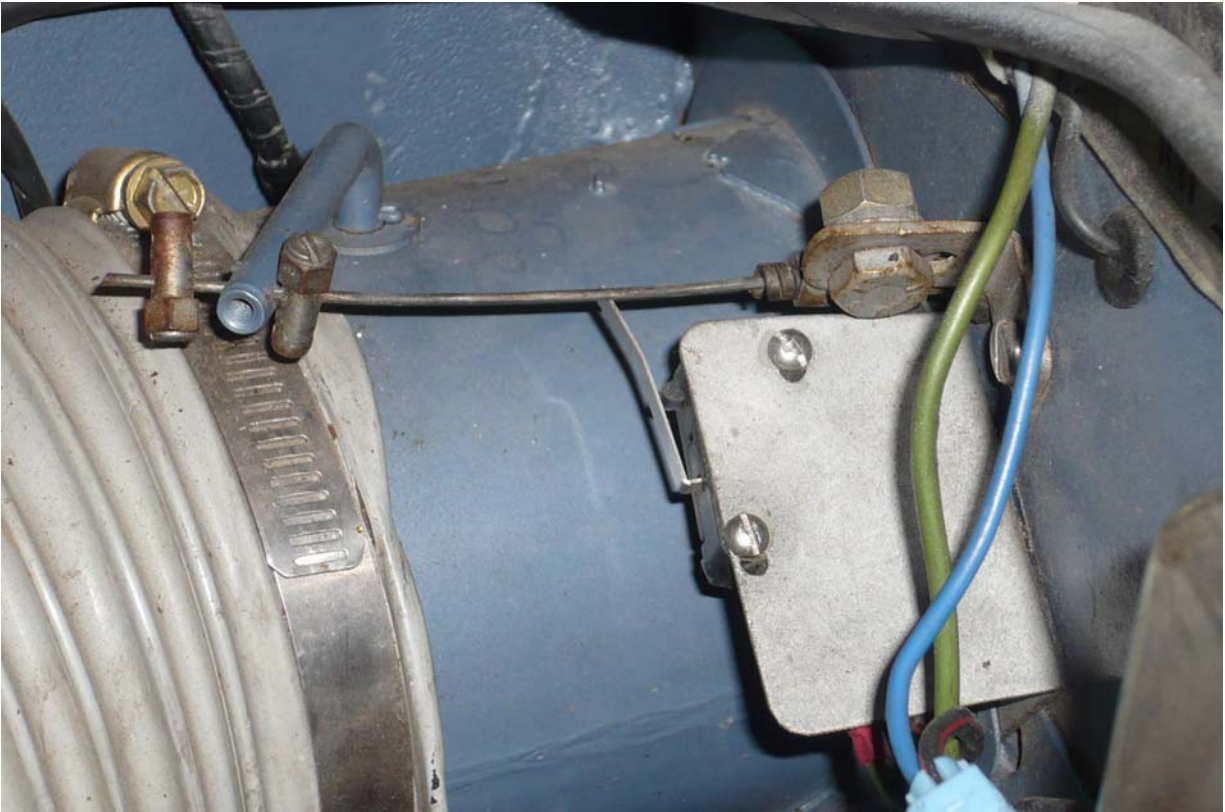
Vent fully open - fan switched on.

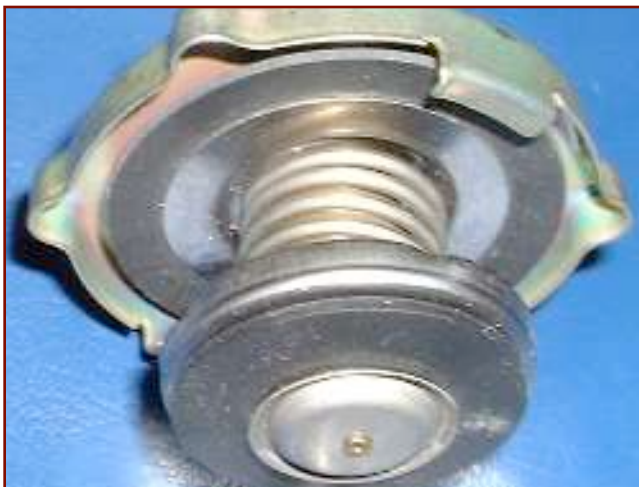
Answer: *No.* Thankfully the radiator cap is designed so that at a preset pressure its spring-loaded foot seal will displace from a step at the bottom of the filler neck, allowing the pressure to safely escape. As temps go up first the air at the top of the tank, then eventually coolant blows past the seal and out the overflow hose. Thus the green puddle....

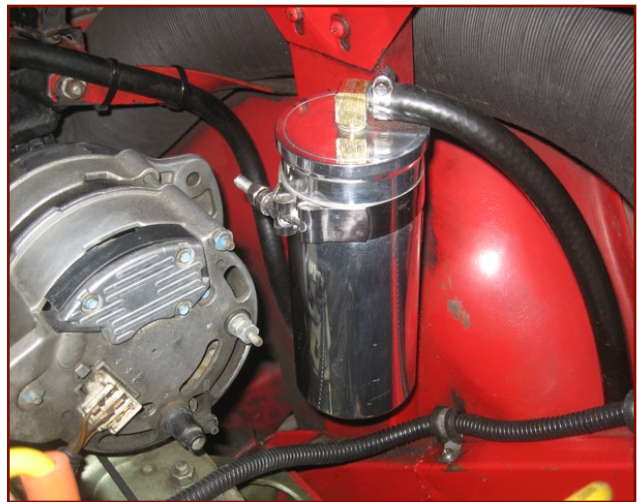
A: *There is a solution: You can install a Coolant Recovery Tank.* This is simply a one or two quart tank connected to the radiator via the overflow hose which catches and holds the expelled coolant, preventing it from winding up on the floor, and then puts it back into your radiator as the car cools off.
