A Tasmanian Supra gearbox conversion

100 TECHNICAL CD-ROM

INTRODUCTION

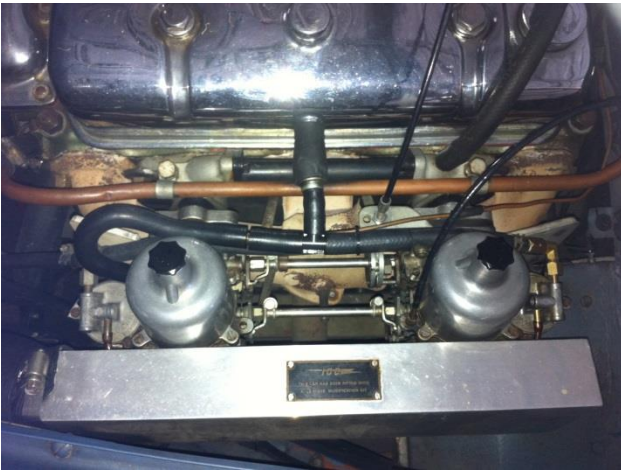
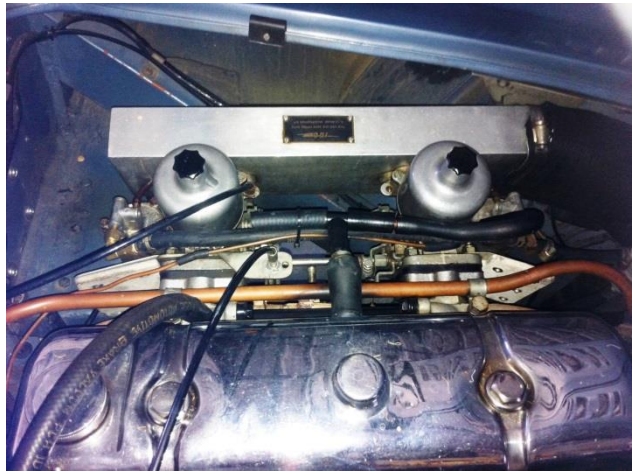
HS6 SU CARBURETTORS

Two HS6 (1 $\frac{3}{4}$ ") carbys off a Rover V8 were modified with various, bits from Midel SU, to fit.

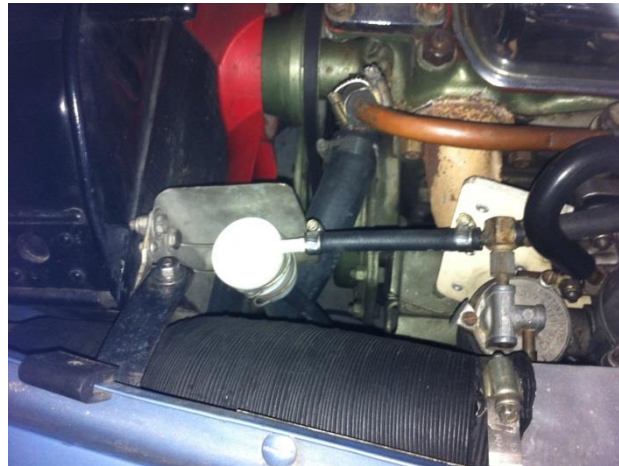
Petrol filter at front and there is one at the rear behind the left rear wheel.

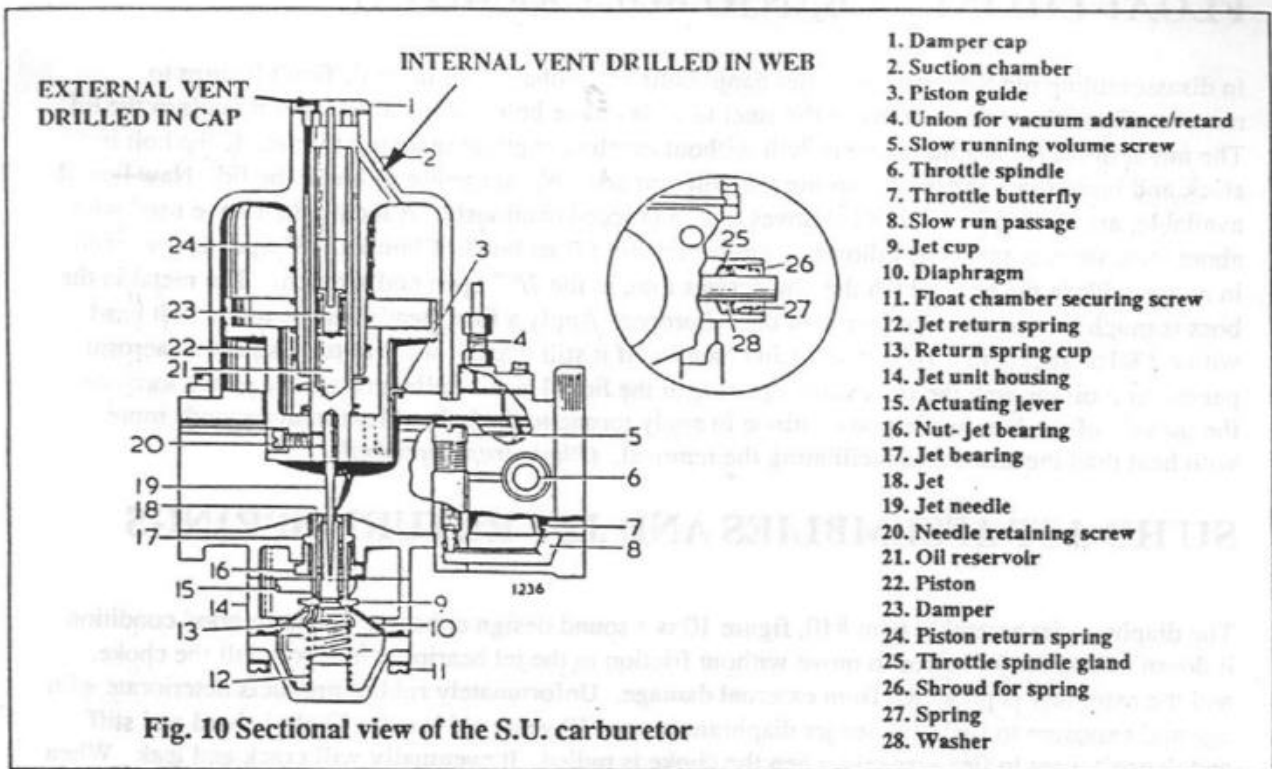
Many of the SU carbs I see have had dampers replaced with the wrong type. Referring to figure 10 it should be noted that the area above the hollow piston rod must be vented. otherwise pressure will build up on the upward movement of the piston and vacuum will occur with downward movement. This will restrict normal piston travel. Venting may be done in two ways. The cap may be drilled to allow venting to atmosphere or the web or gusset on the chamber neck may be drilled to allow internal venting back into the suction chamber. You must have one or the other but not both. If you have a solid cap and no internal drilling there is no vent and pressure/vacuum conditions will occur as aforementioned. If the cap is drilled and the web is also drilled. then there is a direct air leak into the suction chamber. If the chamber neck, such as found on 1 1/4" Sprite carbs, has no web then it cannot be drilled internally and must have a vented cap. If the chamber neck. as found on 1 1/2" and larger carbs. has a web or gusset it may or may not be drilled. The only way to know for sure is to remove the damper and look inside the neck. If you have a plastic damper cap which is wrong, you probably should just replace it with the correct one. If you have a brass damper cap which is wrong you can drill the solid cap with a 1/16." diameter drill, or plug the vented brass cap with a short piece of 14 gauge copper wire. Cut the wire just barely longer than the thickness of the cap and peen from the underside with a hammer and punch. Polishing the top surface with a fine wire rotary brush on a drill will make the plug barely visible.

The diaphragm jet assembly item #10, figure 10 is a sound design concept. When in good condition it doesn't leak, the jet is free to move without friction in the jet bearing when you pull the choke, and the assembly is protected from external damage. Unfortunately rubber products deteriorate with age and exposure to fuel. If your jet diaphragm is over 10 years old it quite likely is hard and stiff and doesn't want to flex properly when the choke is pulled. It eventually will crack and leak. When replacing a jet assembly it is a good idea to have replacement jet return springs available item #12, figure 10. The springs sit down in the lowest part of the carburetor where water collects and will frequently be badly corroded.

On HD carbs, breaking loose the jet bearing locking nut, item #16 figure 10, may be troublesome. After removing the float chamber, jet, and jet housing, access to the locking nut is attained. Squirt an aerosol penetrating oil around the nut head. Rap the head of the nut sharply with a hammer and 3/16" punch around the periphery of the head in about a dozen places. A properly sized Whitworth socket and ratchet handle will then usually easily break it loose.

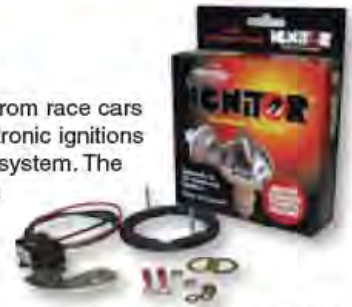
For over thirty years, the Ignitor has proven itself in applications ranging from race cars to tractors. The Ignitor replaces breaker point and troublesome factory electronic ignitions with a dependable, self contained and maintenance free electronic ignition system. The Ignitor has been called the "stealth" ignition because of its quick installation and nearly undetectable presence under your distributor cap.

Temperature Range: -50° to 300° F.
RPM Range: 0 to 15,000 RPM.

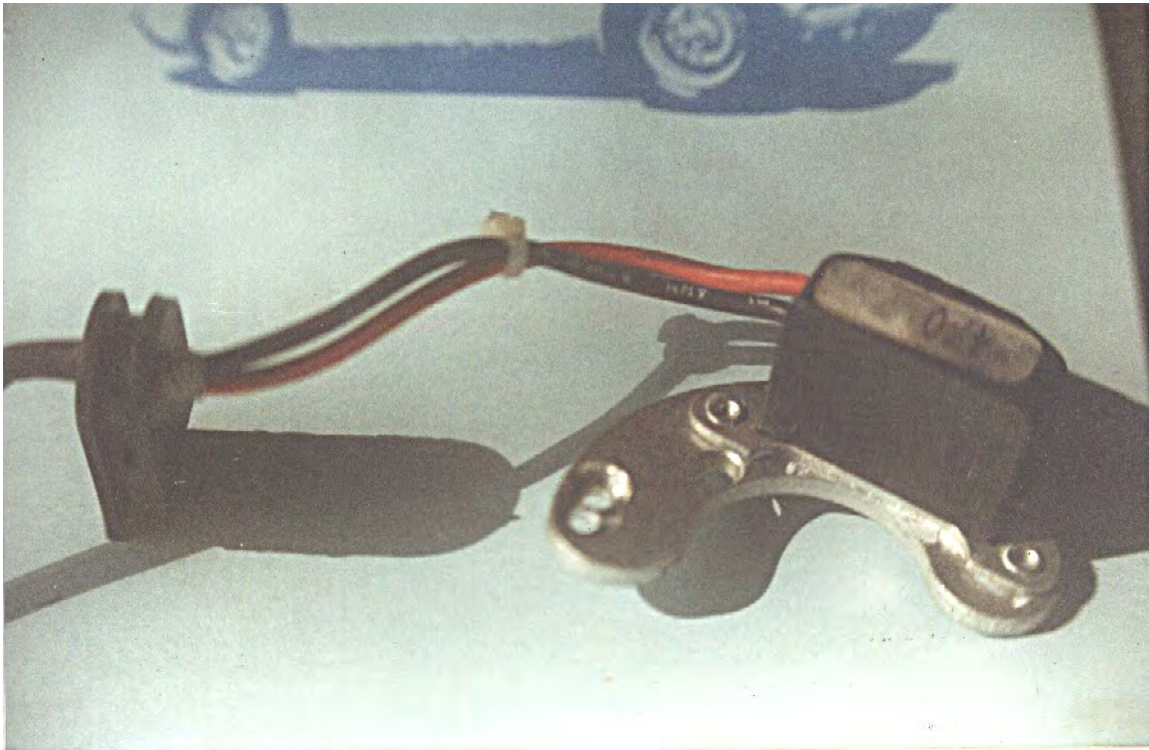
As I have a later 25D4 distributor fitted, I used an Ignitor No 142A,

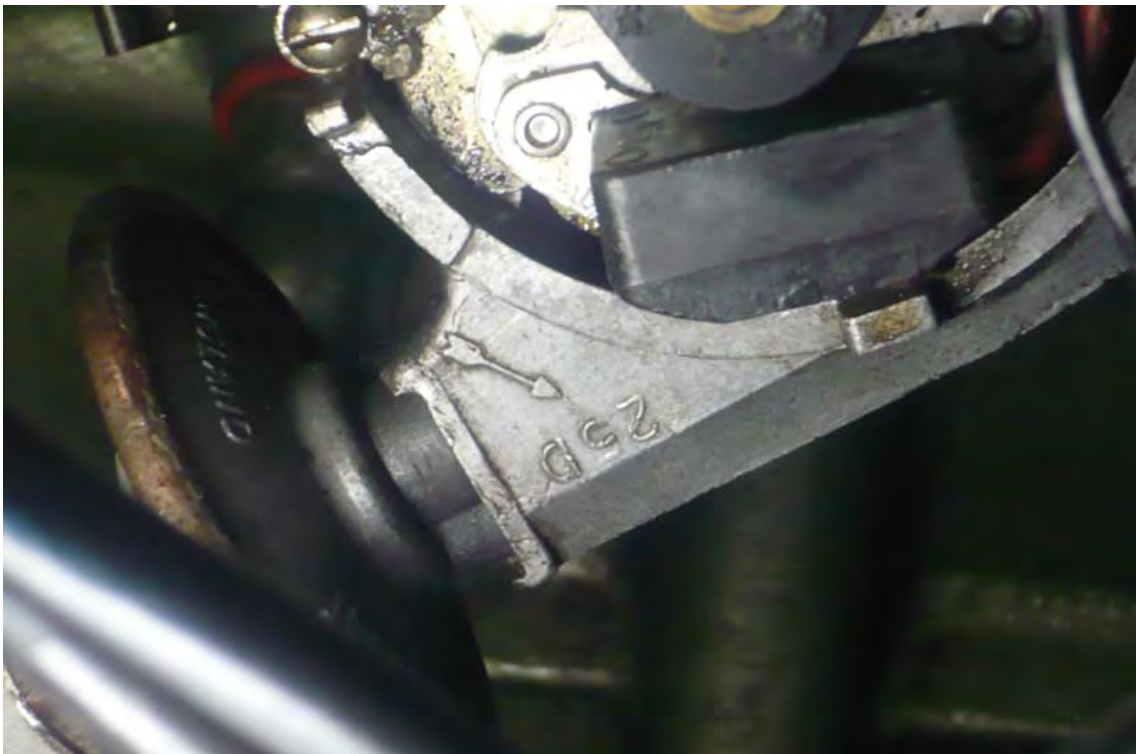
DISTRIBUTOR NUMBER Earlier distributors have the number on the side.

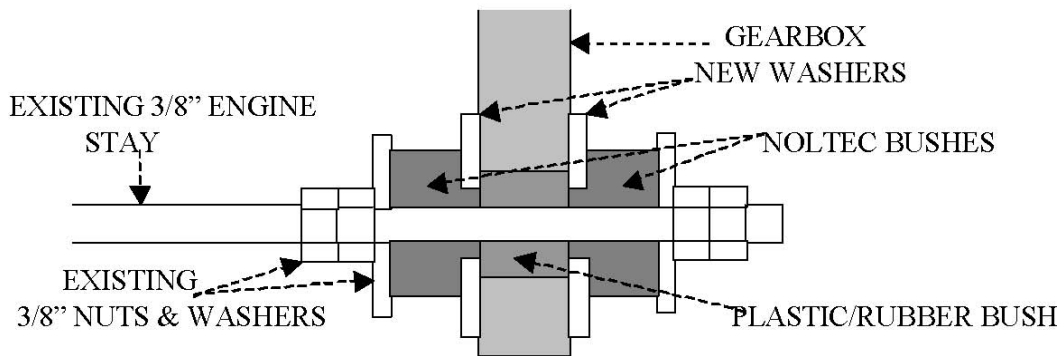
Falcon sway bar link rubbers are the same size as the rear ones, and NOLTEC Urethane ones were obtained, as they won't be troubled by the oil. The rear 2 fitted easily, but as the hole in gearbox is large (3/4"), 2 - 7/16" flat washers and a piece of plastic tube were needed as shown below. The plastic tube is to keep the stay reasonably central in the hole so is not critical, even rubber could be used as when everything is assembled not much oil can get to it.

- 1 - set Noltec N21014 (or equivalent urethane) sway bar link bushes.
- 2 - 7/16" ID x 1 3/8" OD x 1/16" Thick plated washers.
- 1 - 3/8" ID x 3/4" OD x 5/8" Long plastic or rubber bush

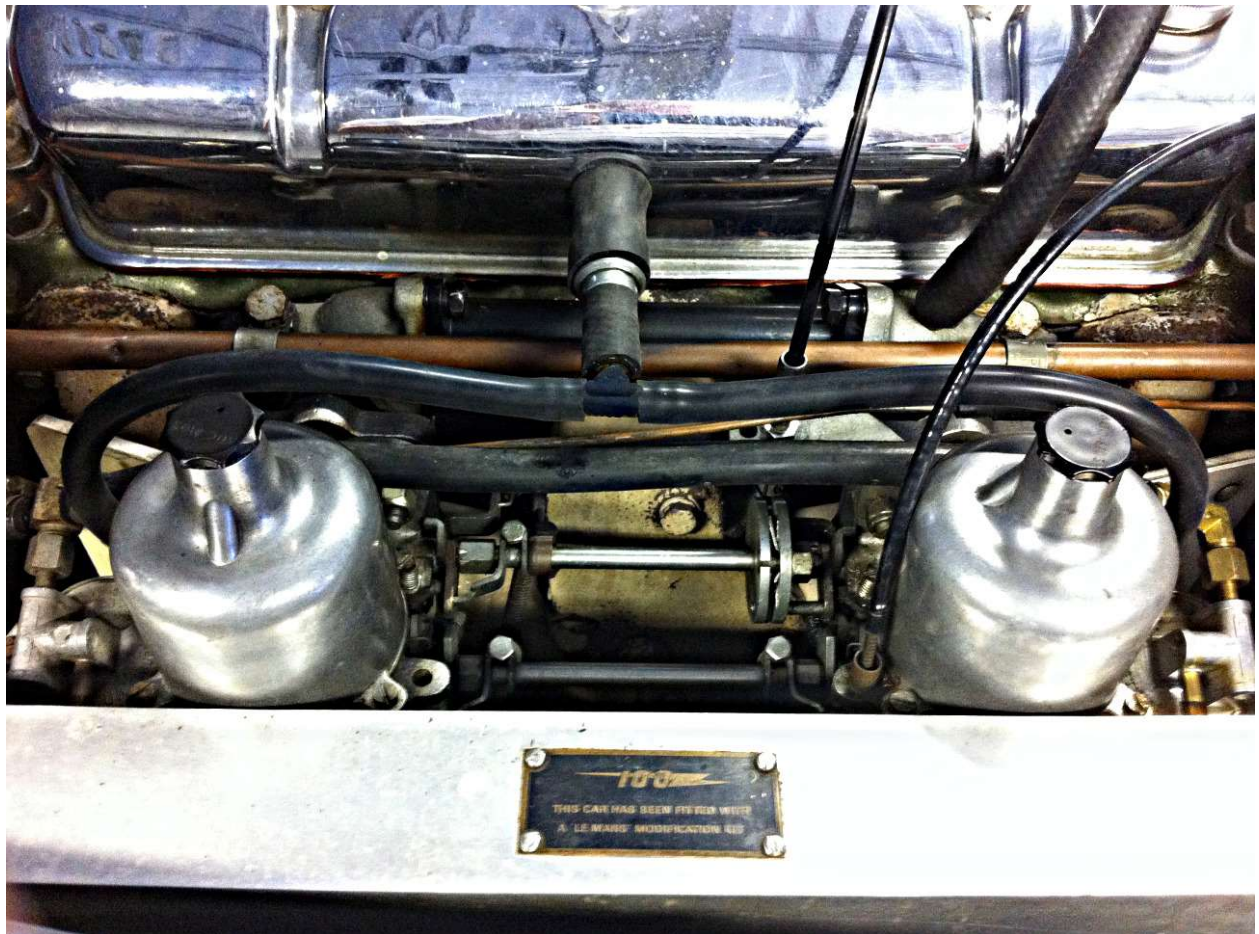
The ventilation plastic pipes were arranged to go from the carburettor vent pipes to a T then through a positive crankcase ventilation valve, to the pipe on the rocker cover.

The crankcase exhaust vent tube which comes off the cam follower cover, was removed and blanked off with a ¼" plate, the plate blanking off the mechanical fuel pump position was fitted with a ½" outlet pipe, which is connected to a fitting in the bottom of the cold air box with a ½" ID rubber tube. This is now the crankcase ventilation inlet with filtered air from the cold air box.

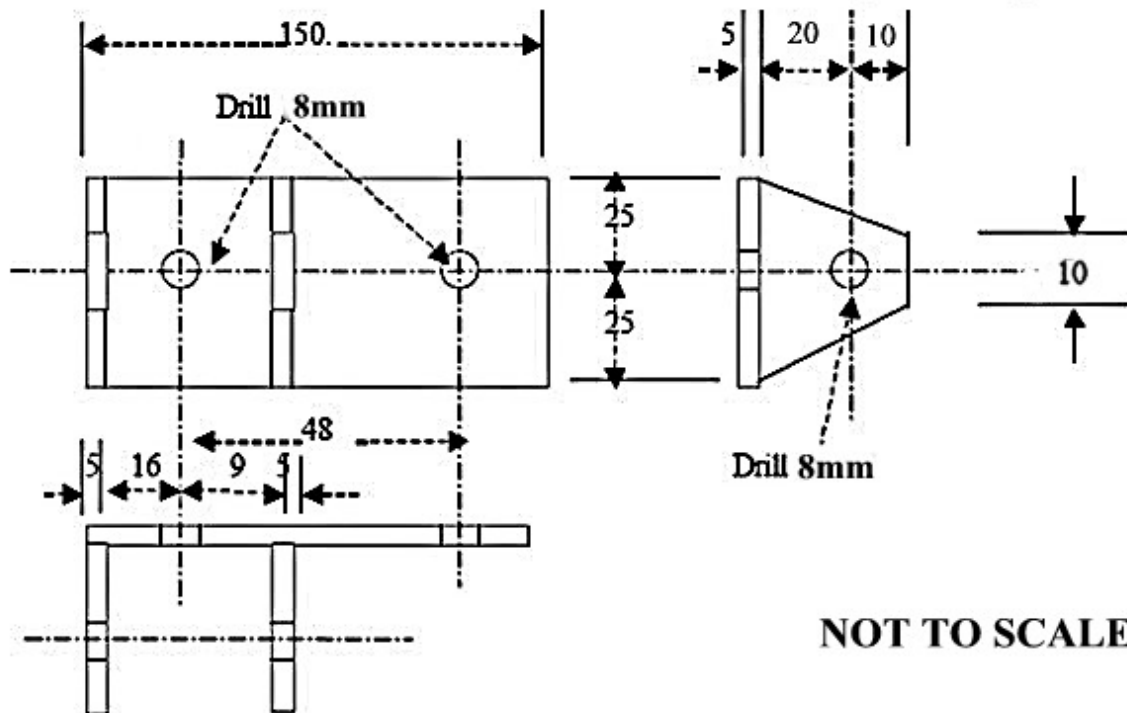
CENTRE HANGER BRACKET -Mounts to existing chassis position

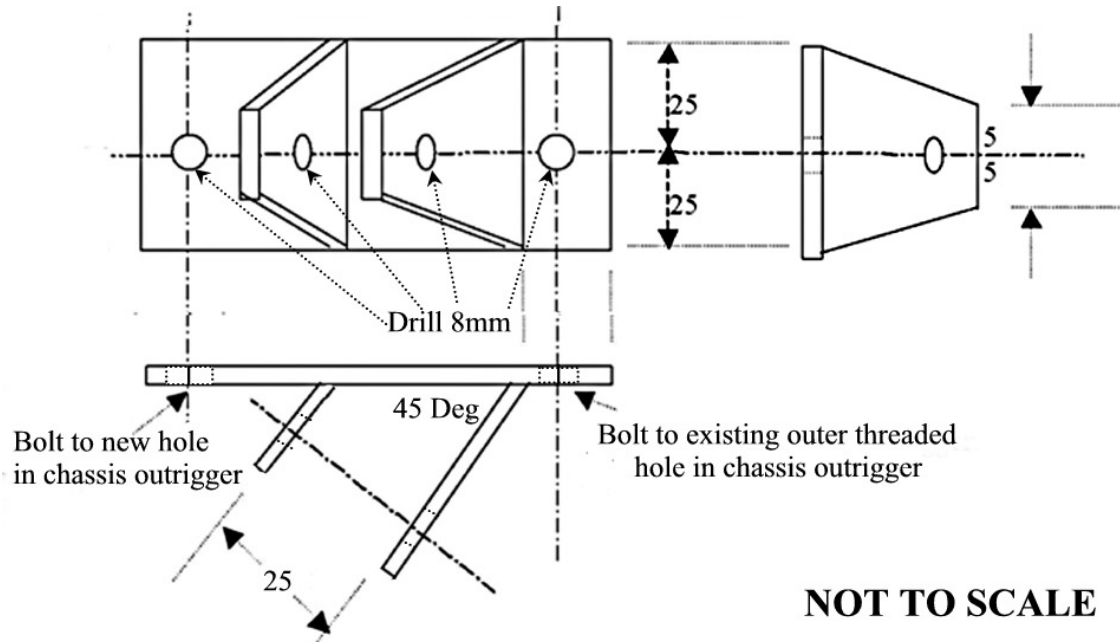
REAR HANGER BRACKET-

Mounts to existing chassis outer bolt position and a new hole had to be drilled in chassis for the inner bolt. I will measure this one up if you need it, just ask.

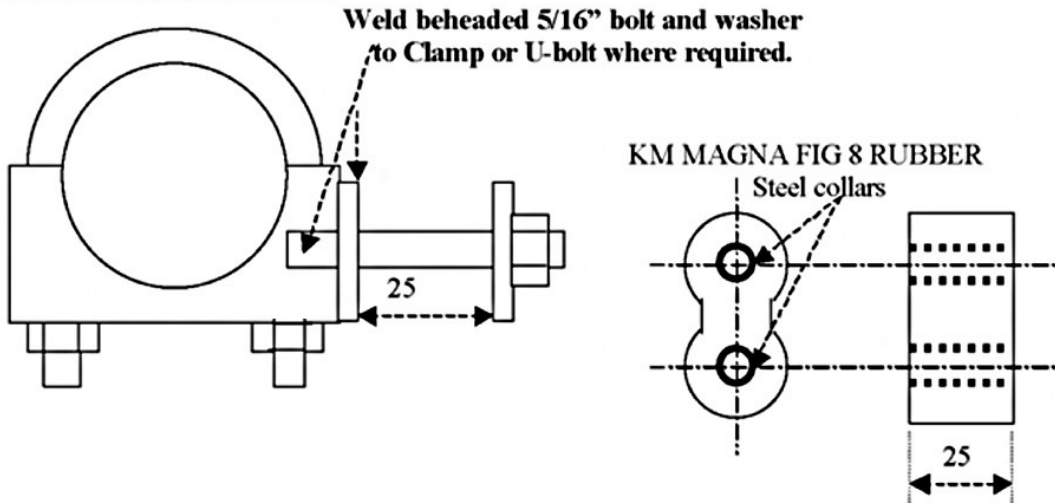
MODIFIED EXHAUST CLAMPS

Barry Campbell's method of holding the exhaust up, so that if (when) the Healey Mount gives way the exhaust won't drag on the road. You should do this before you fit the Mount.

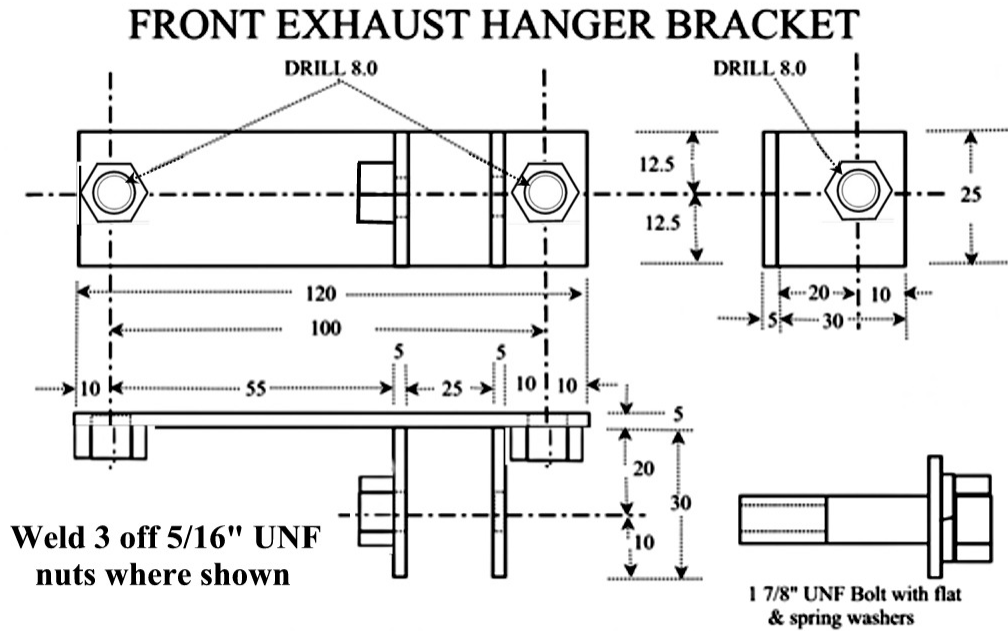
I removed the remains of the original Healey hanger, which had been there for many years, refitted the outside bolt, to seal the hole and drilled another 100mm from the inside hole towards the centre of the car and at right angles to the chassis. The new bracket (below) was bolted into place, the hanger rubber fitted and the muffler clamp modified as above.

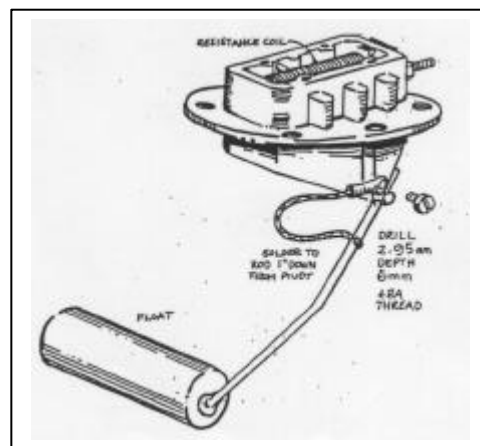
To provide a good earth between the float and the sender unit housing, solder a flexible braided wire from the float arm and attach the other end securely to the housing with a 4 BA bolt. Drill into the thickest part of the housing next to the pivot point.

Flatten the ends of some cotton buds and carefully clean the sides of the coil with some lighter fluid. Be careful of the metal wipers. Don't bend them.

Connect an ohmmeter to the terminal and the housing. Raising and lowering the float should show a resistance range from 0-2 ohms (empty) to 75-85 ohms (Full).

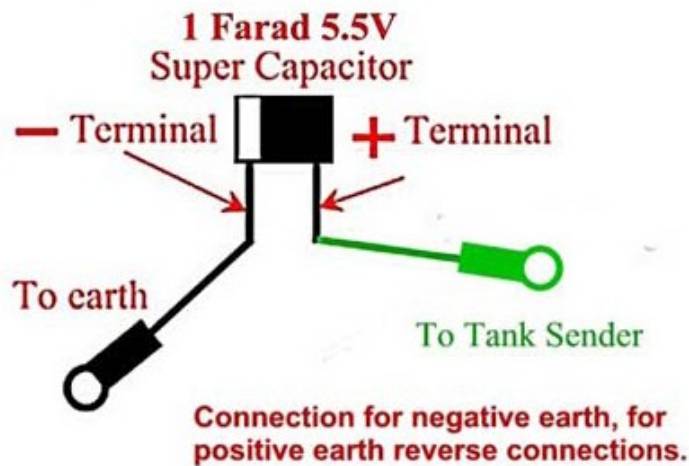
Solder two wires to the capacitor (be careful not to overheat it), install heat shrink tubing over the connections and over the capacitor. The diagram below is for negative earth, switch the wires over for positive earth.

If you don't like it in the boot near the petrol tank, you can mount the Super Capacitor behind the dashboard and connect the positive terminal to the T terminal of the fuel gauge and the minus to any available earth.

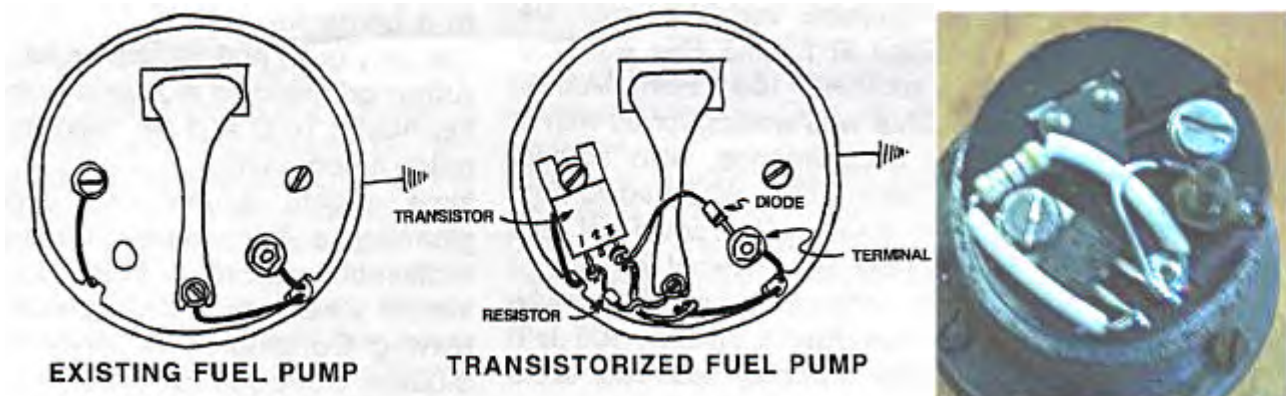
Enlarge the transistor mounting hole, remove the centre lead and wire up as shown. The only difference between the negative and positive earth pumps is the transistor type and the diode on the negative earth pump has the banded end connected to the terminal and on the positive earth pump the banded end is connected to the transistor. I used a 1Watt resistor (all that was available at the time), insulated with the covering stripped off some wire, removed the tag off the pump wire that went to the points and soldered it to the end of the transistor emitter lead. It was a bit fiddly but not too hard.

Diagrams and picture are for NEGATIVE EARTHED pumps.

The idea and diagrams were taken from David DuBois article in a Jaguar Club website and the picture is of my pump.

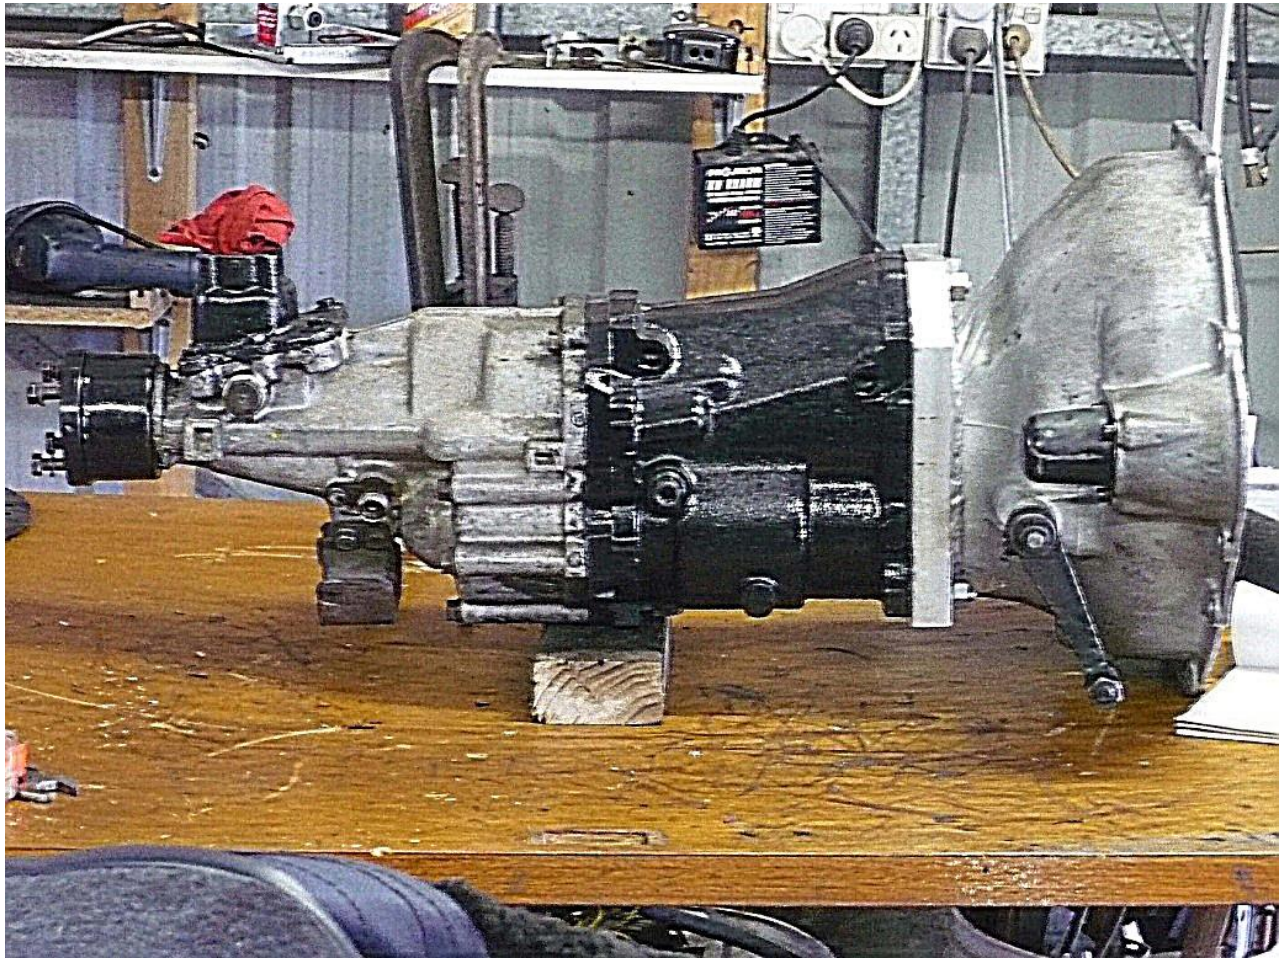
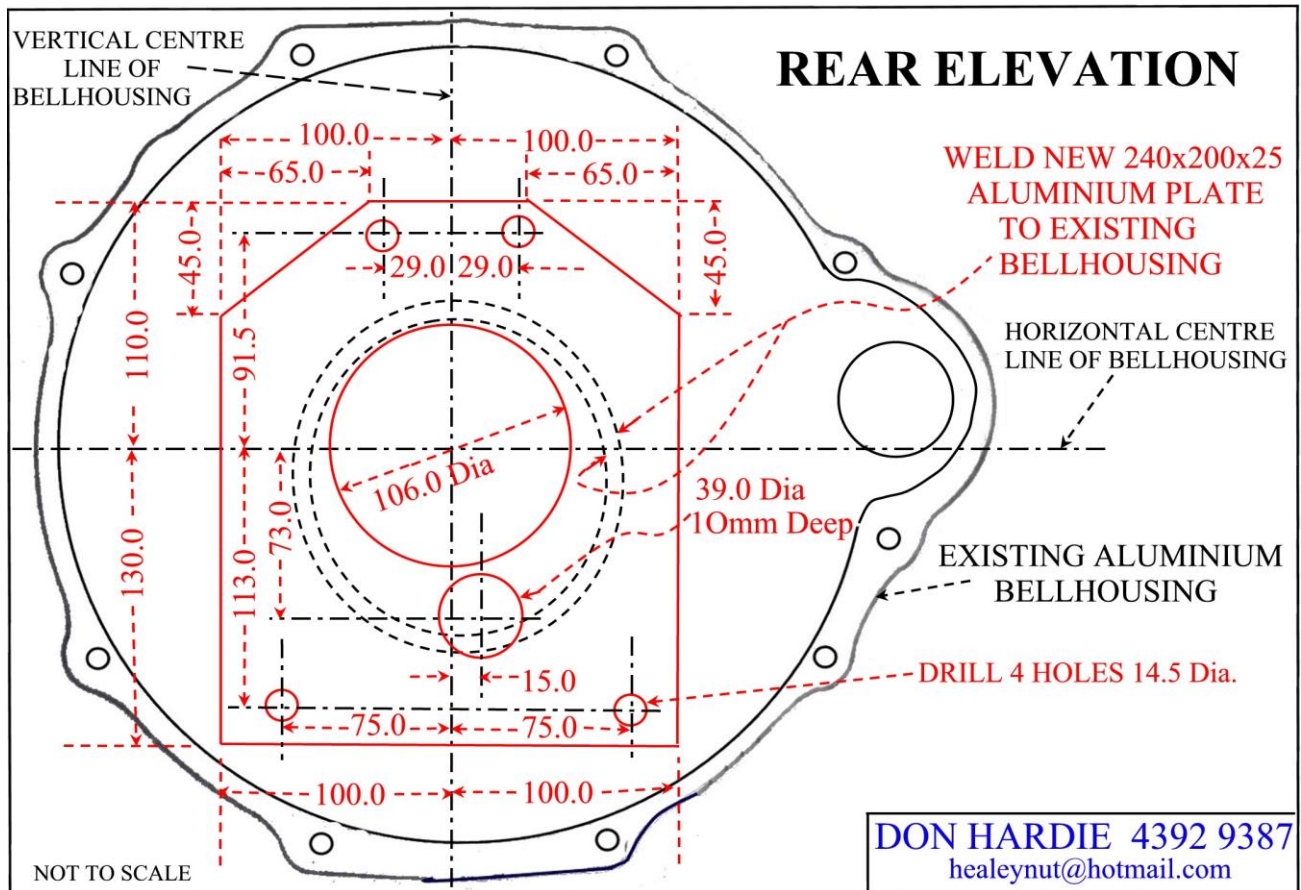
SIDE ELEVATION

WELD 25mm ALUMINIUM
PLATE TO EXISTING BELL
HOUSING

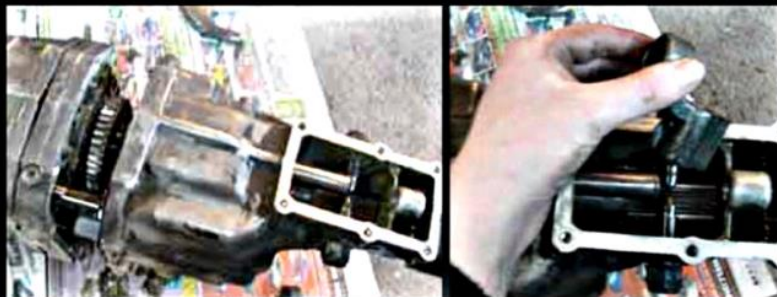
Shifter measurements are taken from the front of the gearbox, (not bellhousing) back to the shifter hole.

Celica 18" 18" 19" and 20.5"

Luckily there are many different shifter positions available for toyota boxes and most of them can be swapped over. Sometimes this just involves changing over the alloy shifter mount. But if you are going from quite far forward to one further back you will also need to swap over the shifter yoke also. This is easy. You remove the pin holding the yoke then you need to undo all the bolts around the tailcase. Then gently split the tail case from the sandwich plate. Don't dig in with a screw driver because you don't want to munch the alloy. Use something wide and flat like a chisel to pry it apart. Yes oil will go everywhere. Then the shaft with the yoke can be slid forward and the yoke removed.

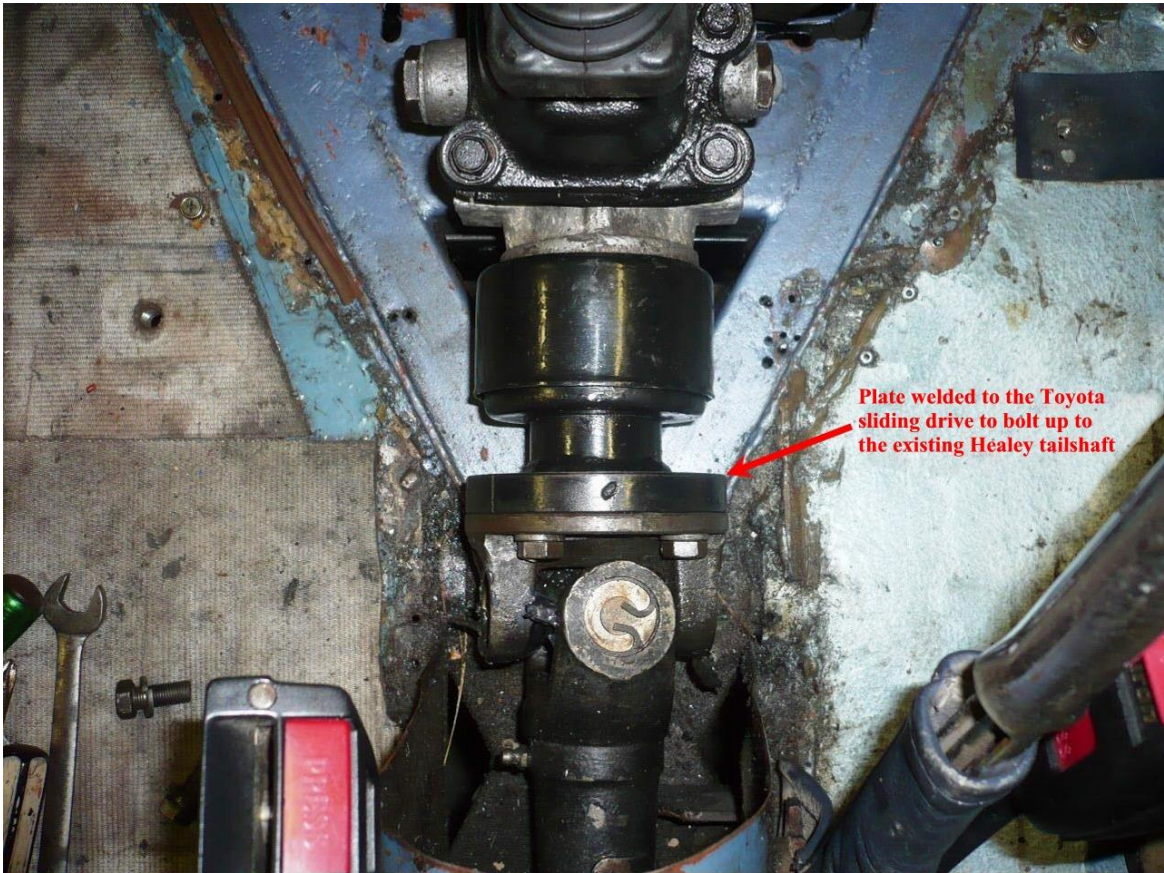
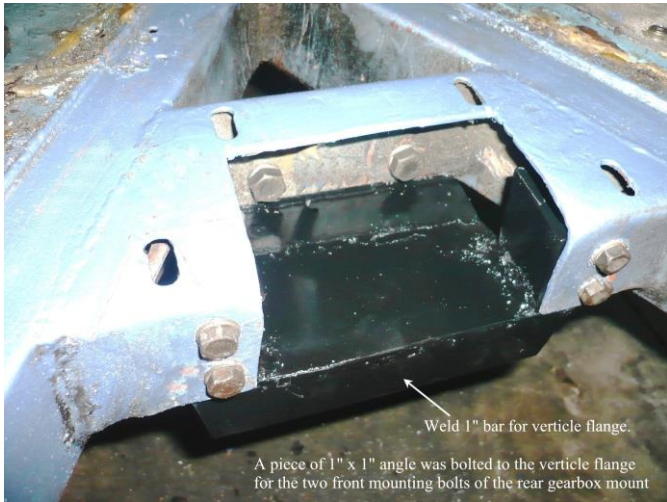
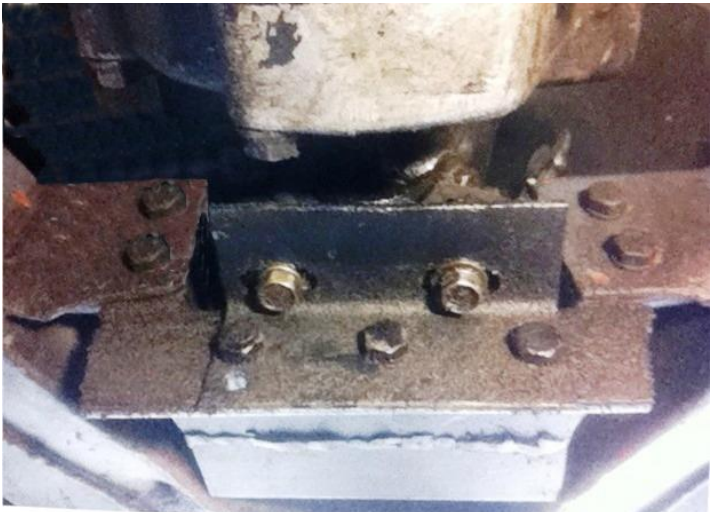
REAR GEARBOX CROSS MEMBER ALTERED FOR CELICA REAR MOUNT

FRONT UNDER SIDE OF REAR MOUNT

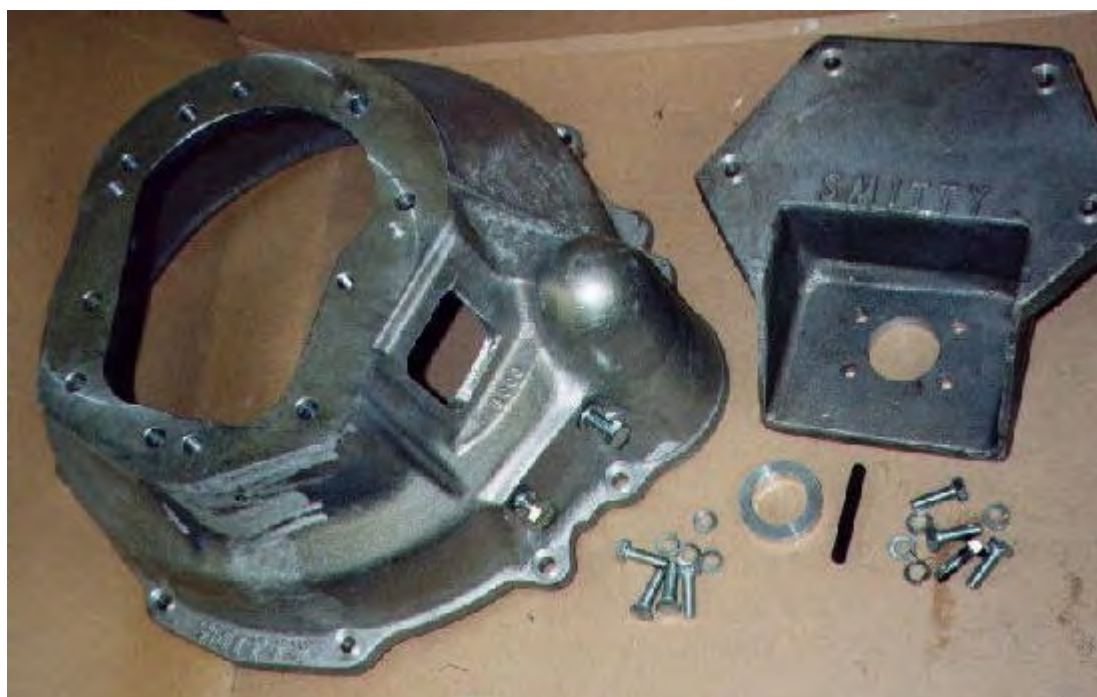
The kit from Smitty

Components for correct Healey location of gear lever, not easily obtainable in UK but Smitty will supply:

- ✂ Housing, shift lever 33521-35221
- ✂ Retainer Assembly (Shift Tower) 33570-35030

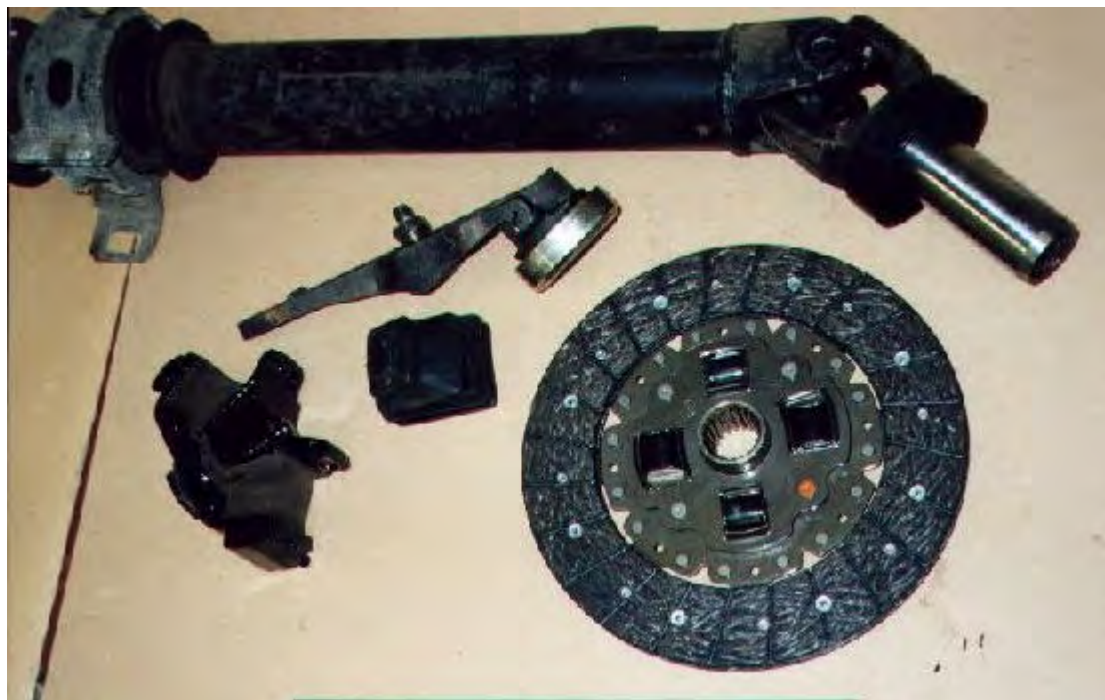
The Supra donor bits, release bearing and friction plate should be renewed.

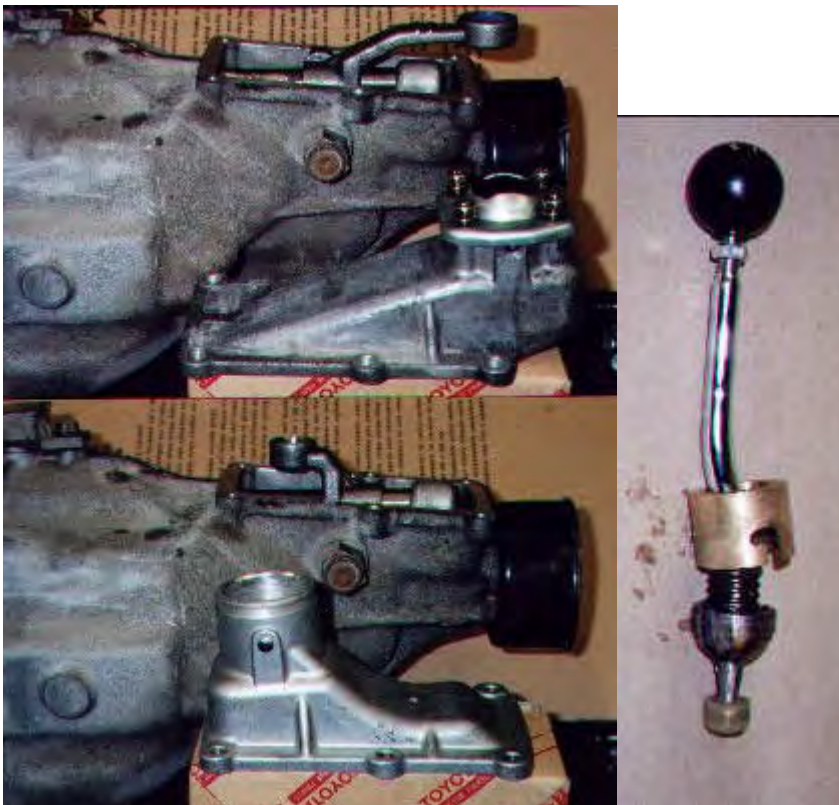
Illustration of the two lever positions, standard Supra, top, and as Healey centre change bottom. Also lever with new brass retaining bush.

These towers employ different means for retaining the gear lever. The Supra uses a 4 screw cover plate whilst the forward tower uses a bayonet fitting retaining bush. This is not available from Toyota, nor could I find one in a scrap yard. So, I drew one up, had it made in brass by a local machine shop and hand cut the bayonet fitting. Drawing to be added to this site soon.

In the Supra, the gear lever has an extension incorporating a metalastic bush. This is easily removed and the lever fettled and chrome plated.

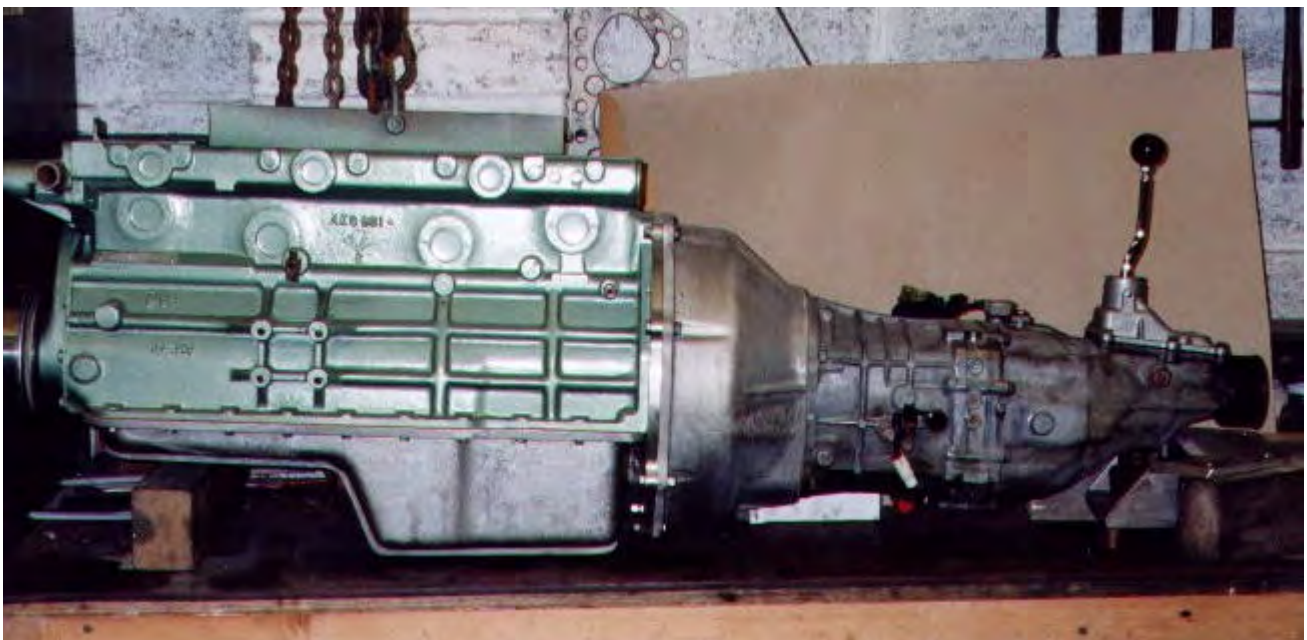
Toyota Supra box assembled with gear lever in forward position.

The amount of work required depends upon where you want the gear lever to be. The standard Supra gear lever arrangement will fit under a side change transmission tunnel but will protrude about where the ash tray is. Smitty recommends using an MGB rubber gaiter and chrome retaining ring with this arrangement. However, the W series box can be fitted with different shift towers that place the lever between 23" and 27.5" from the engine back plate. The former matches the Healey centre change box and comes from the pick up truck (I think!), the latter being the Supra. The tower and internal lever for the 23" location are available but UK Toyota agents that I contacted do not stock them; they are available in the US, and if requested Smitty will supply them.

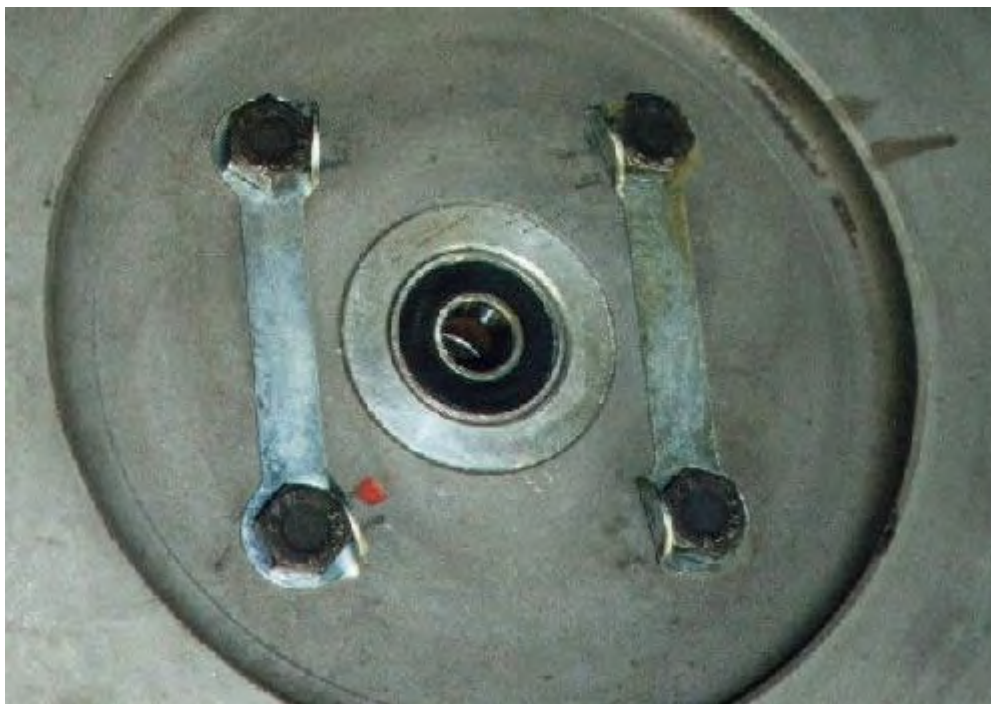
The standard bronze bush in the back of the crankshaft becomes redundant but, can be left in place. The Smitty kit includes an aluminium housing this is pressed into the centre of the fly wheel, and the Toyota bearing is pressed into the housing.

First motion shaft

spigot bearing.

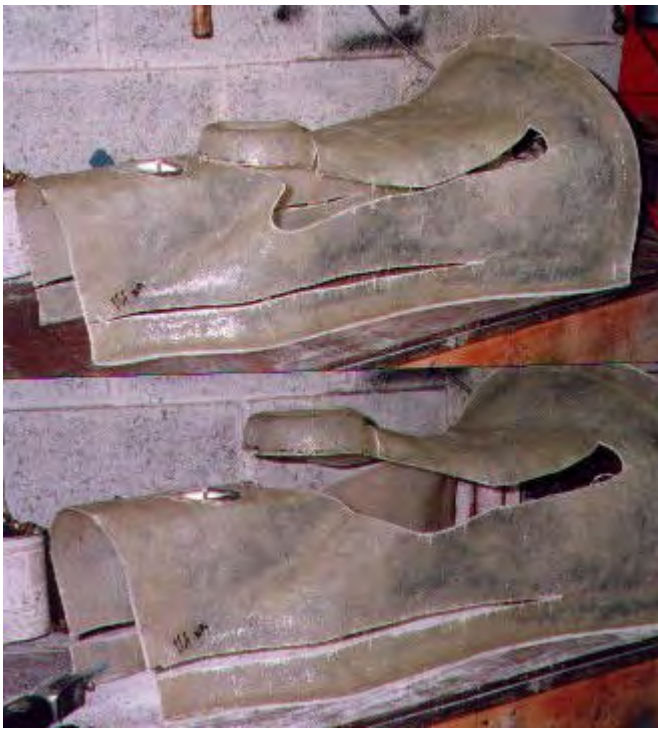
The Toyota lever is shorter than the Healey lever, and the pivot point is lower. For it to look right, and not to restrict the movement at the point where it emerges from the cover, I had to cut about 35mm out, lower the top and re-fibre glass it as shown:

Cutting a new transmission cover to reduce the height, prior to fibre glassing.

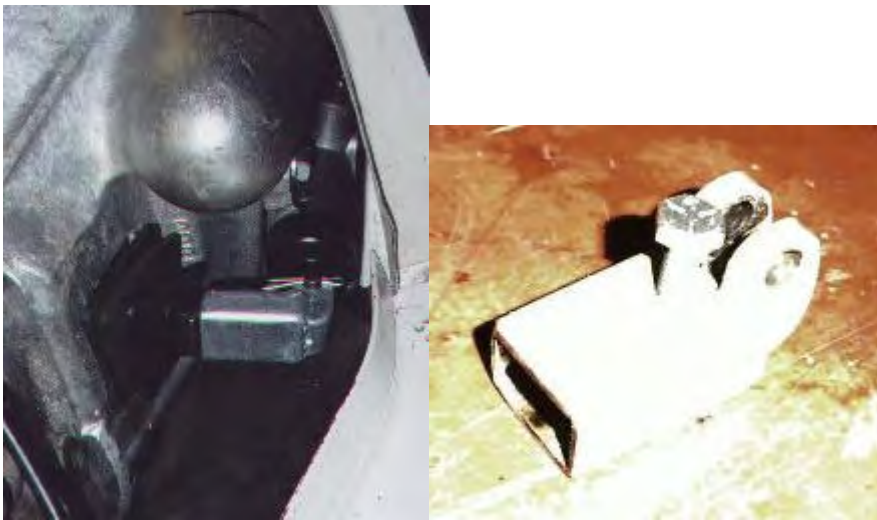
The Toyota release arm does not use a clevis pin for connection to the slave cylinder push rod. Instead, it just has a recess and the push rod (supplied by Smitty) is trapped between it and the slave cylinder. The alignment of this was not very good as the slave cylinder is mounted too far away from the transmission centre line, apparently to cater for different donor cars. I decided to make up a sleeve to go over the release arm with a pinch screw to locate the recess and drillings to take a clevis pin and standard Healey push rod. The next problem was that now effectively being a longer arm, the clutch would not disengage until the very end of pedal travel. A BJ8 brake master cylinder was substituted (7/8" up from 5/8") but this made the pedal too heavy. Finally, a 3/4" master cylinder provided the correct feel and travel.

Release arm adapter sleeve.

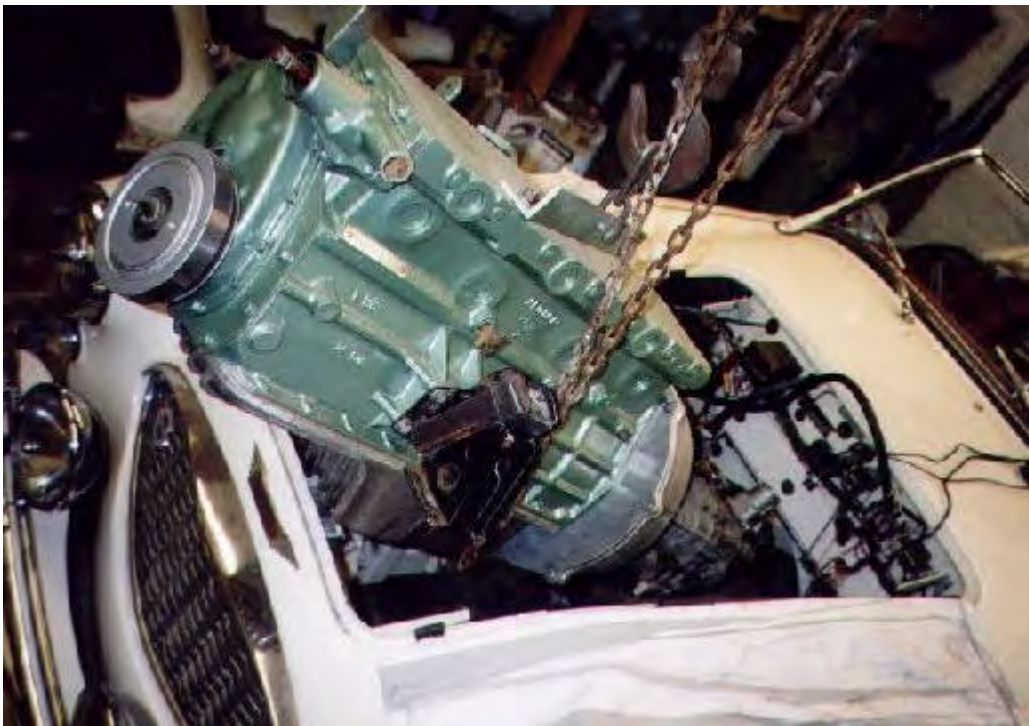
With gear lever removed, the engine (minus cylinder head) and transmission went in in one piece, see below.

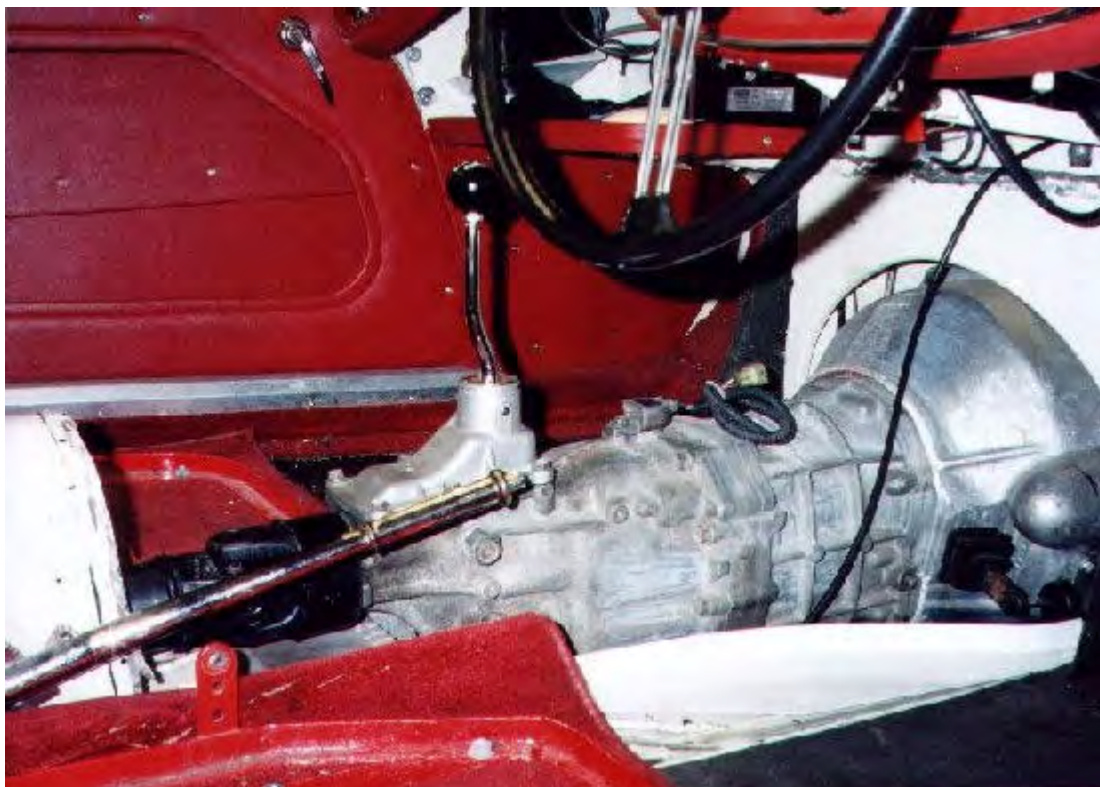
The new transmission tunnel required a new BJ7 bulkhead adapter plate and new BJ7 infill sections to each side. Being a bit lower in height than a standard centre change, and because off the peg carpets never fit very well, the carpeting is being made to fit.
