A Tasmanian Supra gearbox conversion

100 TECHNICAL CD-ROM

INTRODUCTION

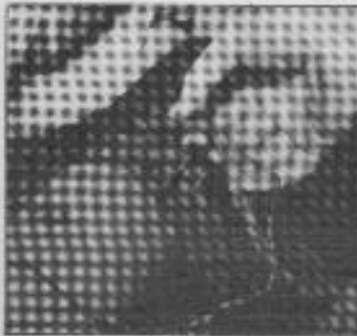
Broken, dirty, or oil soaked connections can cause problems in checking and cleaning these is one of the early stages. Look at these on the control box as well.

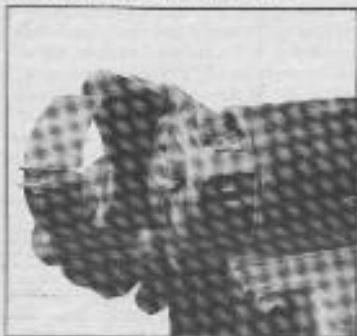
Dynamo problems quite often come down to fitting new brushes. You may be able to inspect them in situ, but you'll need to take the dynamo off to change the brushes.

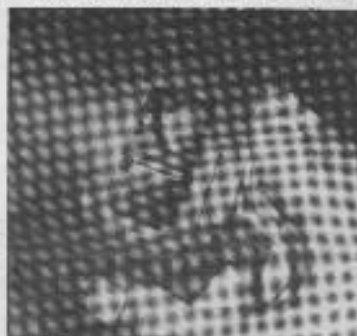
It's always worth cleaning the commutator with a petrol-soaked rag. If the commutator is scored, get it skimmed and the segments wear by an auto-electrician.

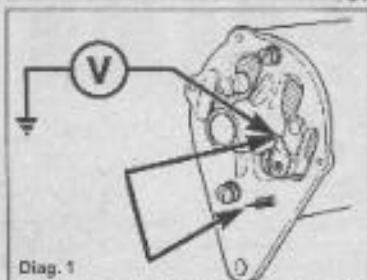
Diag. 1

Connecting a voltmeter between the bridged dynamo terminals and earth can tell you quite a lot about the state of the dynamo itself.

For this and for a number of subsequent checks you'll need to use a good moving coil voltmeter (0-20V). Leaving the unit in the car, disconnect the two leads and use some cable to bridge the two terminals. Then with the voltmeter between the bridged terminals and earth (Fig. 1), start the engine and gradually increase the engine speed, while watching the dial. A reading of 12V should be achieved quite easily without raising the engine and in no circumstances allow it to rise above 20V.

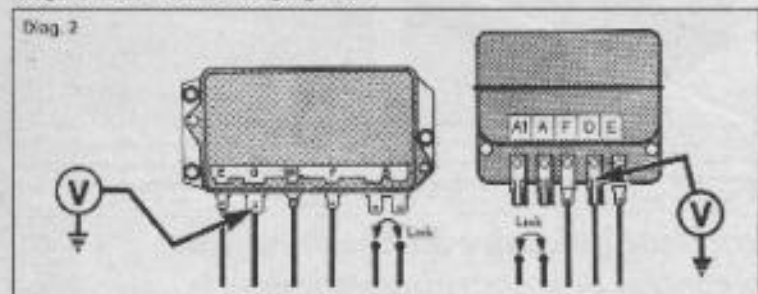
Diag. 2

This is the left hand bobbin on both types of control box. Connect the voltmeter as shown in Diag. 2, and run the engine at about 3,000 rpm. Readings should be:-
16.0-16.5V for an RB106 (two-bobbin).
15.0-15.5V for an RB310 (three-bobbin).
14.5-15.5V for RB340 (three-bobbin).

Using a voltmeter to check the voltage regulator.

If you don't get these figures, adjust the screw and locknut on top of the bobbin. A clearance of 0.01in. should produce the right voltage which can be re-checked on the voltmeter.

If this doesn't do the trick, try the effect of a jump lead between the E (earth) terminal and a good clean earth point. If this clears the trouble, clean or make a new control box earth connection. If it doesn't, you need a new control box.

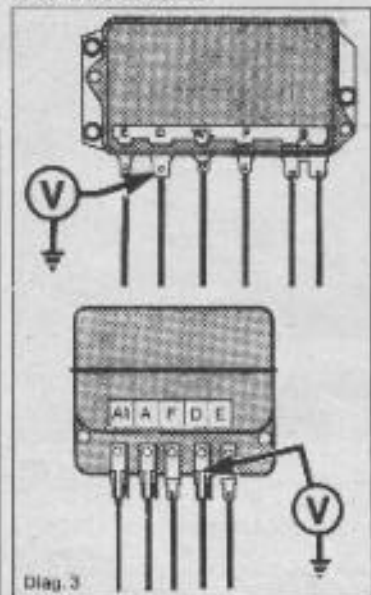
Diag. 3

Checking the voltage at which the cut-out contacts close.

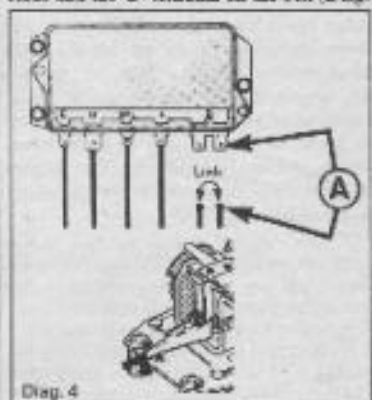
Diag. 4

This is the centre bobbin on the three-bobbin type of control box. To make the check, the dynamo must produce maximum output irrespective of the state of charge of the battery, and this means putting the voltage regulator out of action by clamping the contacts together; a small crocodile clip will do. The ammeter is connected between the linked 'B' leads and the 'B' terminal on the box (Diag.

Putting the voltage regulator out of action by clipping the contacts and running the engine to show dynamo maximum output on the ammeter. Do this with the headlamps on.

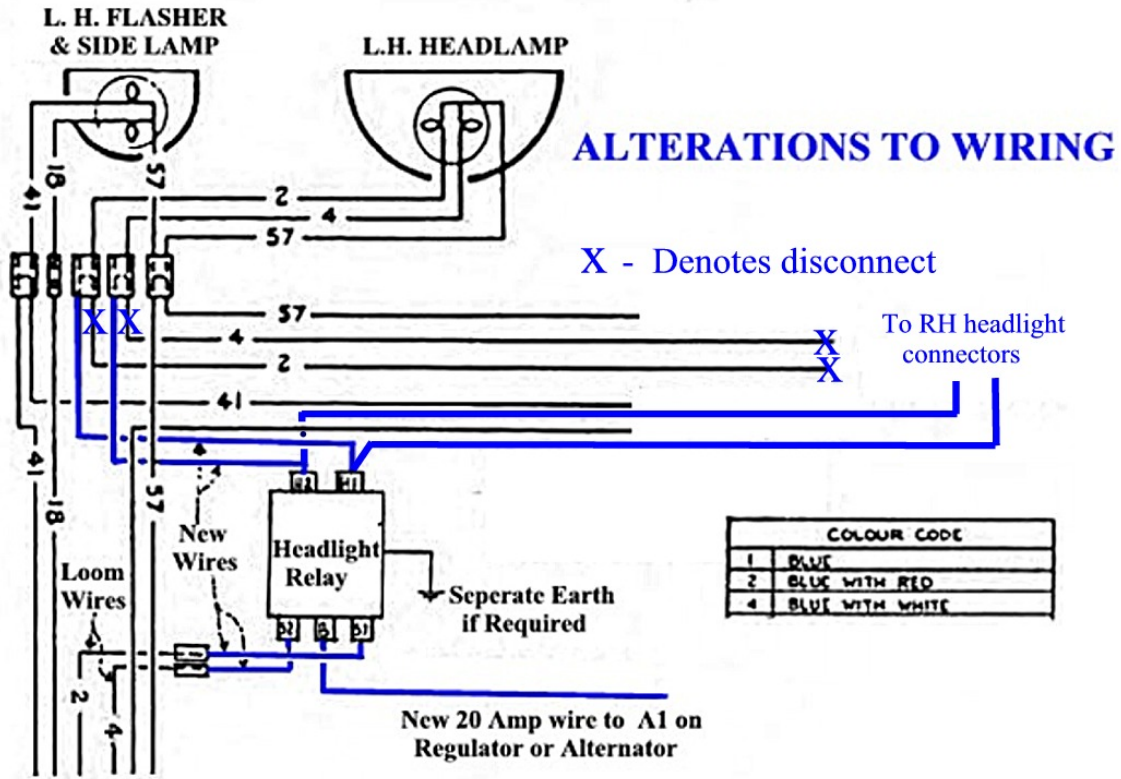
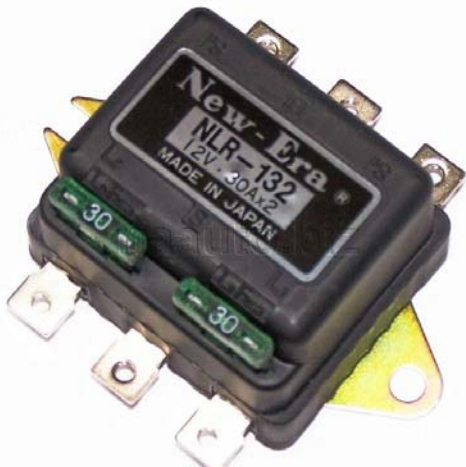
Typical headlight relay – available at most Auto parts suppliers or <http://www.naauto.biz/catalogue/category89/category96/product994>
 This one has external Blade Fuses whereas mine has internal Glass type.

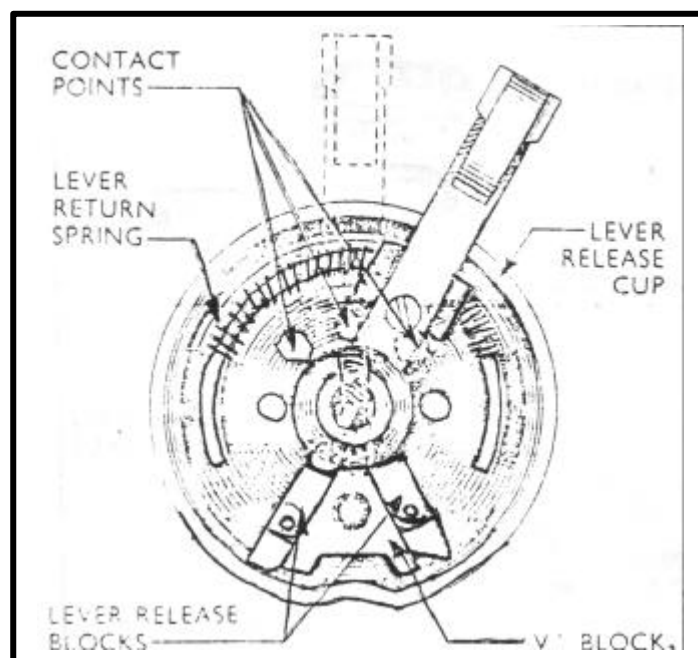
Fig.1

On the return of the steering wheel no such movement is possible and the block is depressed by the projection in the lever release cup, pushing the roller upwards until it is clear of the side of the "V" block. This permits the lever return spring to move the lever back to its normal position shown by the dotted outline in Fig.1. This movement also breaks the electrical circuit at the contact points and the indicator returns to its closed position.

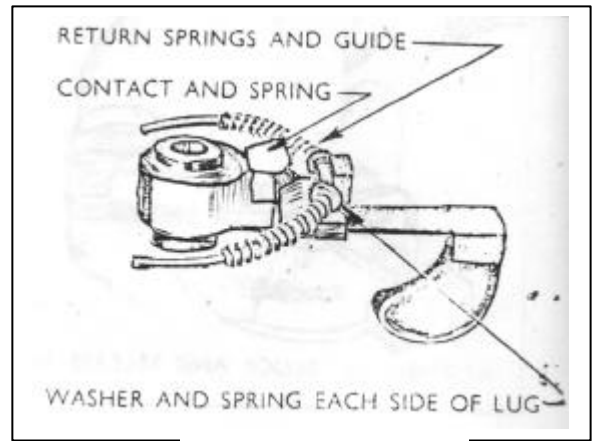
Fig 4.

1. Hold the switch lever upside down and position the sliding contact spring in its recess (See Fig. 4). Locate the switch lever return spring guide in the lug in the lever with one washer and spring on either side.

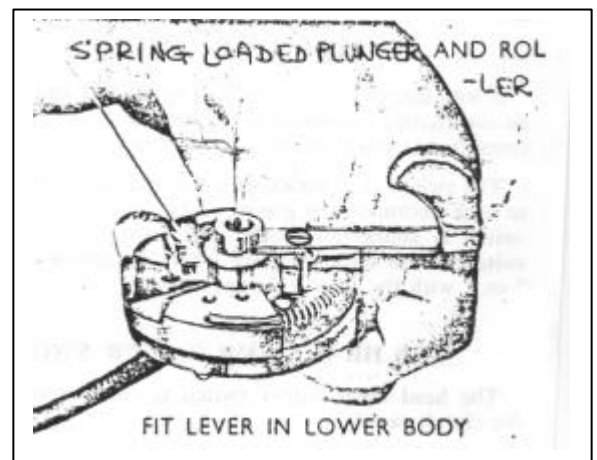
Fig 5.

Holding the lever in position against the switch body (see Fig. 5), press in the spring plunger and roller.

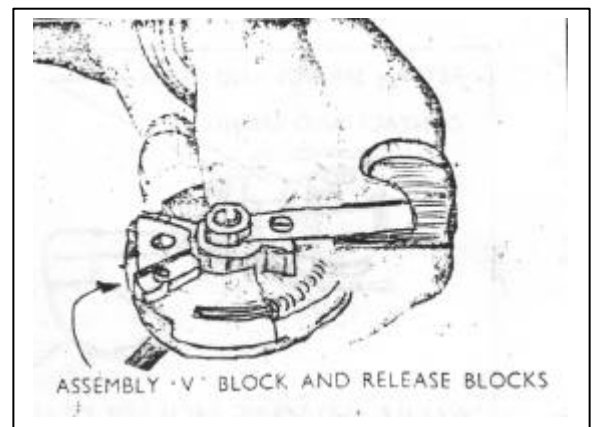
Fig 6.

3. Position the two release blocks in their grooves with the tapered ends pointing away from the "V" block (see Fig.6).

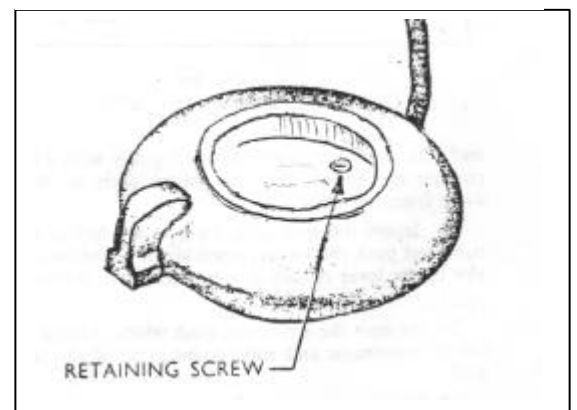
Fig 7.

4. Fit the upper half of the switch body to the lower half, and secure by means of the retaining screw and nut (See Fig 7).

6. To separate the upper and lower halves of the switch body, it will be necessary to remove the third screw now exposed by removal of the horn contact (Fig. 7.) the nut of which has also been unsoldered.

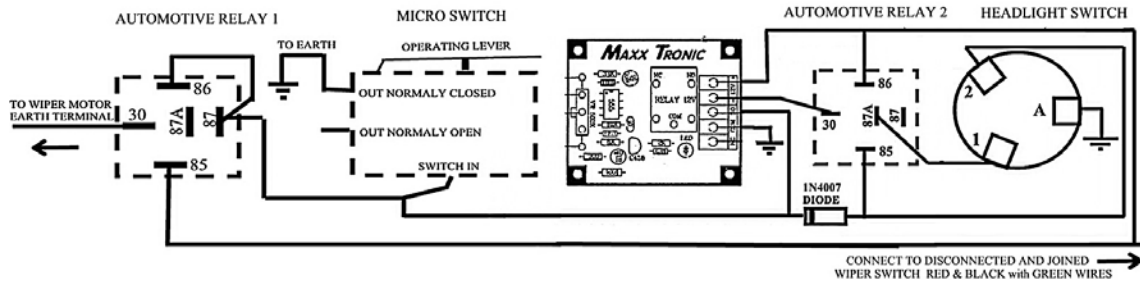
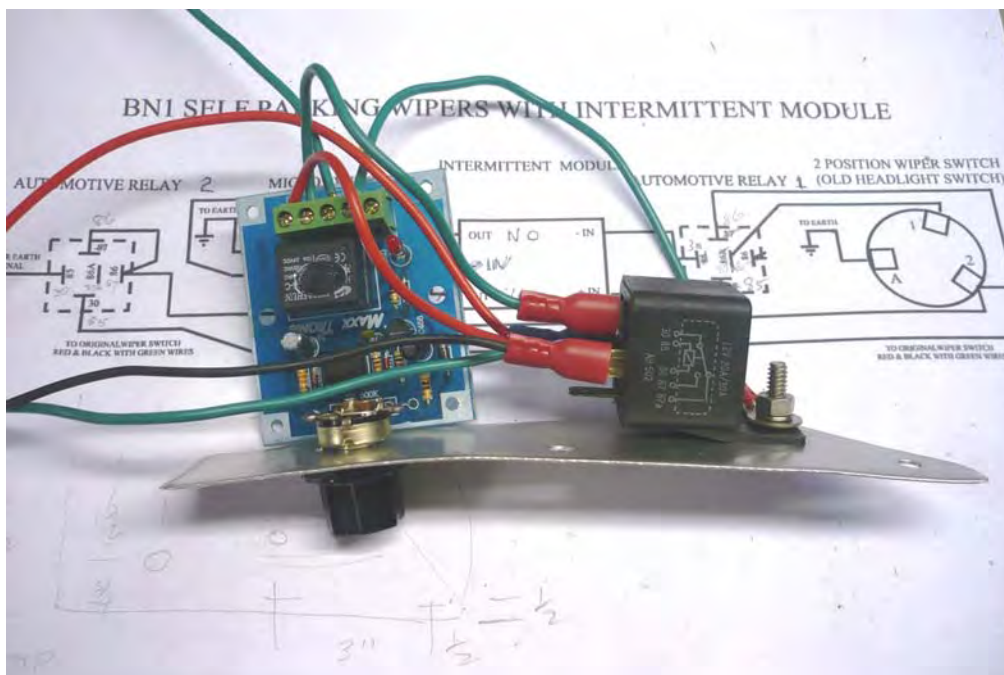
BNI SELF PARKING WIPERS WITH INTERMITTENT MODULE AND USING A HEADLIGHT SWITCH

The 1N4007 Diode (Dick Smith 9cents) is required to stop the intermittent unit actuating the relay when the switch is in the first position.

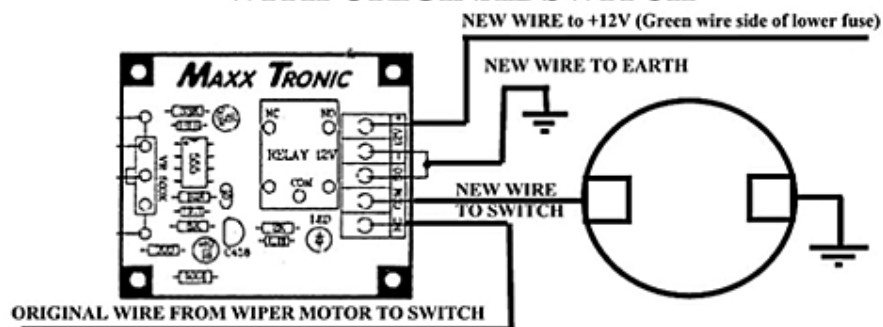
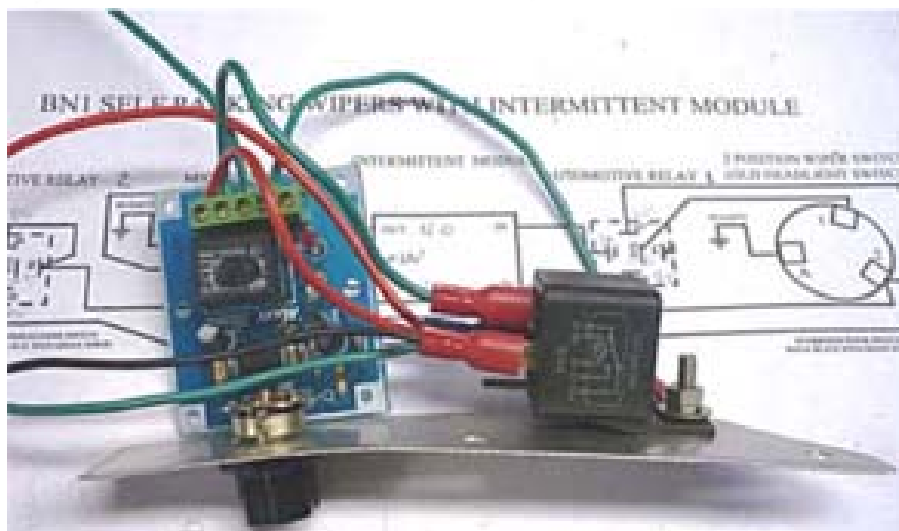
INTERMITTENT MODULE WITH ORIGINAL SWITCH

Below is how you can wire the unit up if you use the original wiper switch. To use the delay unit turn the knob to switch it on and then turn clockwise to get the timing from 3 to 30 seconds. To use the normal wipers turn the unit off and pullout the original wiper switch. You must turn the intermittent unit off before you turn the ignition switch off or the unit will start immediately next time you turn the ignition on again. In a BN1 you'll have to switch it off at the end of the wiper stroke, the same as you do with the wiper switch.

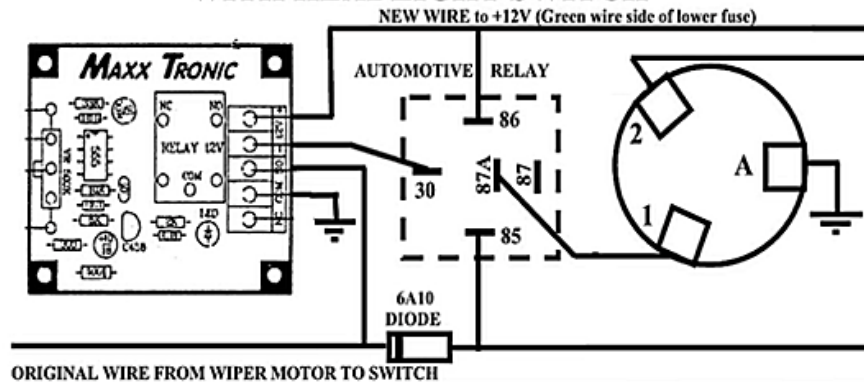
INTERMITTENT MODULE to BJ7 WITH HEADLIGHT SWITCH

Below is how you can wire the unit up using a headlight switch. The beauty of this is you don't have to turn the unit off just leave at your favorite timing setting. When you pull the switch out to the first position it actuates the unit at the setting you last left it at, when you pull it out to the second position the unit is disconnected and the wipers work at full speed. Pushing the switch back to the first position, the wipers go back to the intermittent setting and pushing it right in turns everything off and parks the wipers. The existing wiper labeled knob fits the new switch. The 6A10 Diode (Dick Smith \$1.35) is required to stop the intermittent unit actuating the relay.

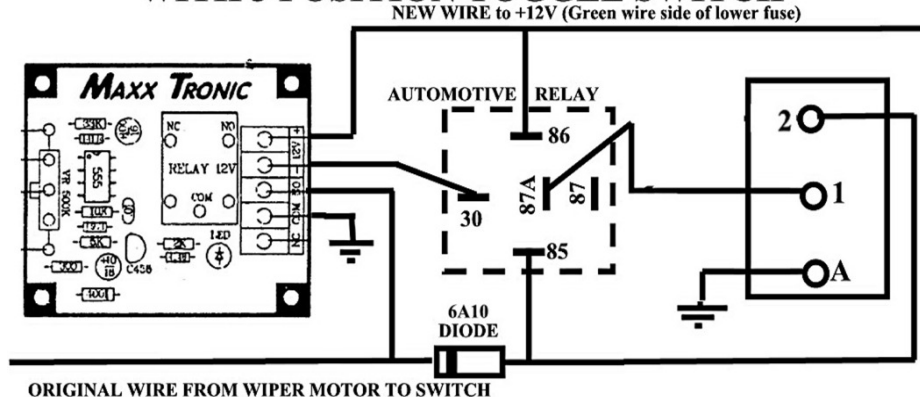
INTERMITTENT MODULE FOR BJ8 WITH 3 POSITION TOGGLE SWITCH

For the BJ8 you can wire it up using a headlight switch or a 3 position toggle switch available at most electronic suppliers.. When you move the switch down to the first position it actuates the unit at the setting you last left it at, when you move it down to the second position the unit is disconnected and the wipers work at full speed. Raising the switch back to the first position, the wipers go back to the intermittent setting and raising it right up turns everything off and parks the wipers. The 6A10 Diode (Dick Smith \$1.35) is required to stop the intermittent unit actuating the relay

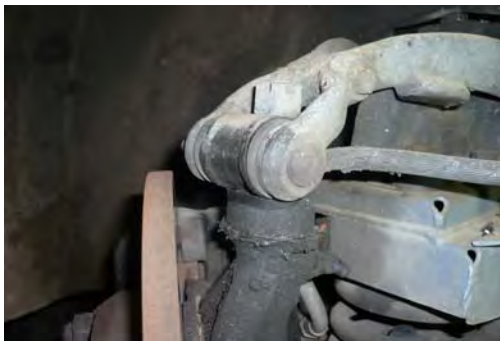
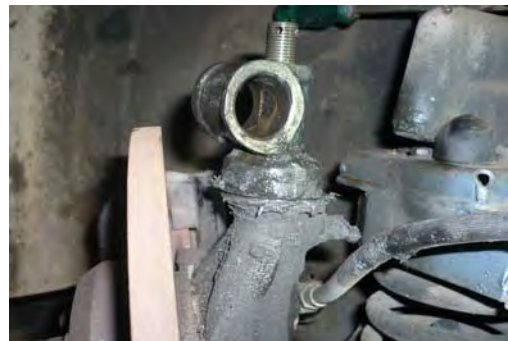
Jack up under the spring pan, to remove the top trunnion but first you have to remove the pin through the shock arms and the rubber bushes. There's a chance that the pin will be rusted to the steel tube inside the bush and you might have to hacksaw through it both sides of the trunnion. Then you can remove the trunnion nut, trunnion and steel & bronze thrust.

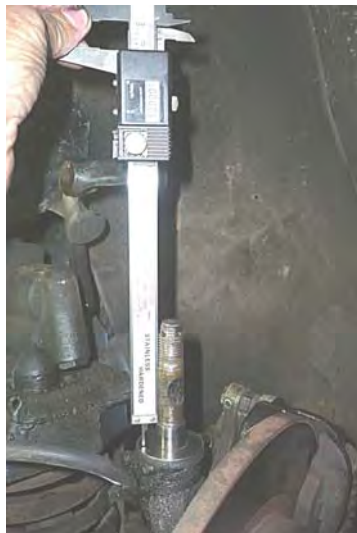
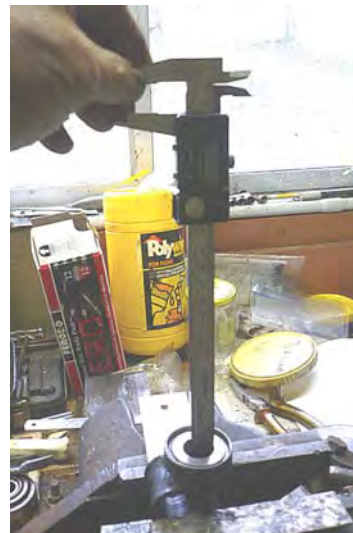
Measure the distance from the step on the king pin to the top of the stub axle and subtract the distance from the step inside the trunnion to the roller bearing fitted inside the trunnion to get the end float.

Install the thrust with sufficient shims to leave 2 thou end float, replace the trunnion and tighten the top nut. Check the end float by using a long screwdriver under the stub axle and over the wishbone to lift it and note the movement. Measure this end float, with the stub axle lifted up, between the bottom of the stub axle and the bottom of the king pin with Feeler Gauges and adjust the number of shims if necessary to get the required 2 thou end float.

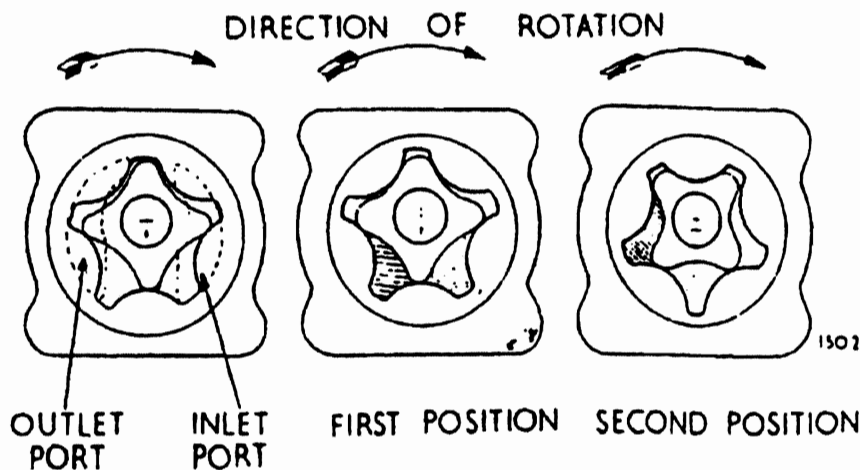
Figure 1: An eccentric rotor type oil pump has one lobe less than the number of internal segments in the outer rotor.

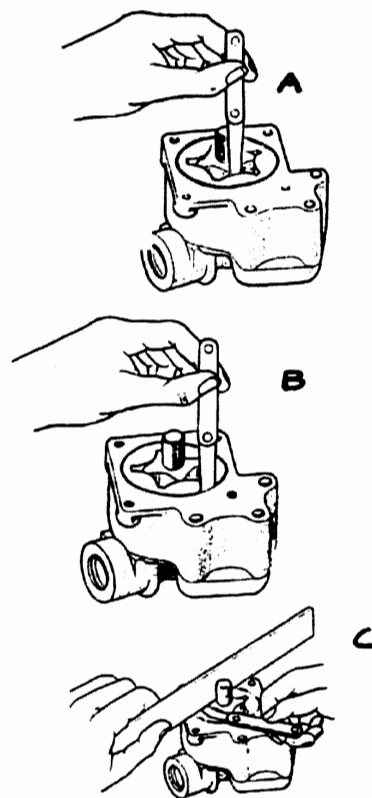
Figure 2: Typical clearances in an eccentric rotor type oil pump similar to those used in an Austin-Healey.
 A. Inner rotor to outer rotor 0.006" max; 0.002" new.
 B. Outer rotor to pump body 0.010" max; 0.003" new.
 C. End float of rotors: 0.0025" max; 0.0015" new.

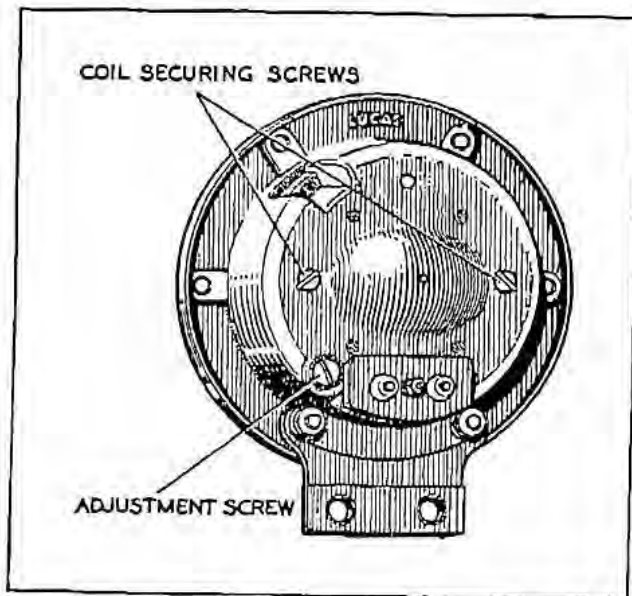
Fig. 1.

Rear view of horn showing adjustment screw.

Whilst energising the horn, turn the adjustment screw anti-clockwise until the correct horn note and current consumption is obtained.

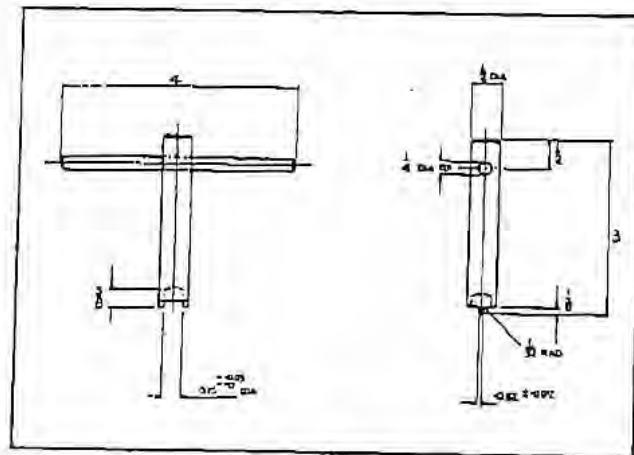
Fig. 2.

Tool for adjusting air gap setting.
(Measurements in inches)

The air gap adjusting tool (Fig. 2) and centralising jig (Figs. 5 and 6) must be made under local arrangements. The correct material for both tools is mild steel, case hardened.

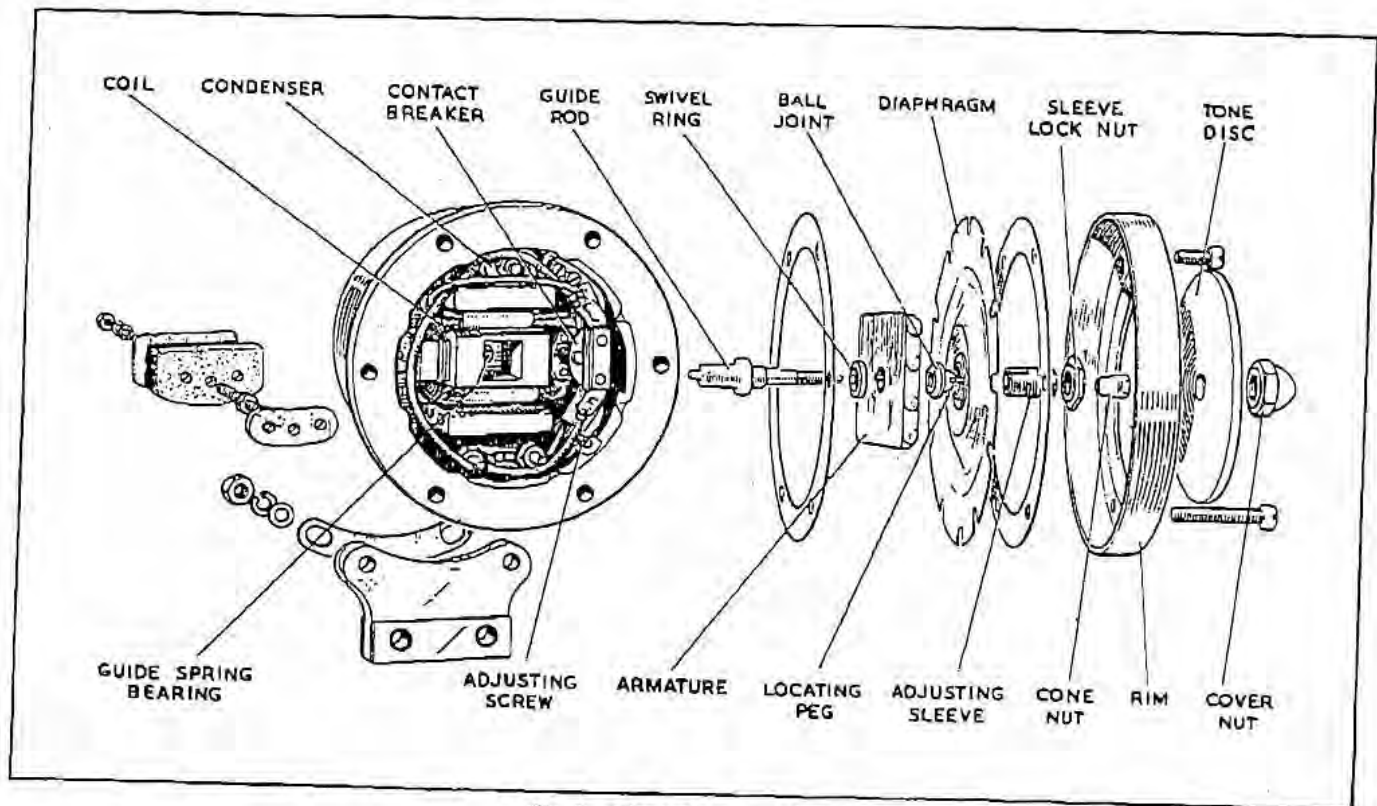
Fig. 3. Dismantled view of horn.

A partly dismantled horn is shown in Fig. 3 and the sequence of removal operations is laid down in Fig. 4.

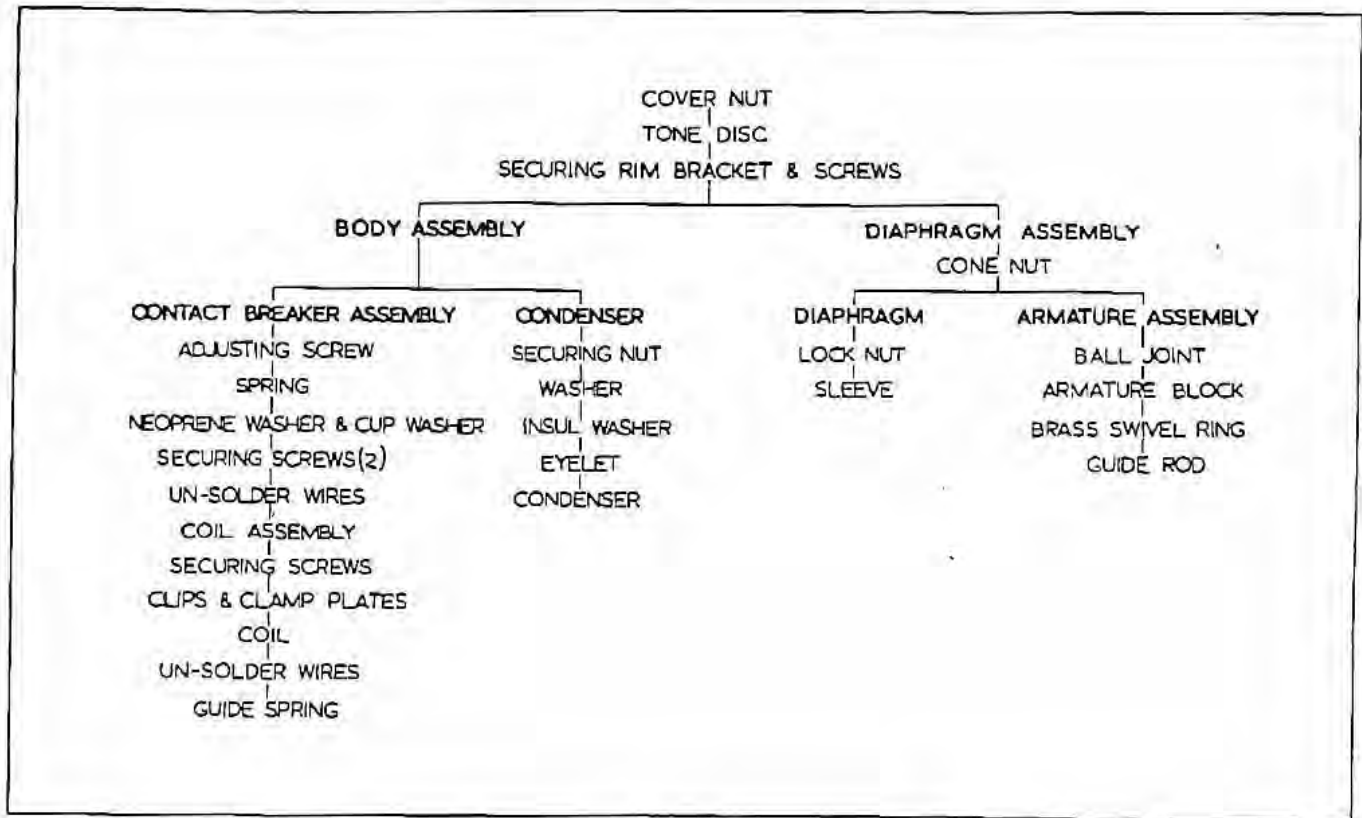
Fig. 4.
Sequence of dismantling and reassembly.

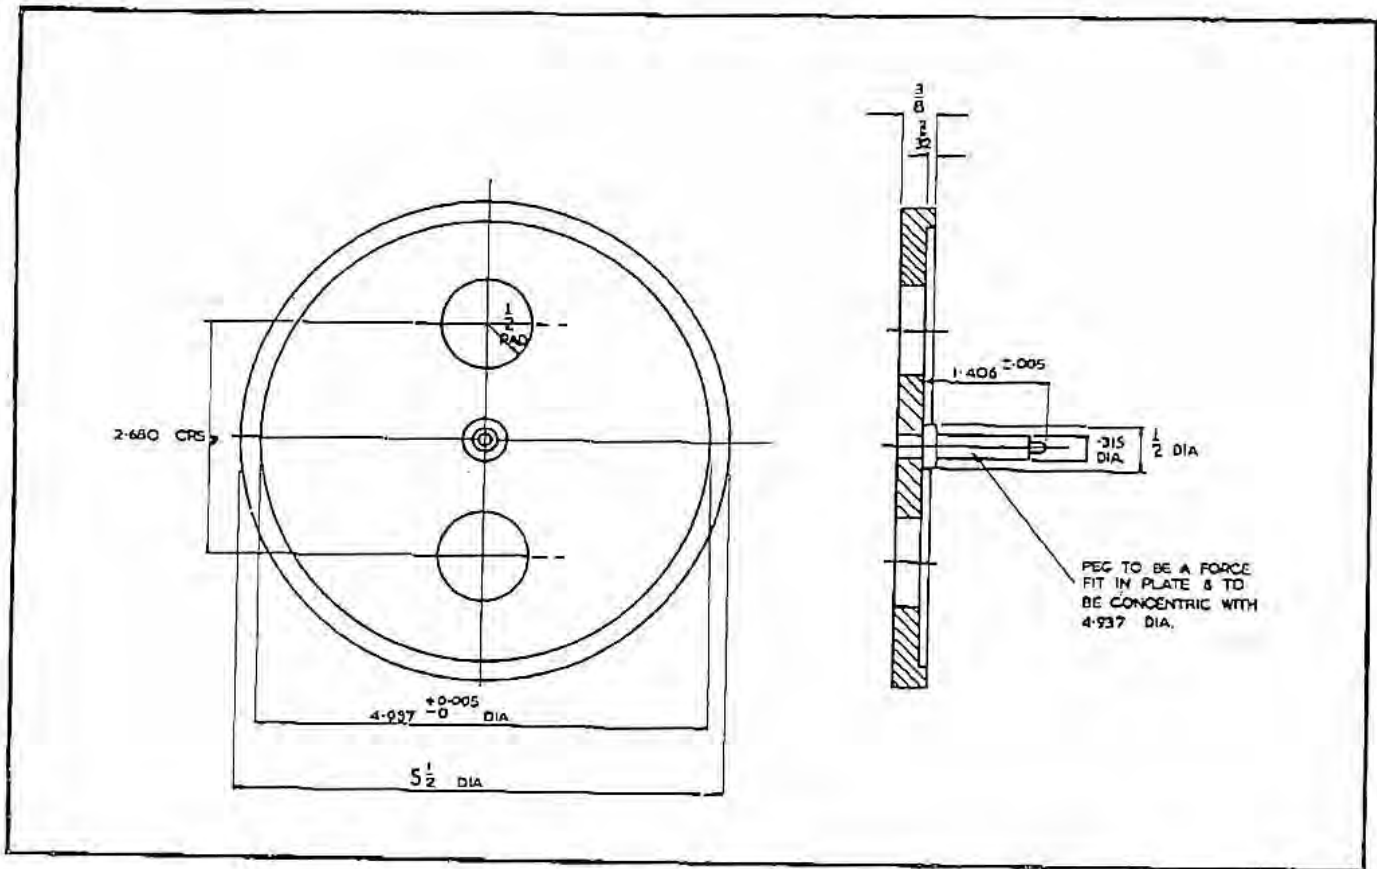
Fig. 5.
Plan view of centralising jig.
(Measurements in inches).

- (a) Before tightening the screws securing the coil assembly, the guide spring bearing must be centralised in the horn body. Place the centralising jig (Figs. 5 & 6) over the horn body, with the central peg located in the guide spring bearing, and tighten the coil securing screws. Make sure that the coil clamping plates are square to the windings, and that the coil is firmly clamped around the former and not moveable by hand.
- (b) To avoid short circuits due to chafing of cable insulation through vibration, the cables from the coil,

PEG TO BE A FORCE
 FIT IN PLATE & TO
 BE CONCENTRIC WITH
 4.937 DIA.
 See FIG. 6.

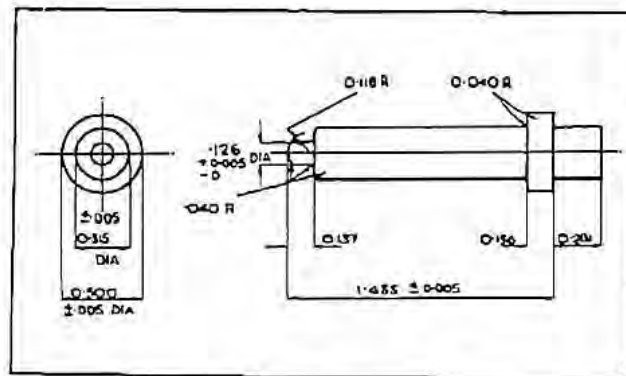
Fig. 6.
Details of peg for centralising jig.
(Measurements in inches).

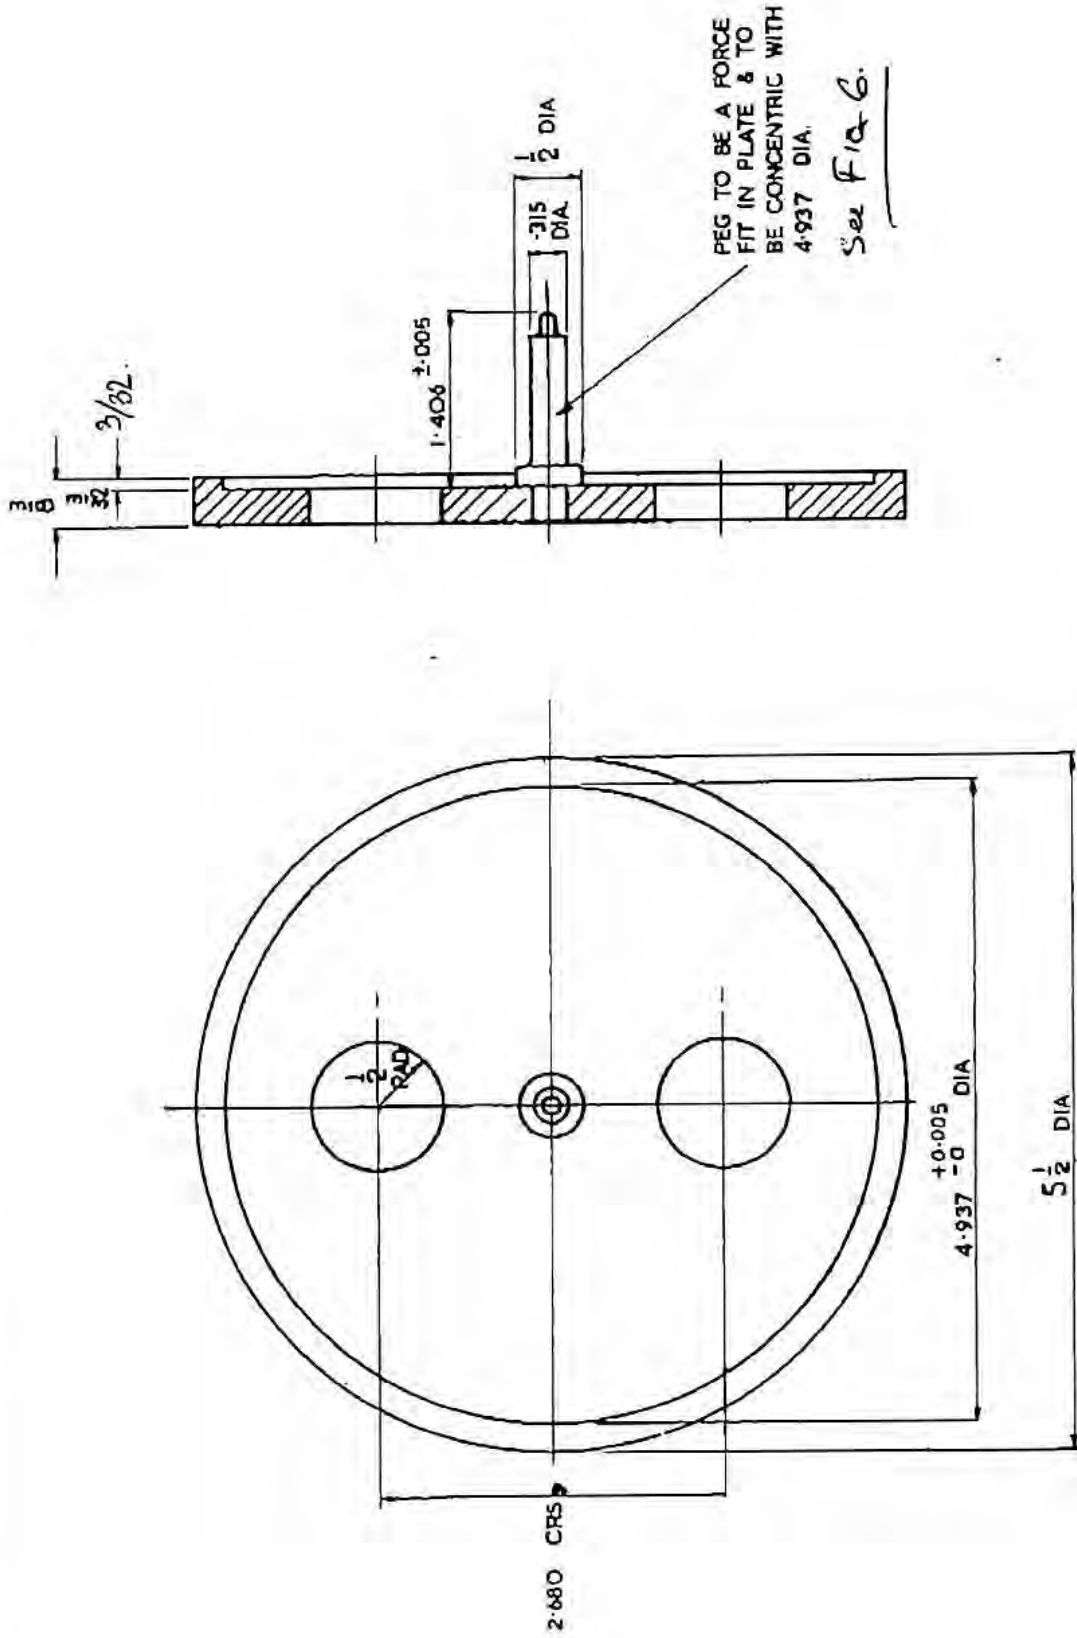
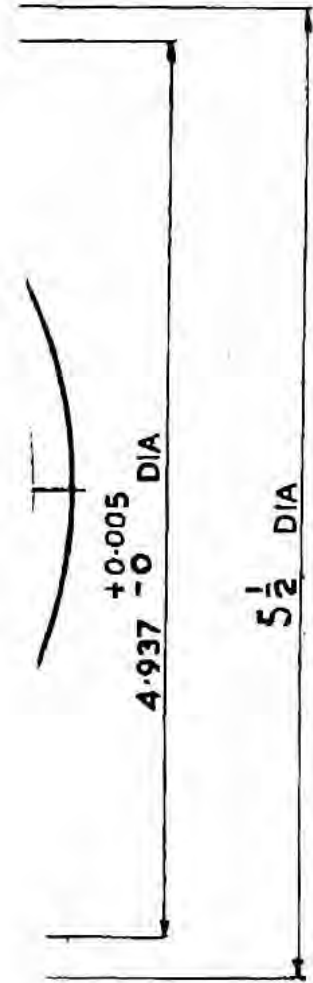
Fig. 5.
 Plan view of centralising jig.
 (Measurements in inches).

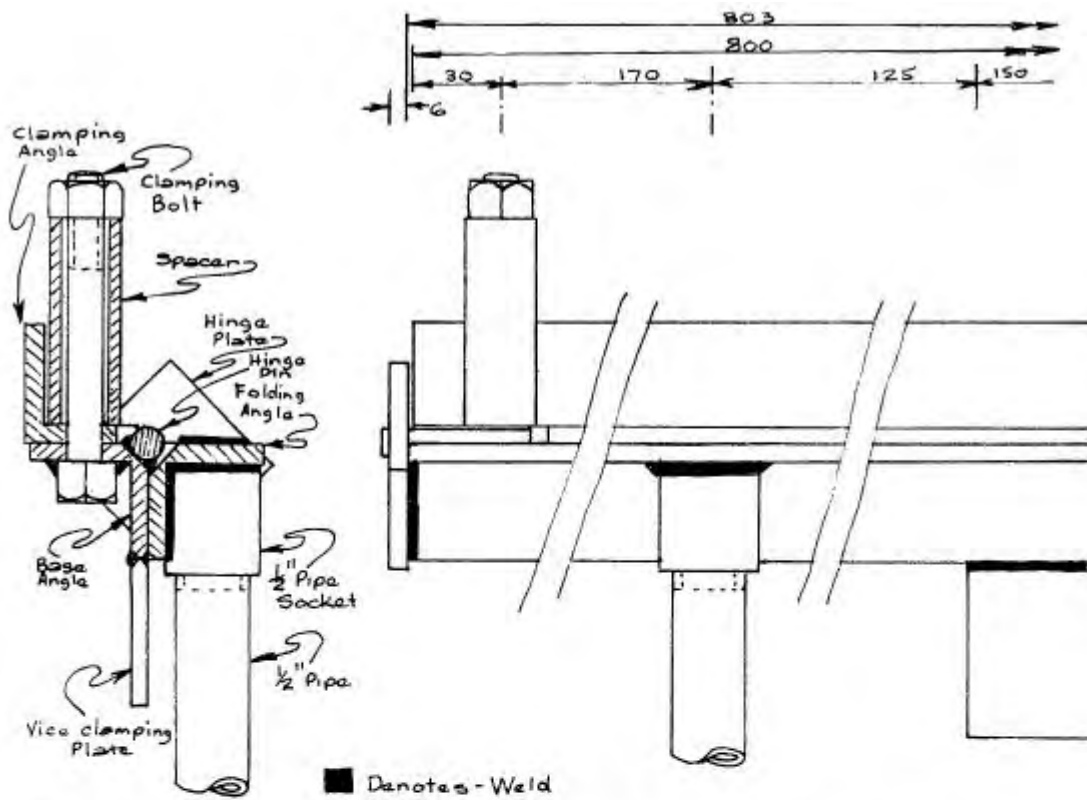
SECTION THROUGH BOLT

PART ELEVATION

40 x 40 x 6 mild steel angle	2 off 800mm....1 off 803mm
Hinge plates.....	2 off 50x50x6mm
Vice clamping plate.....	1 off 150x50x6mm
Hinge pins	2 off 50x1/2" dia. round.
Bolts and nuts.....	2 off 3 'x1/2" Whitworth
Spacers.....	2 off 2"x1/2" Int. dia.
Folding handles.....	2 off 1/2" pipe x 300mm
Pipe connectors.....	2 off 1" pipe

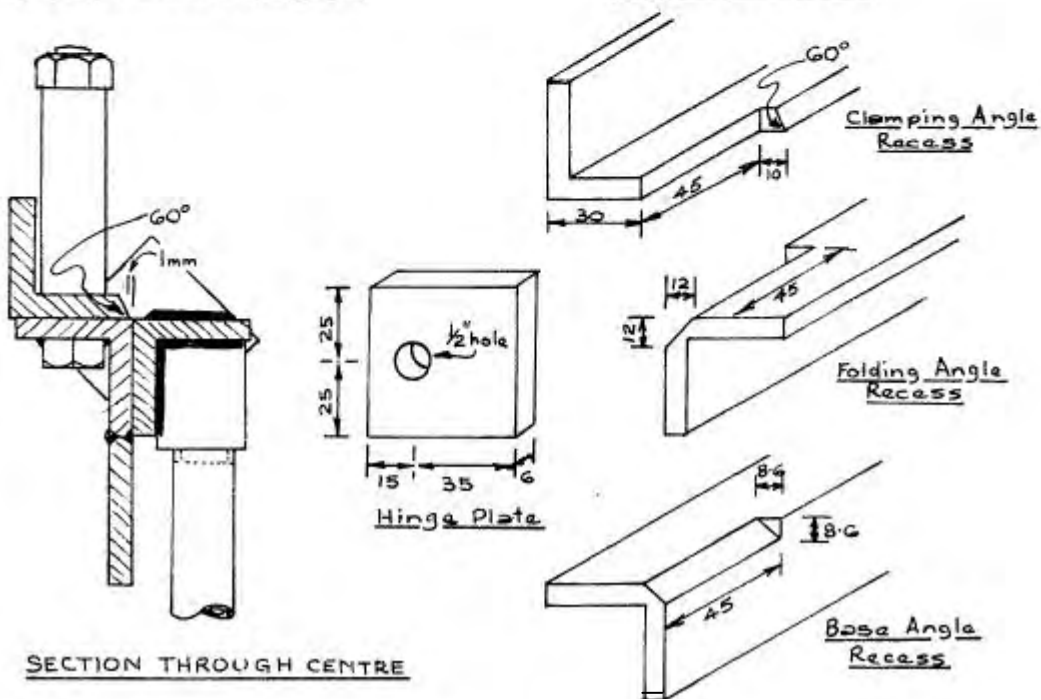
SECTION THROUGH CENTRE

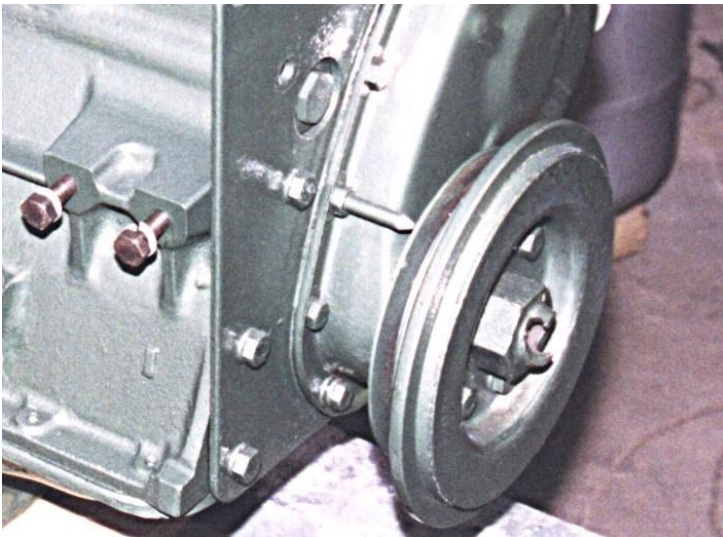
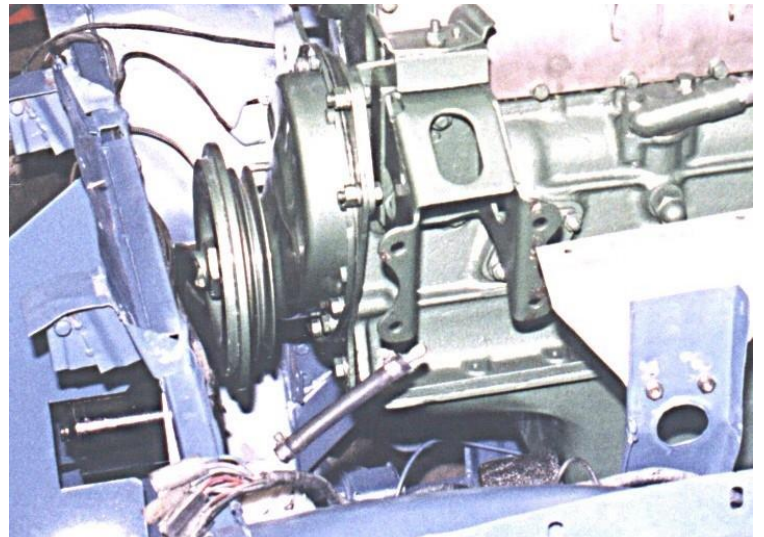
Beheaded bolt and timing mark

A 6 cylinder harmonic balancer fitted exactly in place of the old crankshaft pulley, but first the chain cover bolt directly opposite the outer edge of the balancer pulley was replaced by a 2 1/2 inch 5/16 BSF nut and beheaded bolt with its end tapered into a timing pointer. TDC was found by bringing No 1 piston up to just before TDC (by looking through the plug hole), then a spark plug body (with a thread tapped through the middle) screwed into No1 cylinder and a threaded rod screwed into it to touch the top of the piston. The crankshaft pulley was marked in line with the pointer then turned until the piston again touched the threaded rod and this position marked on the pulley, TDC should be half way between the two marks. This was done twice more with the threaded rod in slightly different positions, to check the accuracy of the first attempt, which proved it to be correct. A notch was filed at TDC and a second one clockwise 8.3 mm away for 6 Degrees Before TDC (6 1/4 inch dia pulley).

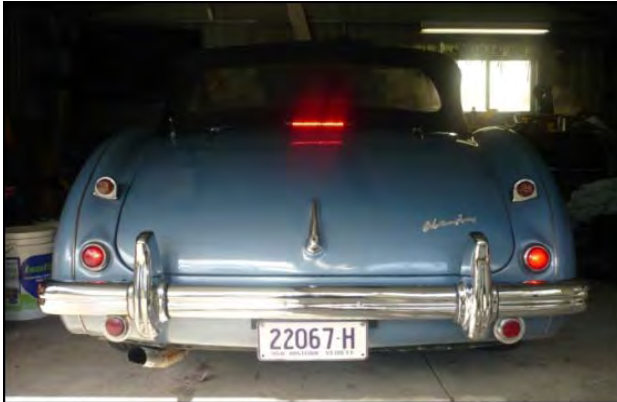
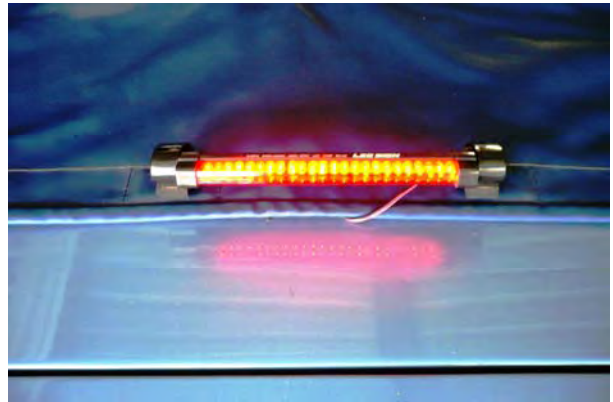
On the Tonneau Cover I have replaced the two pieces of aluminium sewn into the rear that clip into the retainers on the shroud, with a piece of steel bar 20wide x 3thick x 570long. The magnets attach firmly to this.

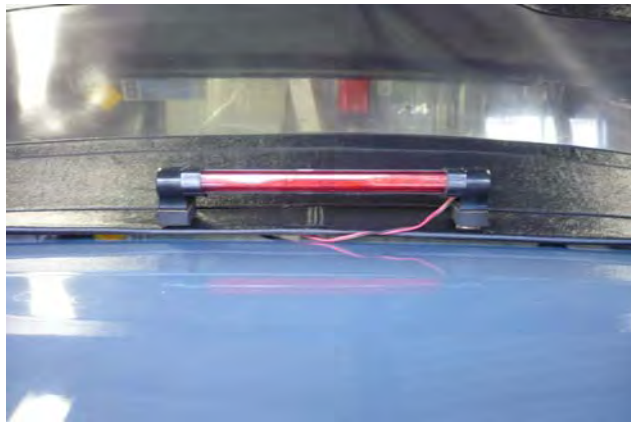
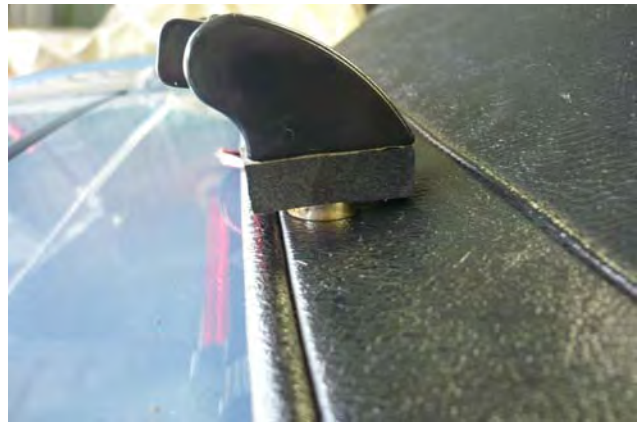
The magnets attach firmly to the existing steel bar at the back of the hood.

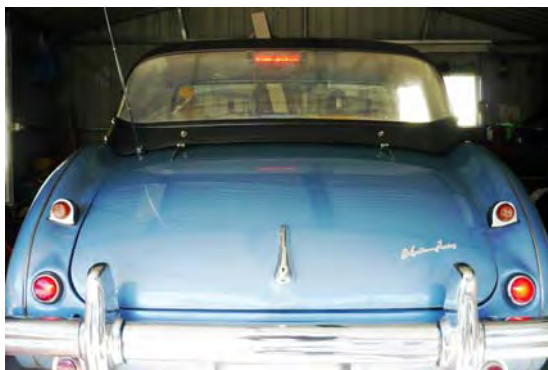
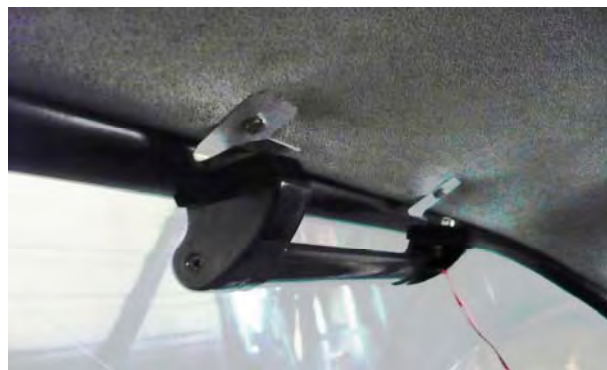
In the hard top two small steel brackets screwed into the wood surround of the back window which is fiber glassed into the shell hold the light firmly.

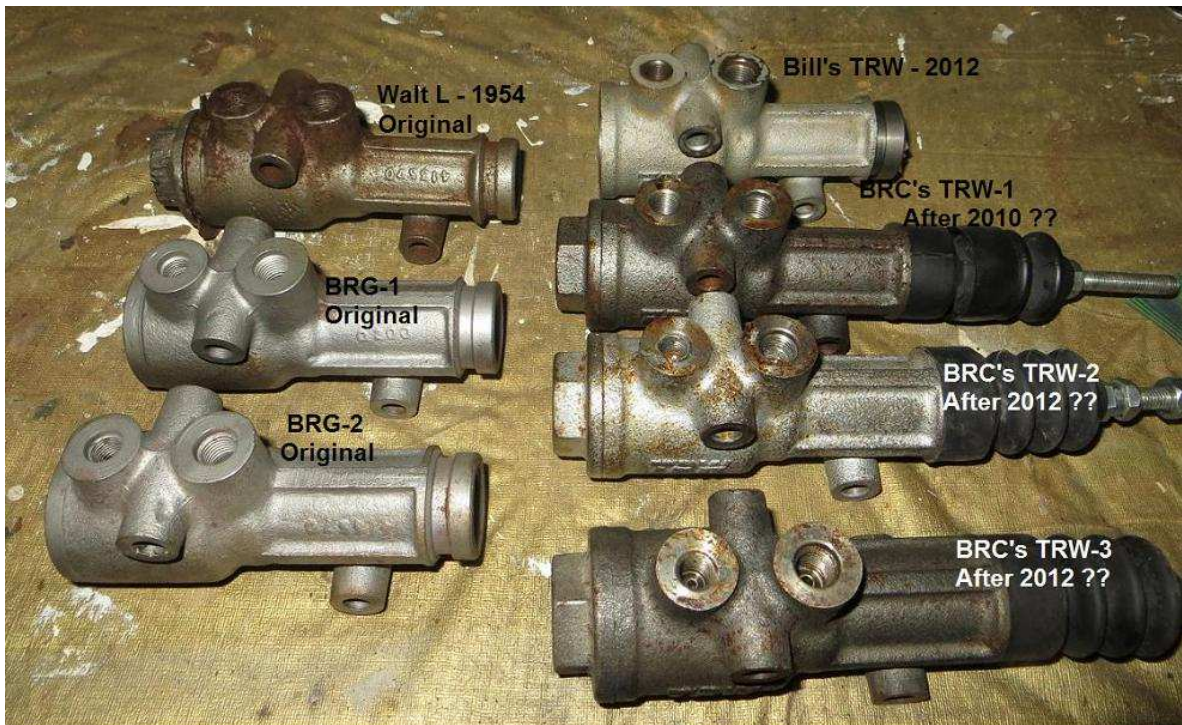
Note Bill's TRW - 2016 measured & returned due to small bleed holes identical to TRW 2012. Traded in for the 2 BRG originals measuring same larger bleed holes as Walt L/1954.....

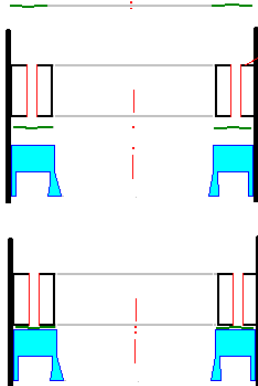
1.115" OD
0.750" ID
0.0070" Thick
0.0050" Bump
Weak Magnetic
8.00 Density (gm/cm³)
304 SS - 7.99

6 Bleed Holes
#53 Bit - Perfect
0.0595" Dia.
~ 0.25" Path

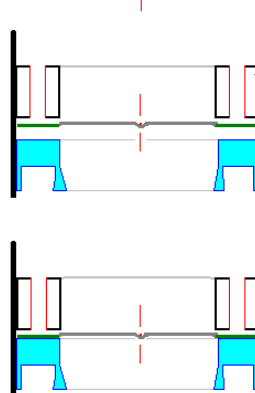
1.115" OD
0.750" ID
0.010 Thick
Bump

6 Bleed Holes
#43 Bit - Perfect
0.0890" Dia
~ 0.25" Path

Casting #s
C0156
413570

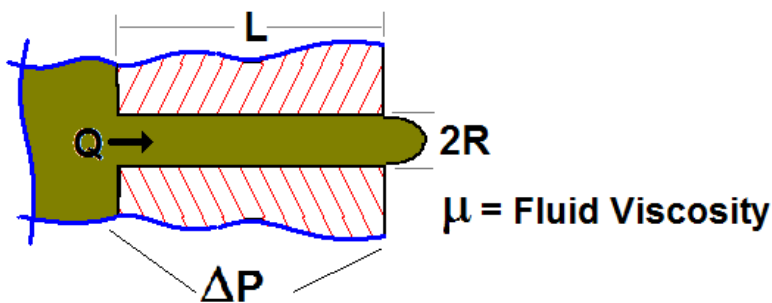
Hagen-Poiseuille Flow - 1839

Well established result relating flow rate of viscous liquid through a capillary driven by pressure difference.....

$$Q = \frac{\pi \Delta P R^4}{8 \mu L}$$

Holding pressures, length, viscosity constant, changing R has major effect on flow Q.
