A Tasmanian Supra gearbox conversion

100 TECHNICAL CD-ROM

INTRODUCTION

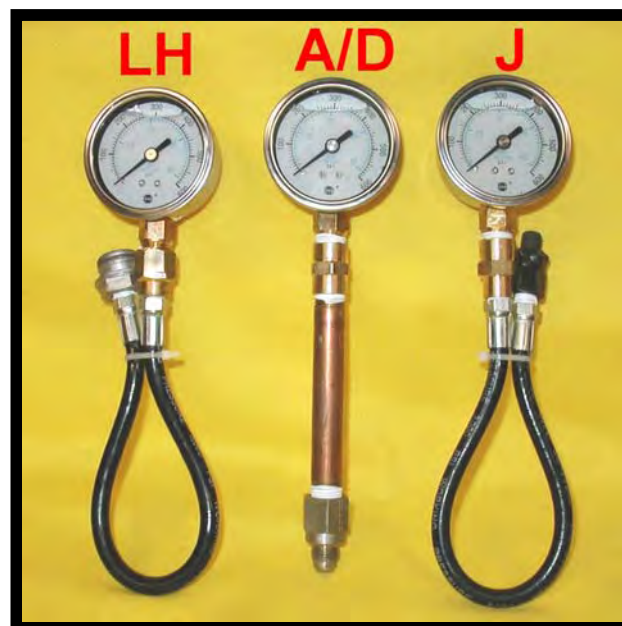
Laycock de Normanville Overdrive A/D Type J Type & LH Type OIL PRESSURE GAUGE TEST SET

Hydraulic Oil Pressure Test Gauge Set - A & D type, J, or LH type Laycock de Normanville Overdrive, functionally equal to / better than Churchill L.188, and Churchill adapter L.188-2, [BL tool 18G251 and 18G251E (LH)] which have long been out of production and very rare.

- Custom machined steel fitting to replace the operating valve plug. (A & D Type)
- Custom fabricated steel fitting to connect to the test port near the solenoid (J Type)

- Custom fabricated steel fitting to replace the relief valve plug (LH Type)
- 0 > 600 PSI - 2 inch diameter pressure Gauge - liquid (glycerin) filled, which helps absorb vibration and pressure spikes, increasing the service life of the gauge. The dampening action of the liquid also reduces pointer flutter and lubricates the internal parts of the gauge. The allowable operating/ambient temperature range for the glycerin is -4F to 140F (-20C to 60C). Gauge: 304 stainless steel case, polycarbonate window, black finished galvalume pointer, galvalume dial (white background with blue and black markings), brass movement, phosphor bronze bourdon tube.

The oil pressure gauge is the key tool for Laycock de Normanville Overdrive problem diagnosis and repair.

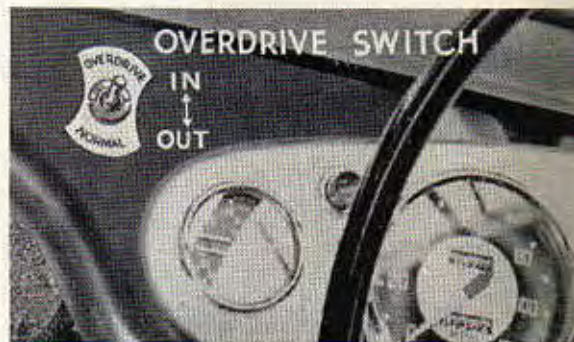
Manual Switch. A switch mounted centrally on the fascia panel provides a means for the driver to override the automatic control at speeds in excess of 30 m.p.h. (48 k.p.h.) providing the throttle is more than one-fifth open.

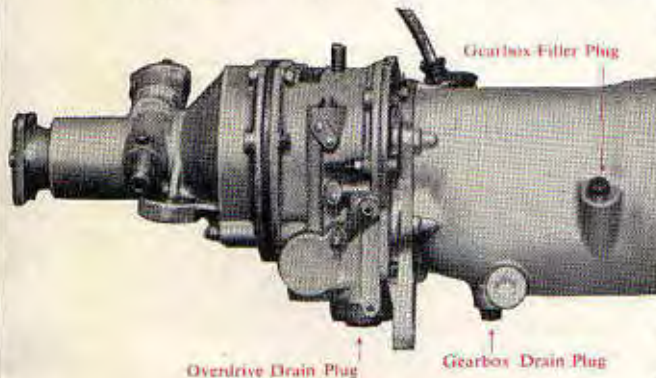
The lubricating oil for the overdrive unit is common with that in the gearbox. To check the oil level, take out the inspection panel in the right-hand side of the gearbox cover when the filler plug will be accessible.

Every 1,000 miles (1,600 kilometers) check the oil level of gearbox and overdrive, and if necessary top-up to the base of the filler plug threads with the recommended grade of oil.

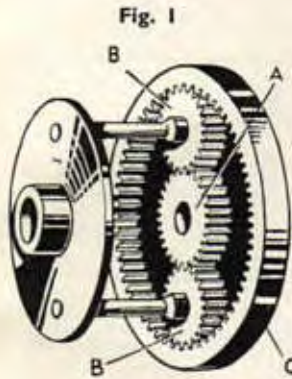
The principle of operation of this unit is simple. Basically it comprises an epicyclic gear train; see Fig. 1, consisting of a sun wheel (A), planet wheels (B) which revolve around the sun wheel, and an outer ring, the annulus (C) cut with gear teeth on the inside. Also there is a hydraulic pump, a hydraulic accumulator or pressure storage chamber, and a uni-directional roller clutch.

This clutch operates as follows. The driving shaft from the gear box carries the inner member on which are cut a number of inclined surfaces. The annulus or outer ring of the epicyclic gear train, which is attached to the propellor shaft carries the outer member.

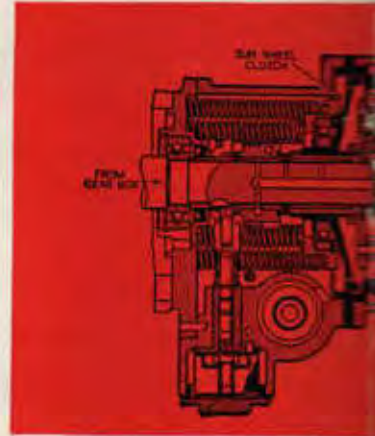
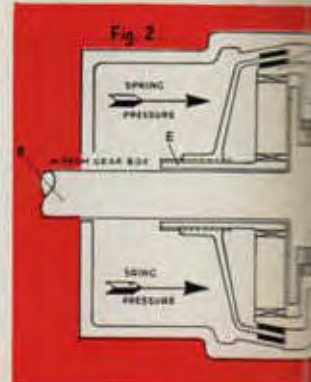
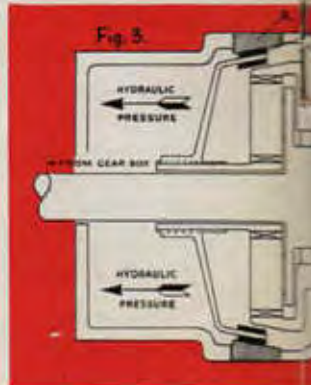
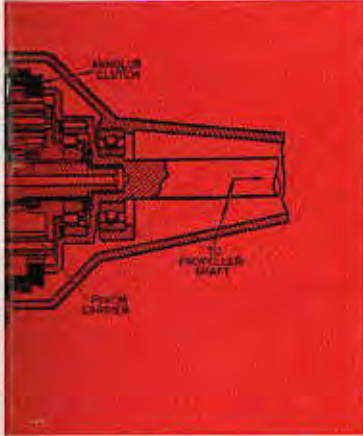
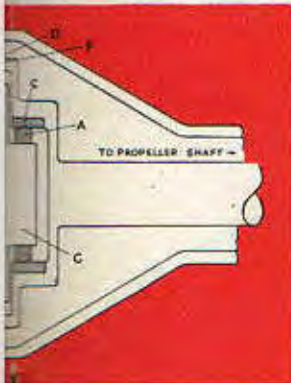
When in direct top gear (see Fig. 2) the overdrive is, of course, inoperative. The drive from the gearbox to the propellor shaft is taken through the rollers (A) from the gearbox main driving shaft (B) to the outer member of the uni-directional clutch (C), and so direct drive is transmitted.

It will be remembered that the Roller Clutch drives in one direction only, and therefore if the car were to over-run the engine, the rollers would be pushed down the inclined surfaces away from the annulus or output member and the drive broken, leaving the car without engine resistance to assist braking. This problem is overcome by means of a cone clutch (D).

This clutch slides on the sun wheel splined extension (E) and it is pushed by springs to engage with the corresponding cone of the annulus (F). This, therefore, locks the sun wheel to the annulus. Between the annulus and the sun wheel are the planet wheels which are carried by the Planet Carrier (G) (Fig. 2) which is mounted on the Driving Shaft (B). The planet wheels are therefore also locked and resistance to over-run is provided by the engine through the gear box and main drive shaft to the planet wheels.

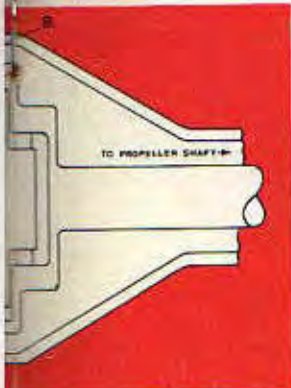
When overdrive is engaged a valve in the unit is opened. Hydraulic pressure contained in the accumulator is thereby applied to two pistons. These pistons operate on the cone clutch member, overcoming the spring pressure and pushing the cone member away from the annulus and against a conical brake ring (A) Fig. 3, built into the main casing.

The sun wheel carries the cone clutch (B), Fig. 3, and is free to rotate on the mainshaft. Therefore, when the cone clutch makes contact with the brake ring (A) it brings the sun wheel to rest and holds it stationary.

The planet carrier and planet wheels are now driven round the stationary sun wheel, causing the annulus to be overdriven at a higher speed than the driving shaft.

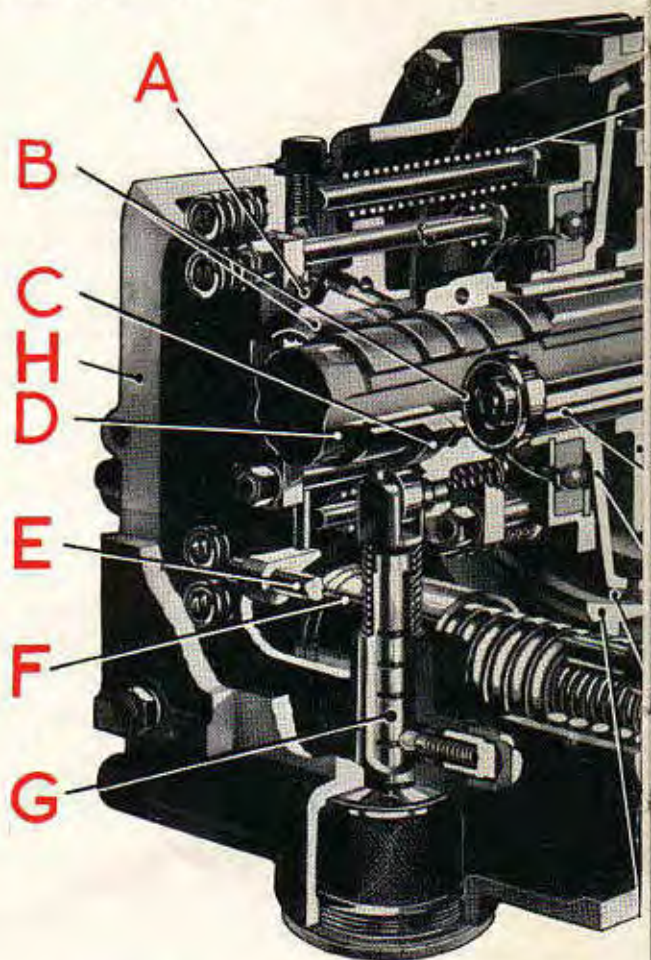
To change into overdrive, the operating shaft (E) is rotated a small amount by the operation of the solenoid. This lifts the operating valve (A) allowing the

stored hydraulic pressure in the accumulator to be applied to two pistons (B). These pistons (B) now move the clutch (K) forward away from the annulus (U) overcoming the springs (V). During the forward movement of the clutch (K) the drive from the engine to the wheels is maintained by the roller clutch.

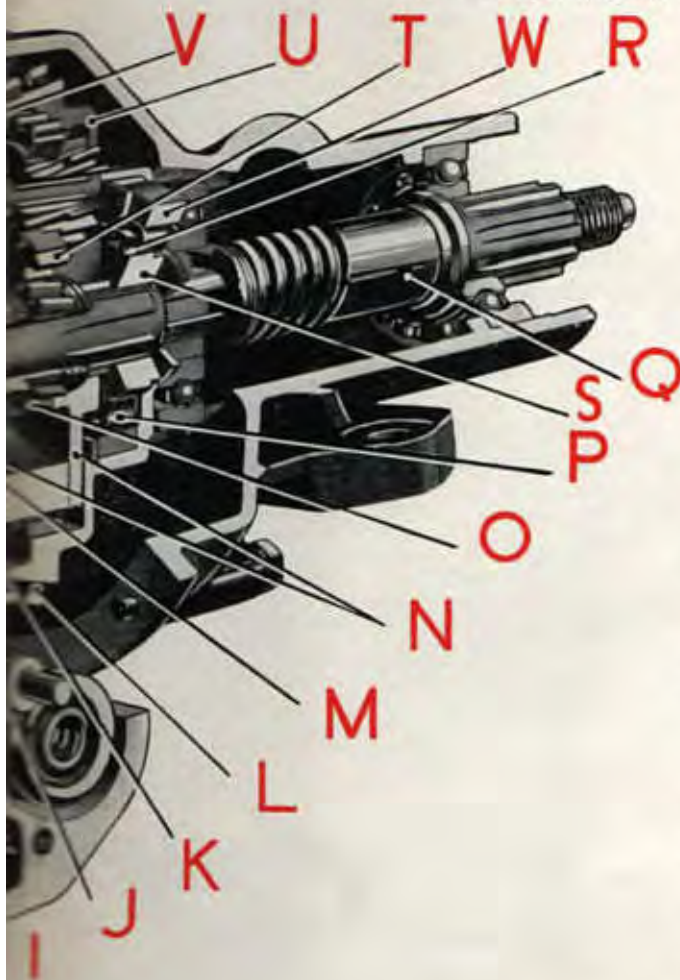
On completion of its forward movement, the outer lining (J) of the cone clutch (K) contacts the brake ring (I). Pistons (B) exert pressure not only sufficient to overcome springs (V) but also to bring clutch (K) together with sunwheel (O) to rest. Note that clutch (K.J.I.) being oil immersed comes to rest perfectly smoothly without shock.

The drive is now via shaft (D) to planet carrier (N) which by rotating the planet wheel (T) round the stationary sunwheel (O) causes the annulus (U) and output shaft (Q) to be driven faster than the input shaft (D). In this condition the outer member (W) of the roller clutch overruns the inner member (S). Because the sun wheel can move neither backwards or forwards there is always engine braking available in overdrive gear.

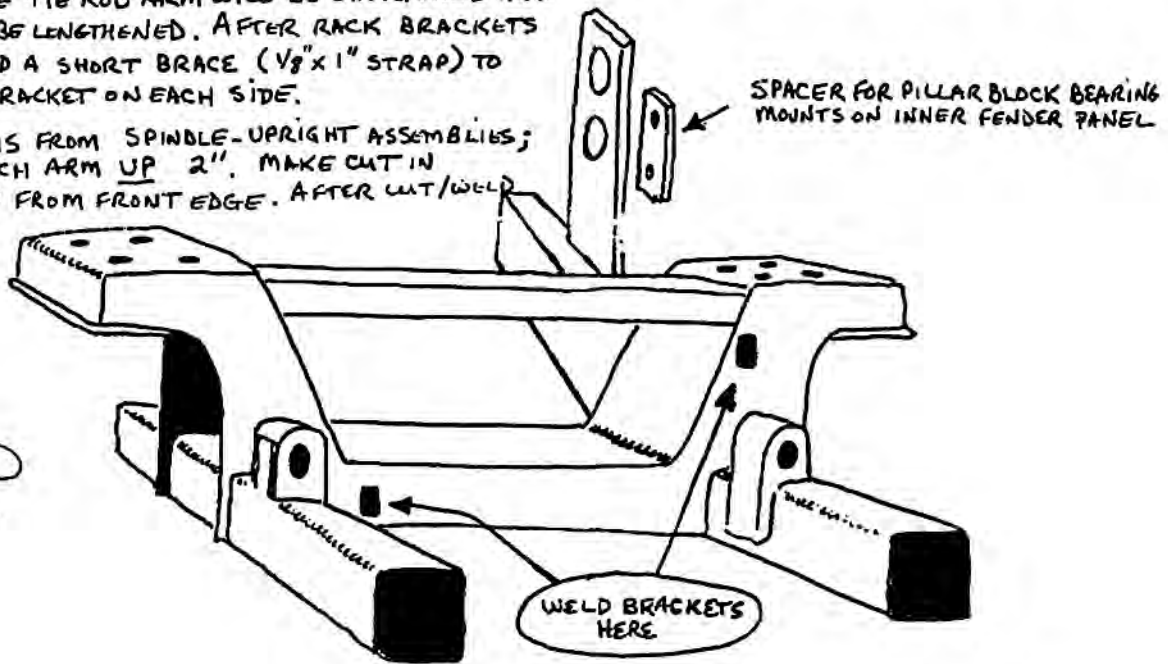
5. INSTALL RACK & PINION BRACKETS WITH RACK ATTACHED. BRACKETS ARE SLIGHTLY LONG WHERE THEY ATTACH TO FRAME (CUT/GRIND FOR FIT). STEERING SHAFT IS POSITIONED SO IT JUST CLEARS THE UPPER CROSSMEMBER AND ANGLES TOWARD THE DRIVERS SIDE INNER FENDER PANEL. OBTAIN A SUITABLE U-JOINT (3/4" I. D) AND PILLAR BLOCK TYPE BEARING SUPPORT WHICH MOUNTS ON INNER FENDER PANEL WITH ALUMINUM SPACER TO FIT. DRIVERS SIDE TIE ROD ARM WILL BE SHORTENED AND PASSENGER SIDE WILL BE LENGTHENED. AFTER RACK BRACKETS ARE WELDED IN, WELD A SHORT BRACE (1/8" x 1" STRAP) TO FRONT CONTROL ARM BRACKET ON EACH SIDE.

6. REMOVE STEERING ARMS FROM SPINDLE-UPRIGHT ASSEMBLIES; CHOP AND RAISE EACH ARM UP 2". MAKE CUT IN STEERING ARM 3" IN FROM FRONT EDGE. AFTER CUT/WELD ARMS SHOULD BE RE-HEAT TREATED.

USE MGB RACK & PINION ASSEMBLY

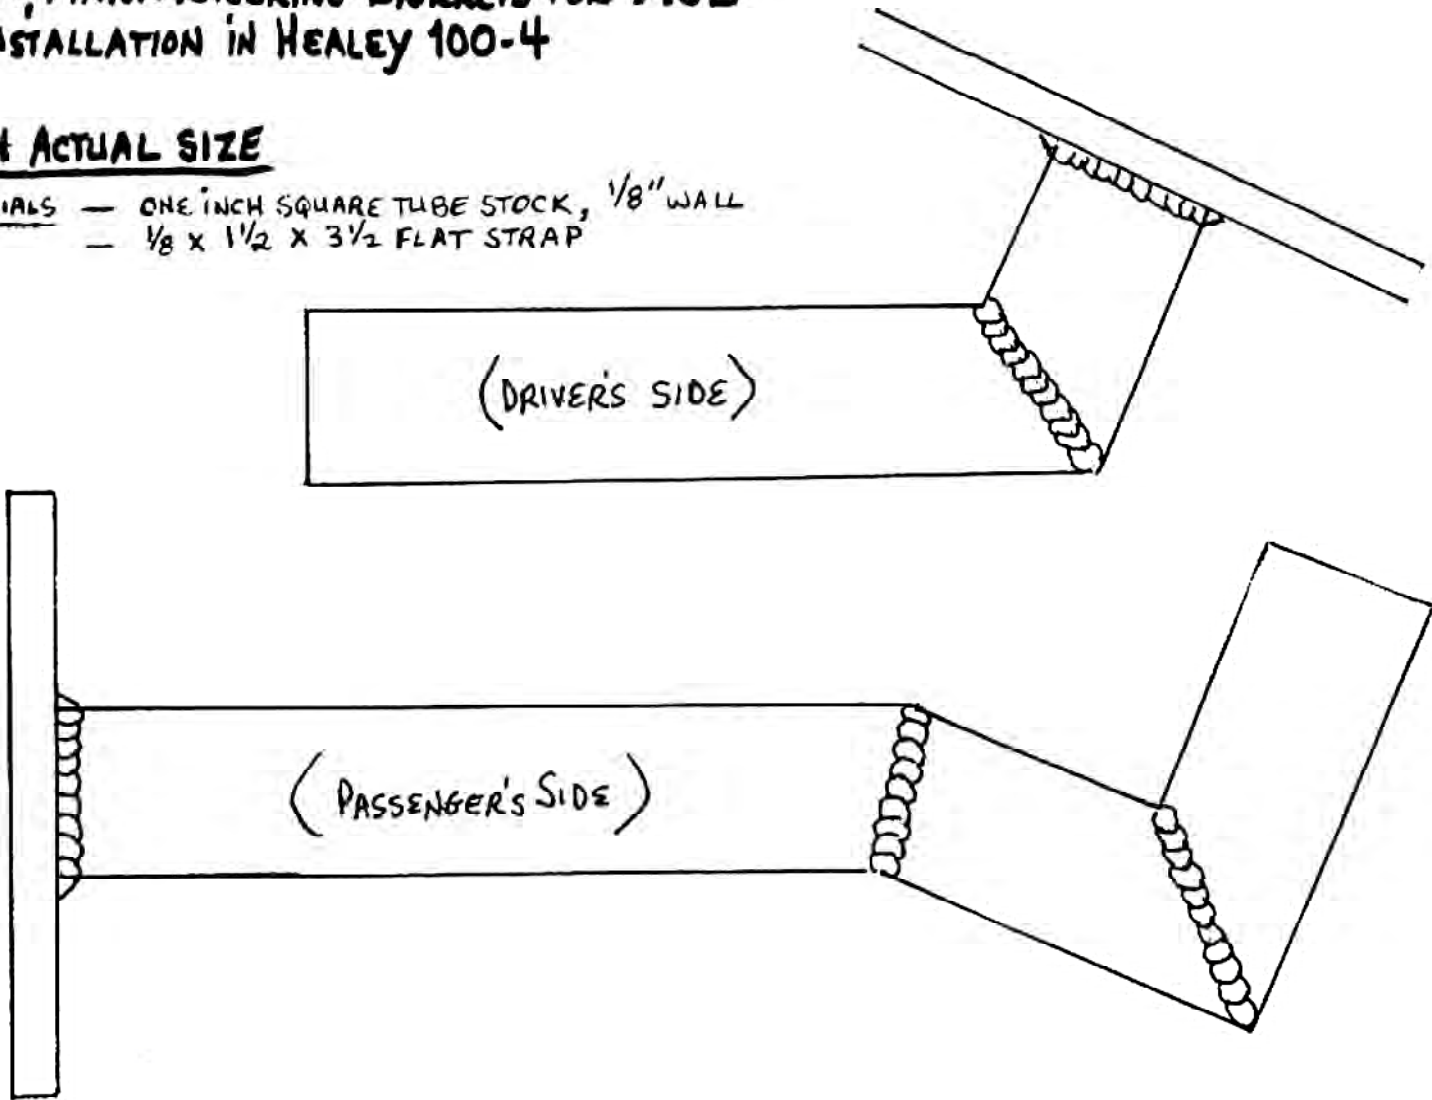
MATERIALS — ONE INCH SQUARE TUBE STOCK, 1/8" WALL
— 1/8 x 1/2 x 3 1/2 FLAT STRAP

NOTE: -This diagram has been copied from the Internet and probably is way out of scale. The square tube is 1" x 1" so it should be easy for you to work it out

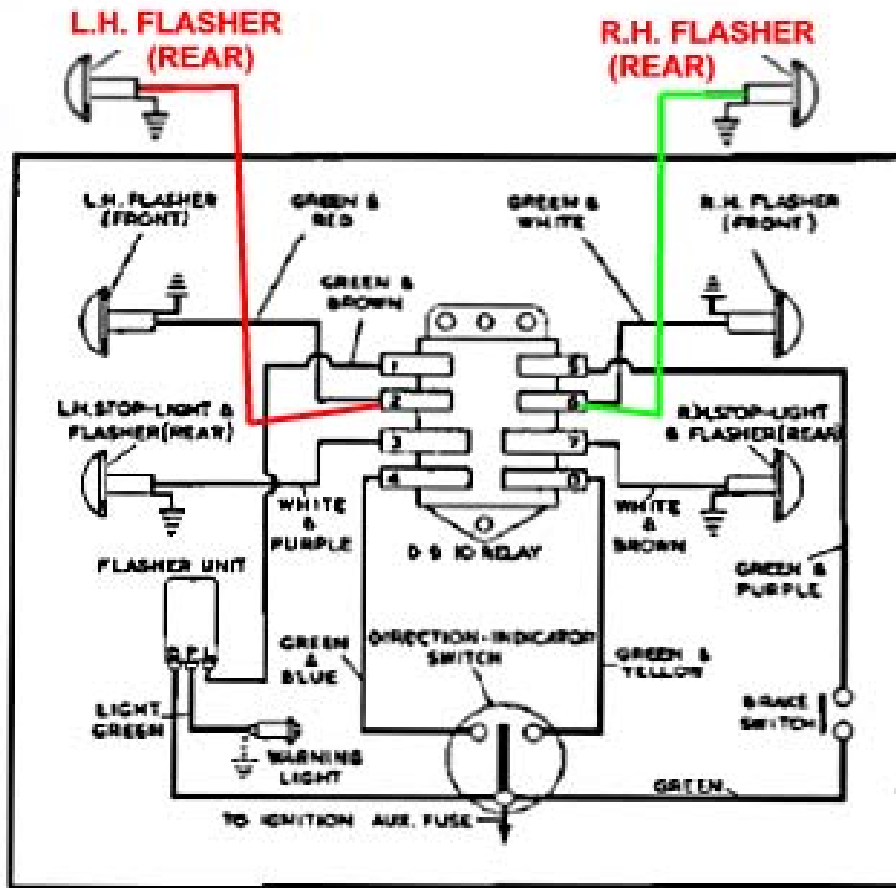
Below is a far simpler way of wiring up the rear flashers, which also leaves the stop lights operating as flashers. There are no alterations to the original wiring just two new wires going from the DB10 relay at the front to the flashers at the rear.

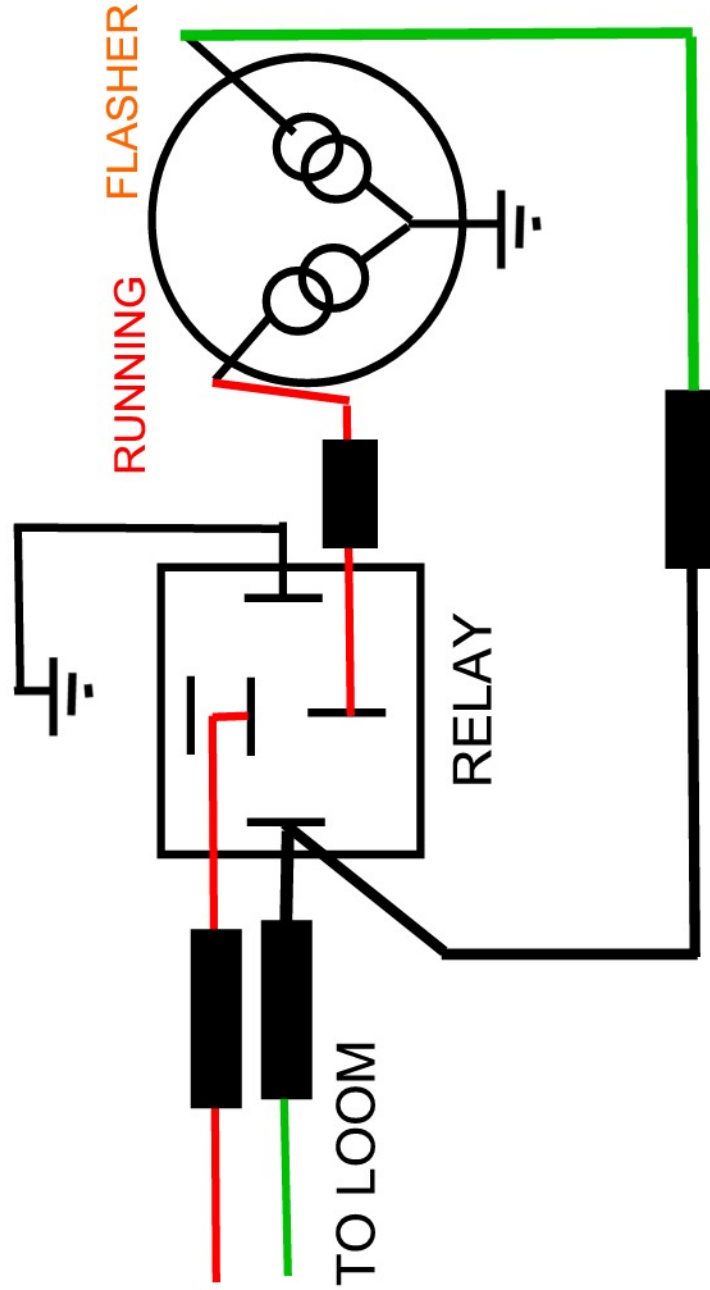
I installed 2 relays, wired them up as shown in the wiring diagram below and reconnected the red wire just under the fuse box. The blue crimp on connectors mate perfectly with the Luces ones.

■ - Denotes connectors.

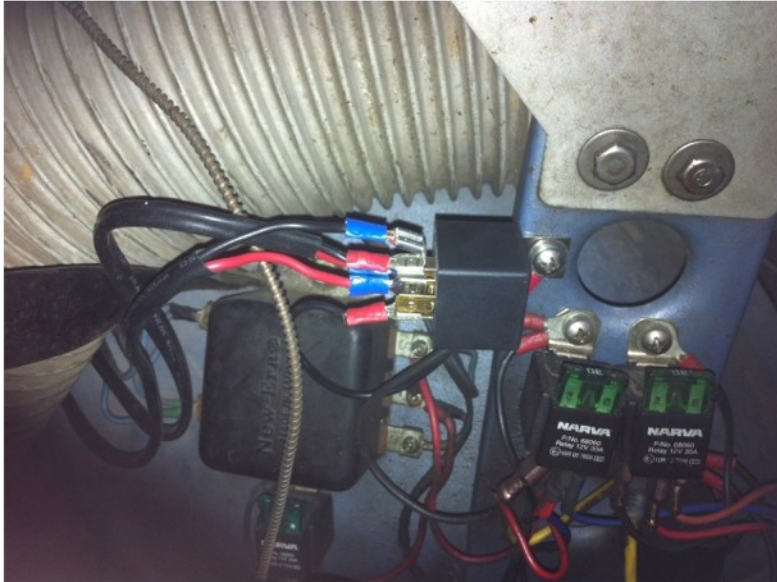
The right hand relay on the shroud support together with the Fog & Driving, Headlight & Horn relays.

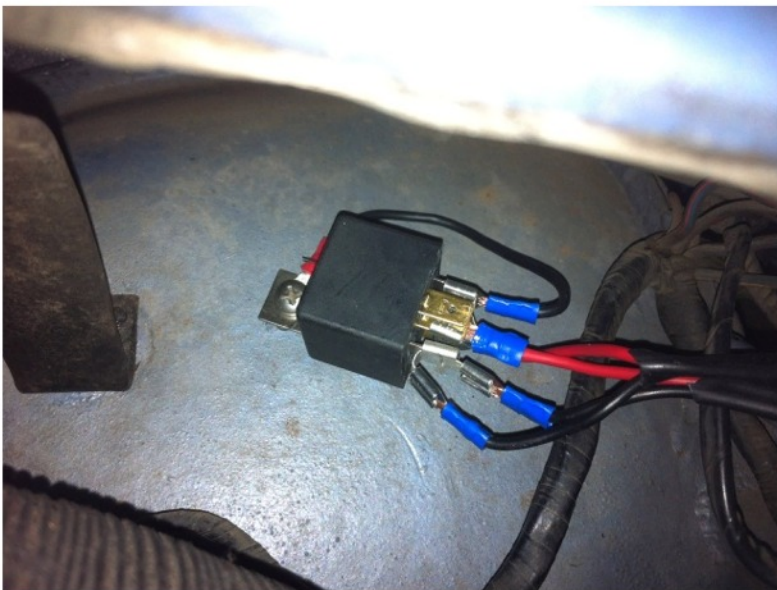
The left hand relay on the inner guard, just near the DB10 Flasher relay.

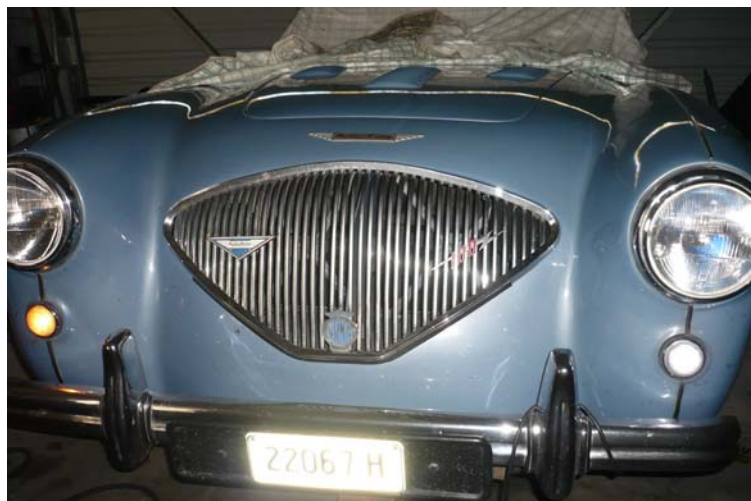
The Lucas candles behind the clear lens on the left and the Eagle Eye 5 on the right and that's only the park LEDs!!!!

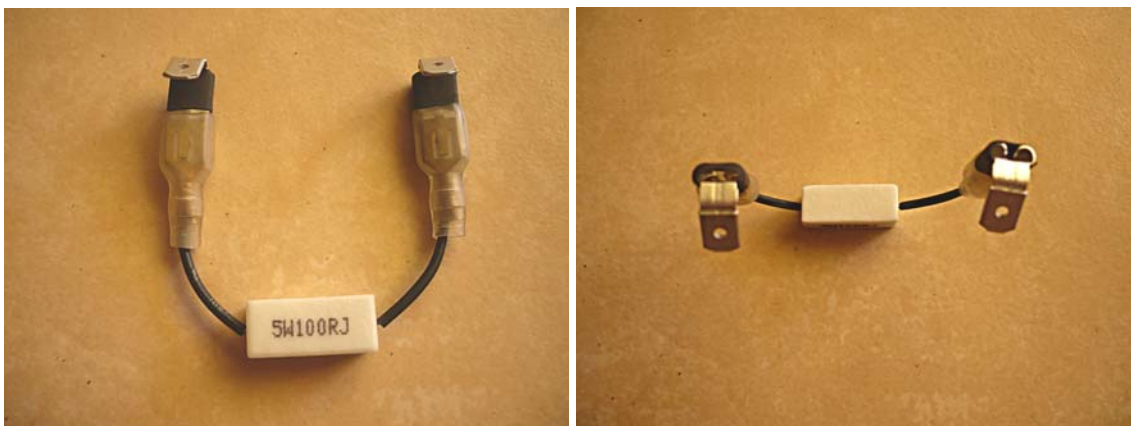
I had an after glow on the blinker warning light and fitted a 100 Ohm 5 Watt resistor (from Dick Smiths – 34 cents) across the wires going to the warning light. As there were already push in connectors on the wires I added connectors and insulated piggy back connectors to the resistor (see below).

Autolumination recommend a 10 watt resistor, but as the draw even at the maximum regulated voltage of 14.4 Volts of a Dynamo/Alternator is only 2.07 Watts I used a 5 Watt resistor even though a 10 Watt was available.

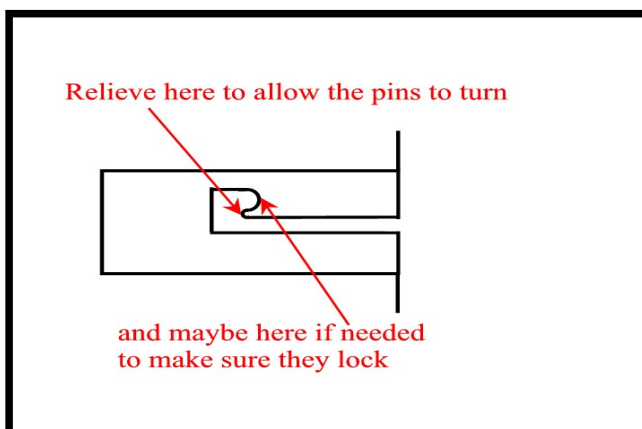
The answer was to relieve the holder for both pins, just enough to allow the bulb to turn, as shown below and the contact springs had enough spring to maintain contact with the globe.

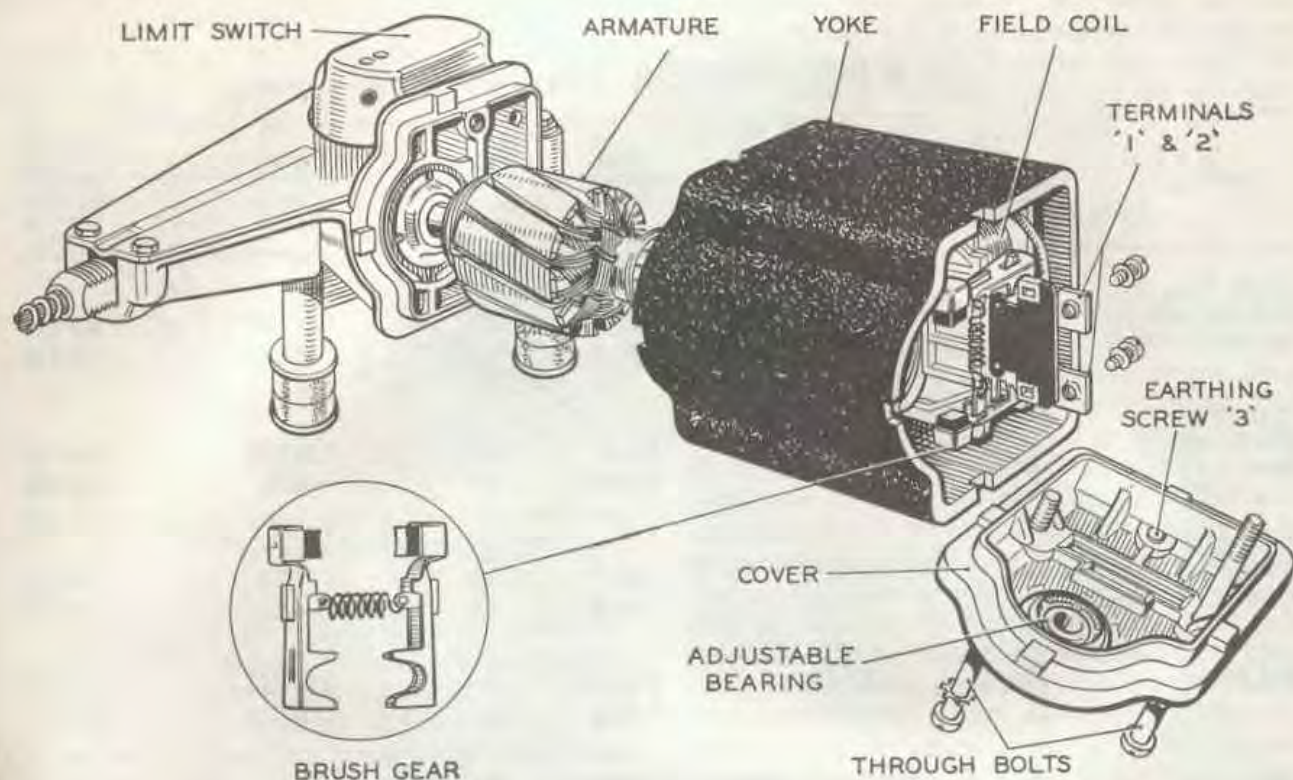
Parts of the Lucas electric windshield wiper.

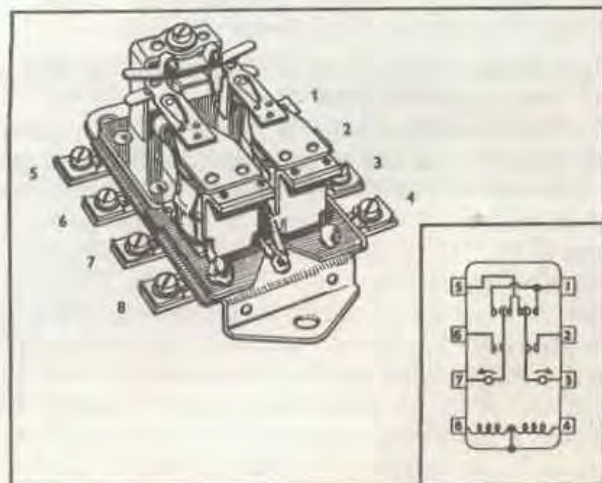
Lucas brake override relay and the wiring diagram.

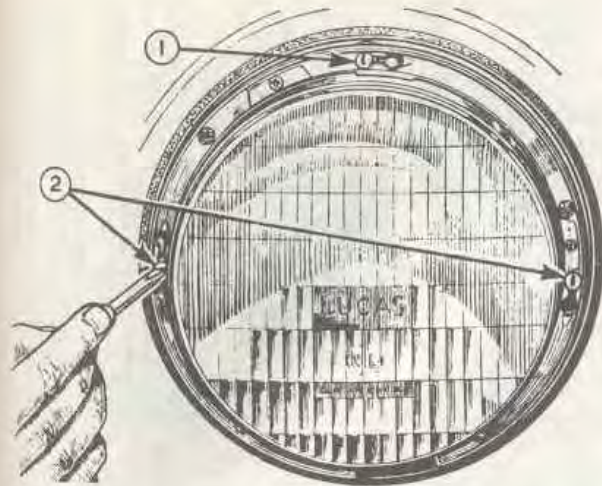
Headlamp aiming screws: (1) vertical adjustment, (2) horizontal adjustment.

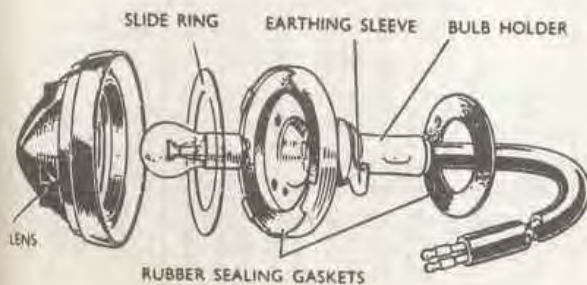
Typical bayonet attached lens. Press inwards and turn counterclockwise to release the lens.

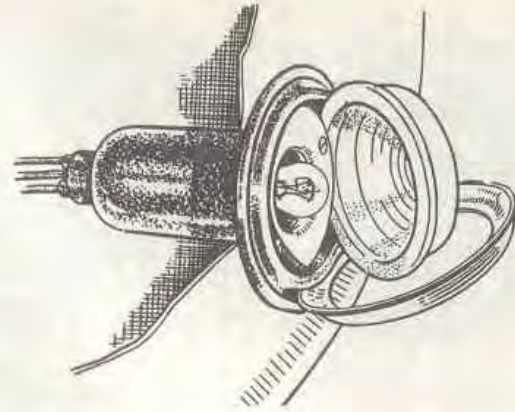
Rubber-secured lens. Peel back the rubber to release the lens.

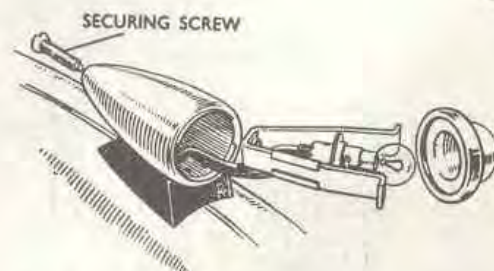
Some lenses are held by a screw from the back of the lamp housing.

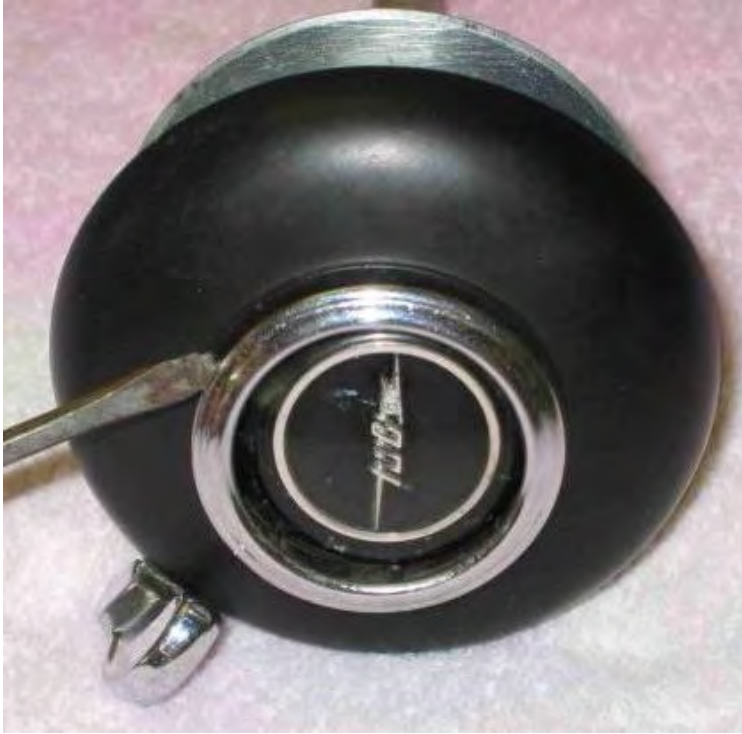
Once the horn button is loosened, the horn spring will be revealed. Its small diameter end faces to the bakelite head. The laminated blades of the horn switch secured by two brass screws also become evident.

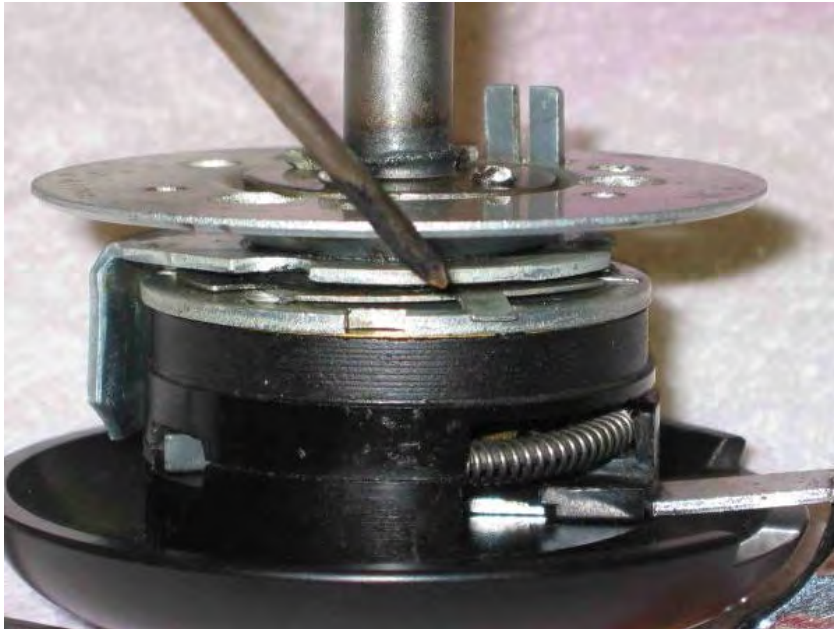
Examine the entire assembly. On the back of the unit, viewed from the side, a small tab bent down into a slot can be observed.

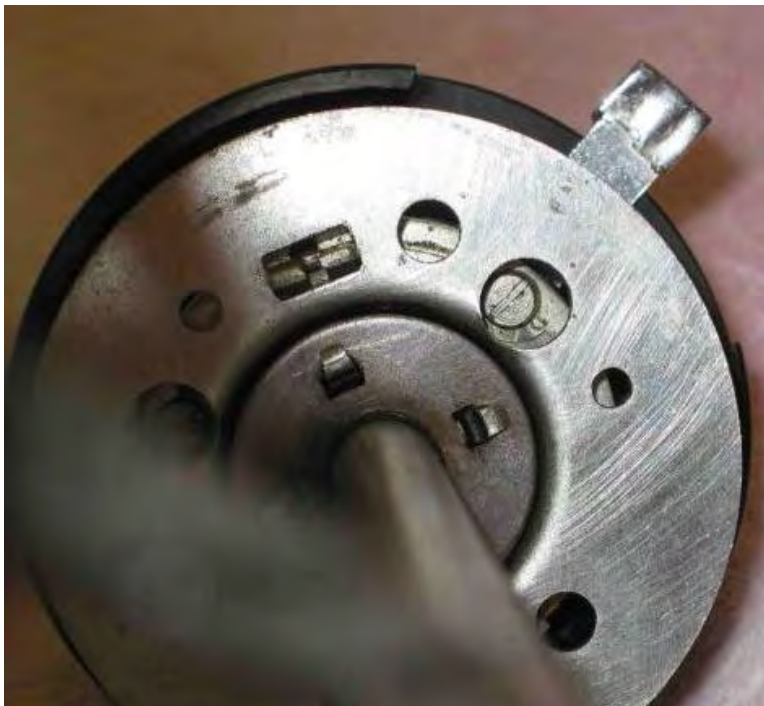
Before removing the three screws, make a note or reference mark of how the two halves of the unit secured by the three screws goes together. Then remove the screws. The correct orientation of the turn signal lever is straight up, but if the two halves are oriented incorrectly, the turn signal lever will be either pointed down, or off to the side.

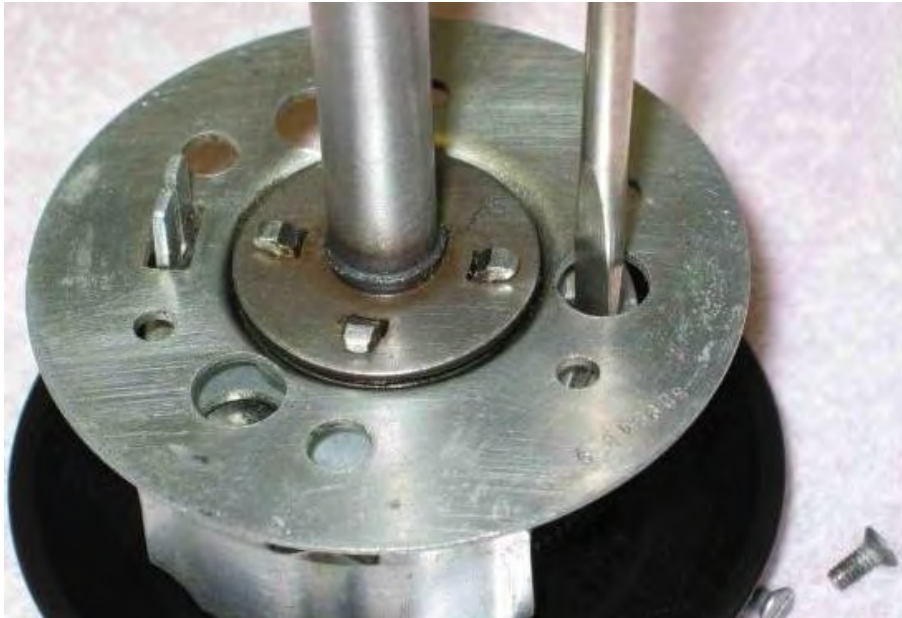
The stator tube, base plate, locating plate, the base mount plate and assorted washers and spring can then be separated from the bakelite mounting plate and head. This assembled unit does not need to be disassembled. It can be pulled off the wires and set aside for assembly later.

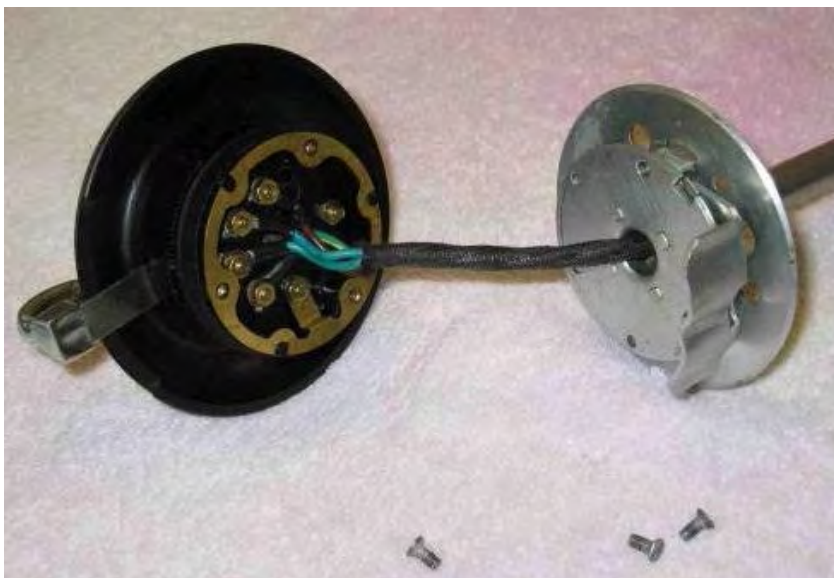
Examine the back of the mounting plate. There are six nuts visible. Three are for the turn signal switch, two are for the horn (one goes through the brass ground ring) and the one without an attached wire is to hold the head and the mounting plate together (It is barely visible in the photo under the wiring sheath). Make a drawing to illustrate the color code and where each of the wires should reconnect to its proper fitting.

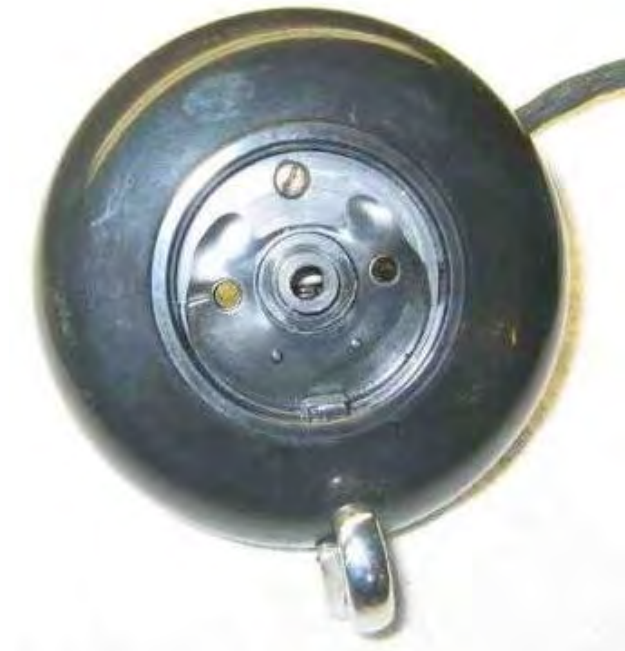
The turn signal lever is attached with one screw to the back of the bakelite mounting plate. Underneath it is a curved wire with a spring on each side of the lever.

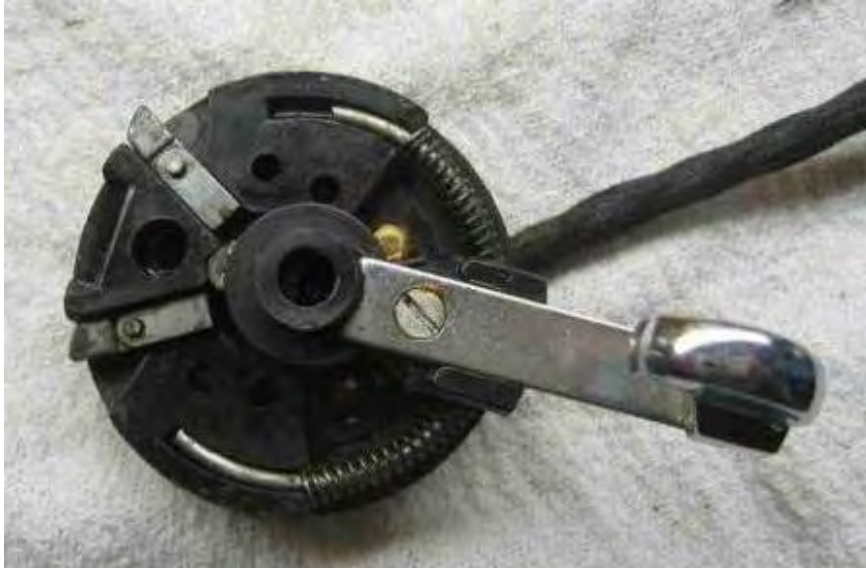
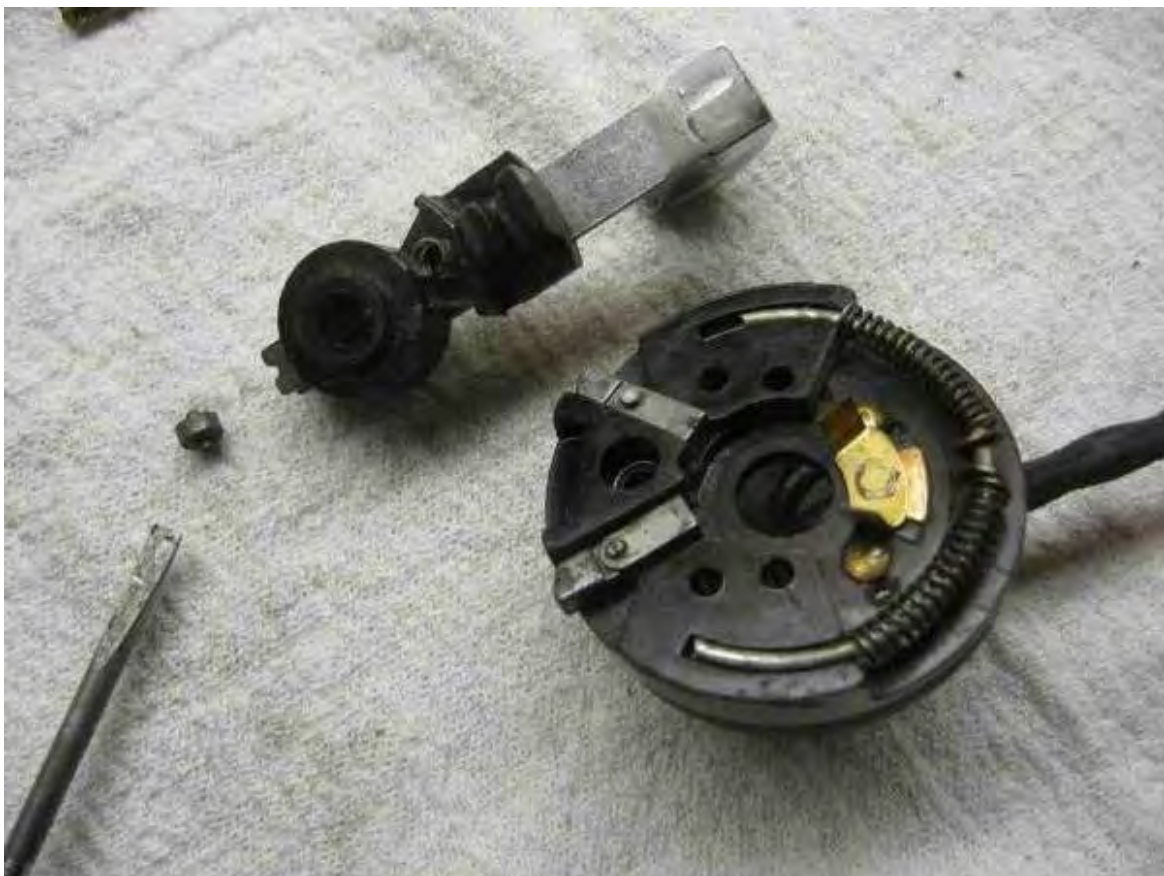
There is another little spring and ball at the bottom of the turn signal lever.

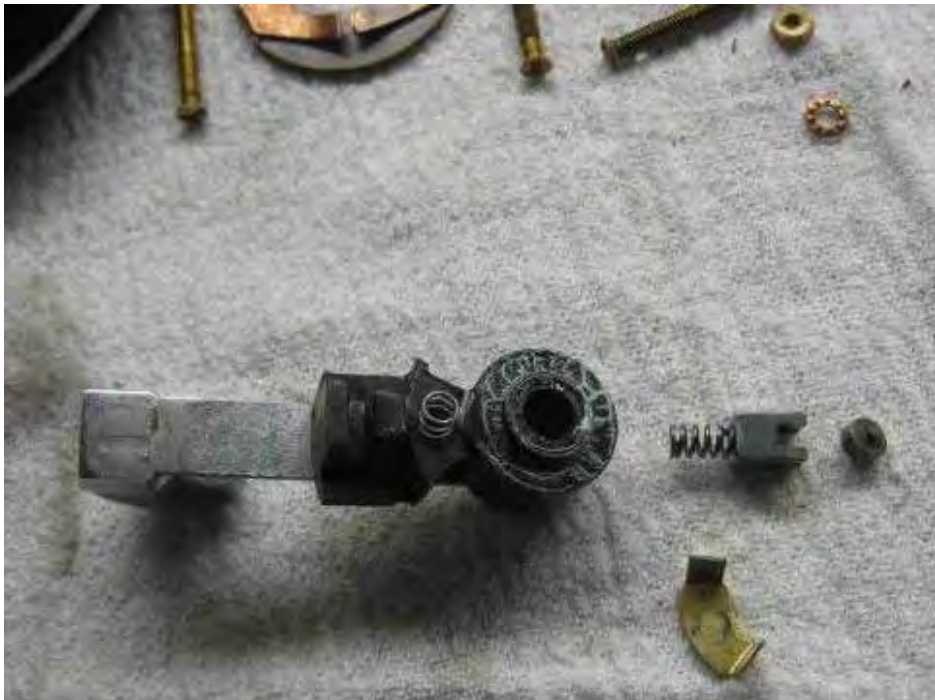
If you carefully remove the single screw to separate the lever from the assembly, the springs and small parts should stay in place. Note how they should be reassembled, then take apart, clean and lubricate with a little lithium grease.

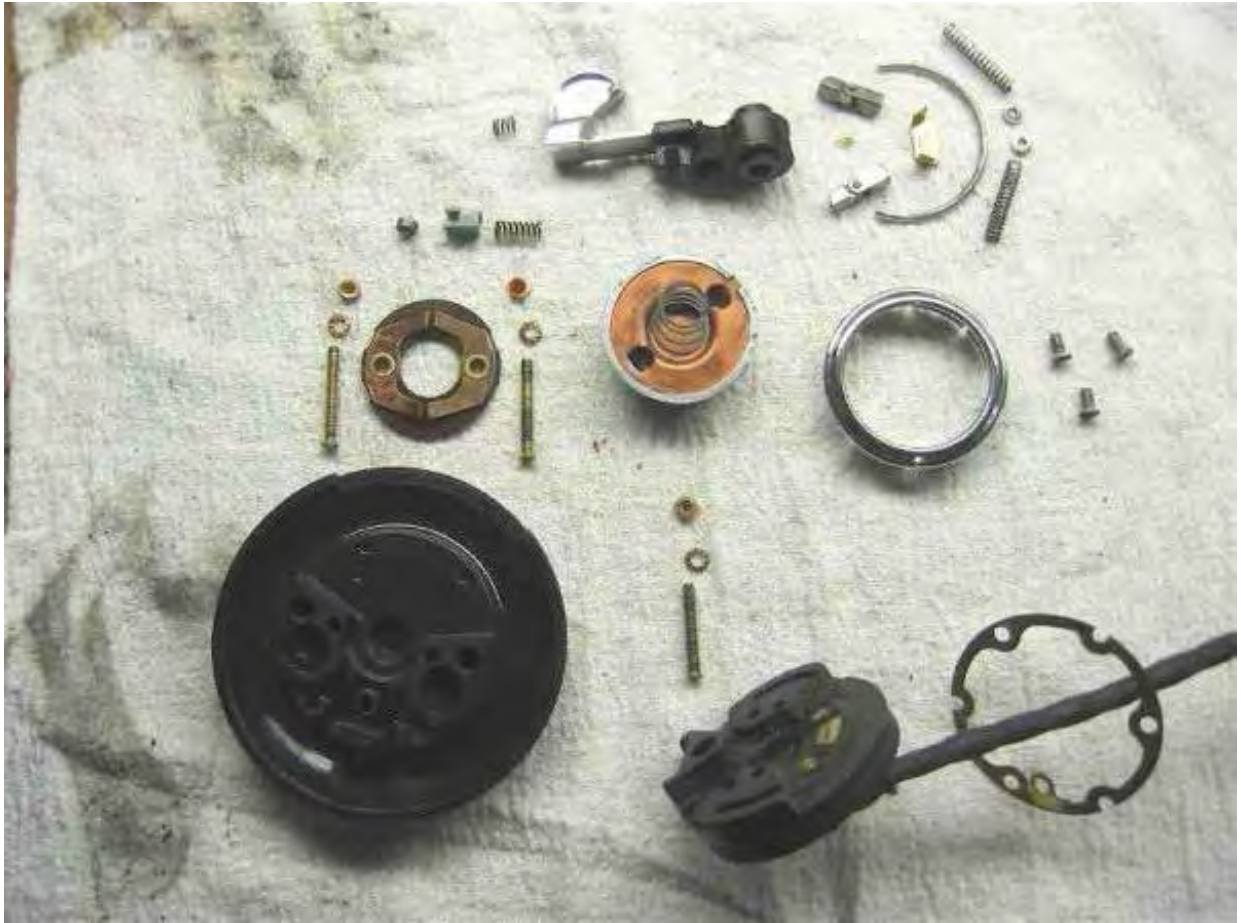
If you experience an explosion of parts, don't be alarmed. It will all go back together! All components are identified in the photo below:

The proper positioning of the two hinges or "triggers" is important. They have angles on the end that fit opposite each other. They need to be placed as seen in the image and drawing for the canceling switch to work. Before reassembly of the complete unit, now is a good time to refinish the bakelite if it is needed.

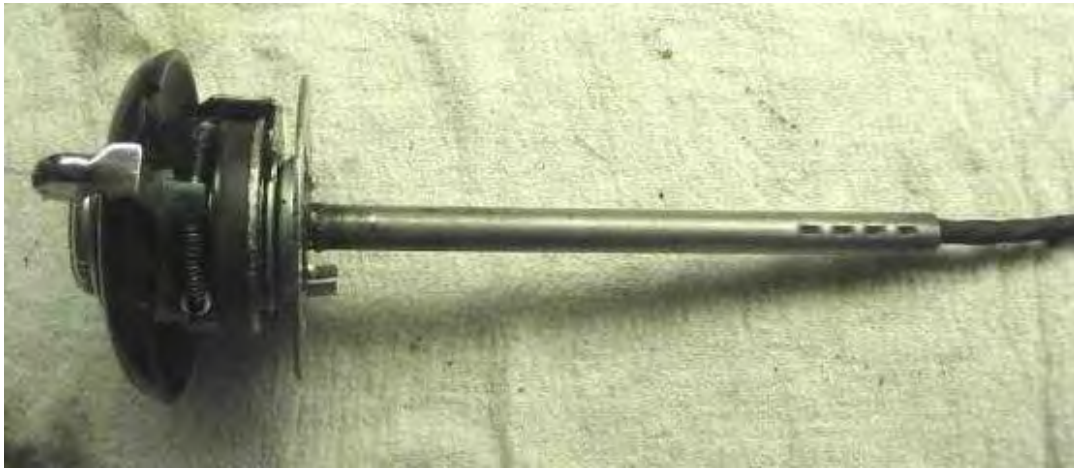
Carefully place the head and the mounting plate together pushing the spring at the end of the turn signal lever into the mounting plate. Holding the two pieces together install and tighten the single screw and nut at the bottom of the unit. This screw/nut will securely hold the two pieces together while the horn switch screws and nuts are inserted and tightened.

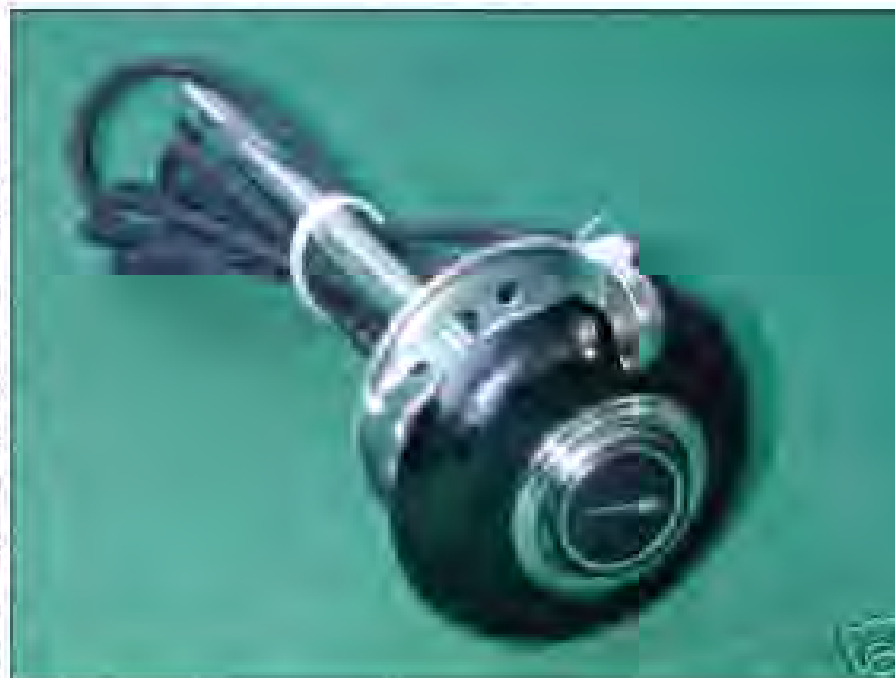
Refinishing your Trafficator Head

Bakelite is a cross-linked polymer of phenol and formaldehyde. When it cures, there are no polymer chain ends to absorb the dye in shoe polish.

Thus, when you apply and polish with black shoe polish, you are seeing only the polishing effect of the wax in the shoe polish.
