A Tasmanian Supra gearbox conversion

100 TECHNICAL CD-ROM

INTRODUCTION

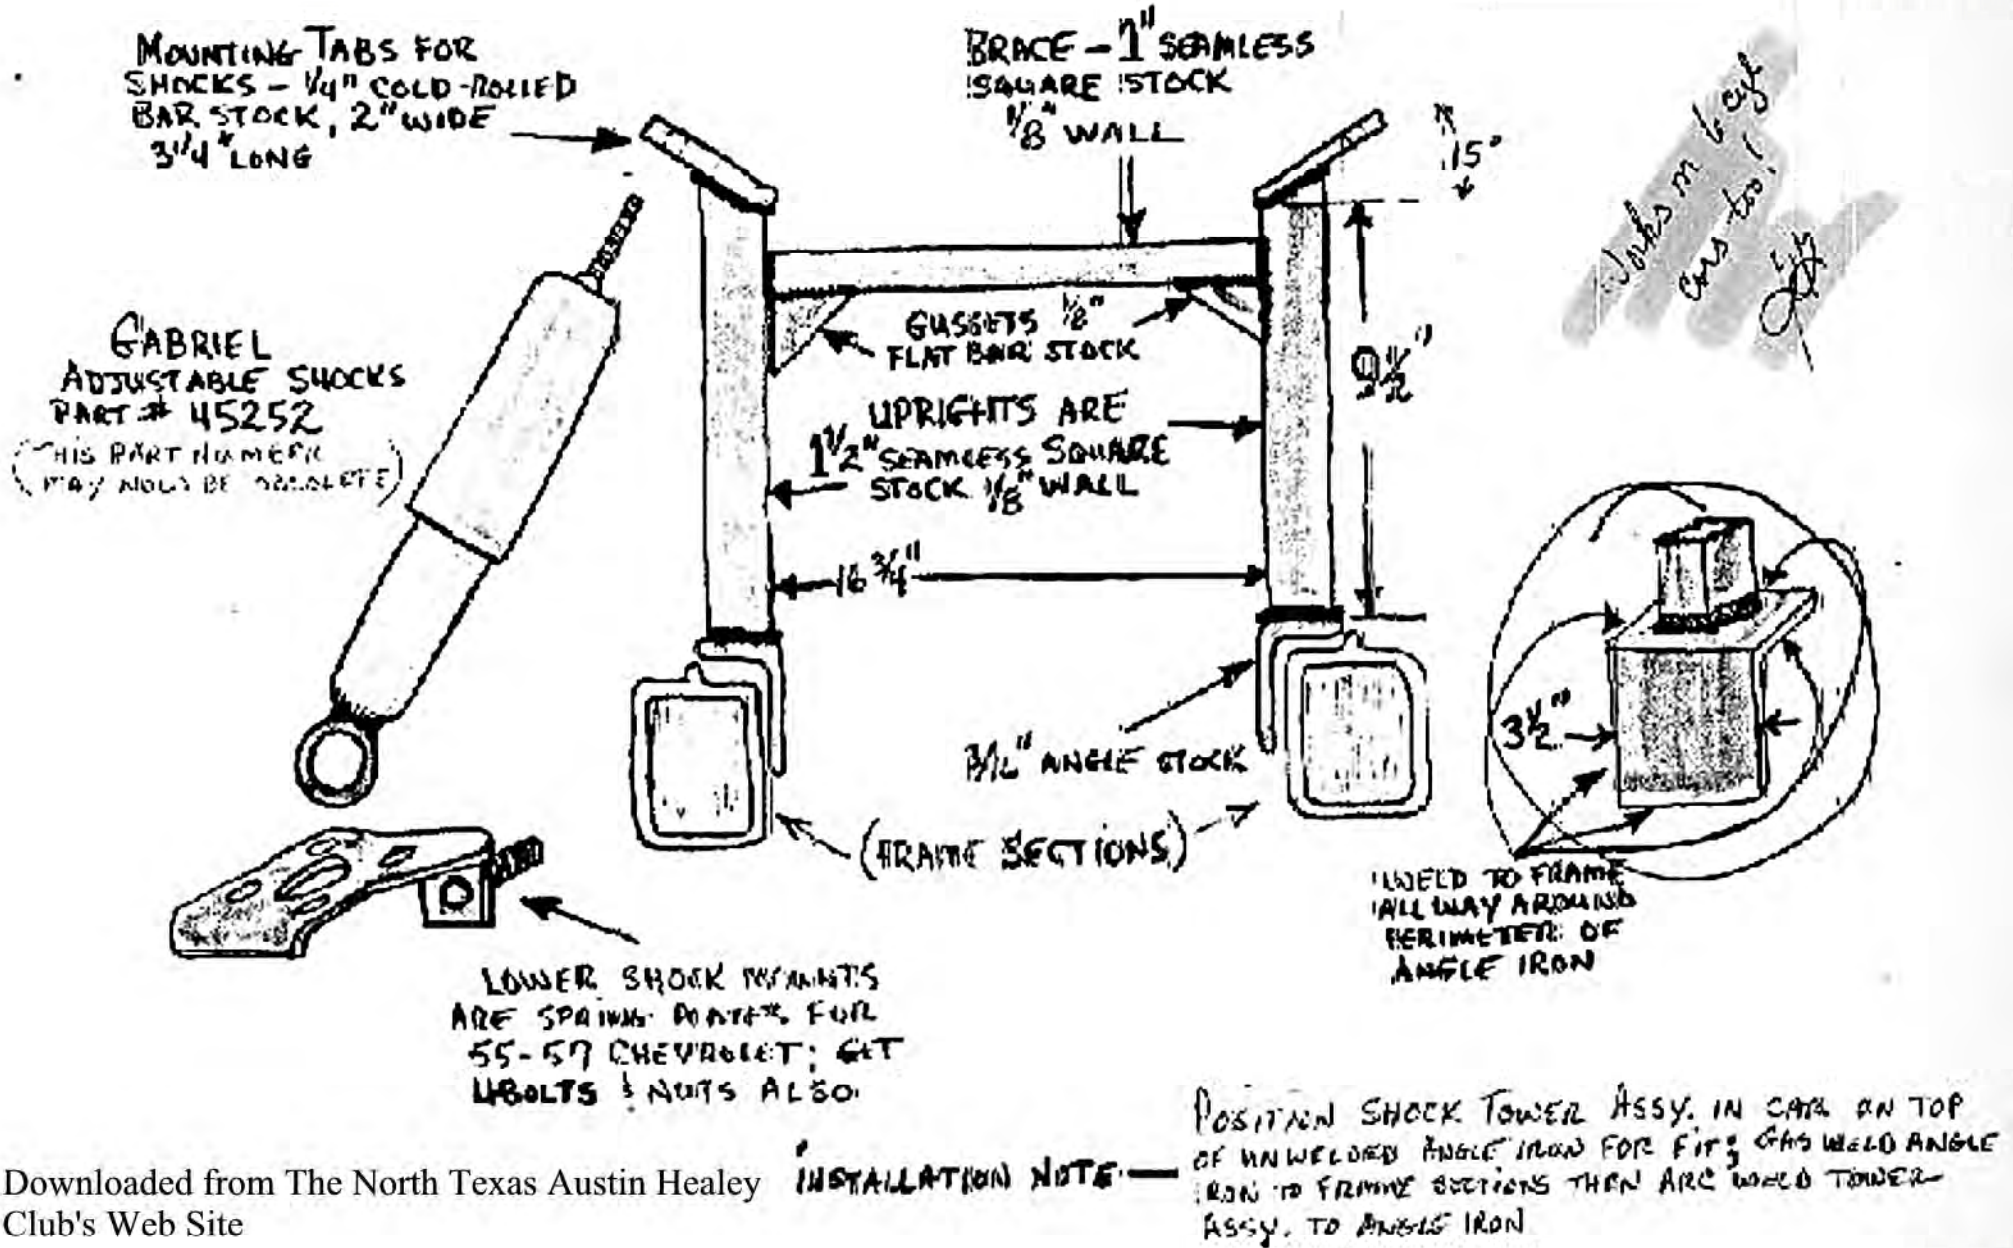
REAR SHOCKS

- MOUNTS BEHIND REAR END

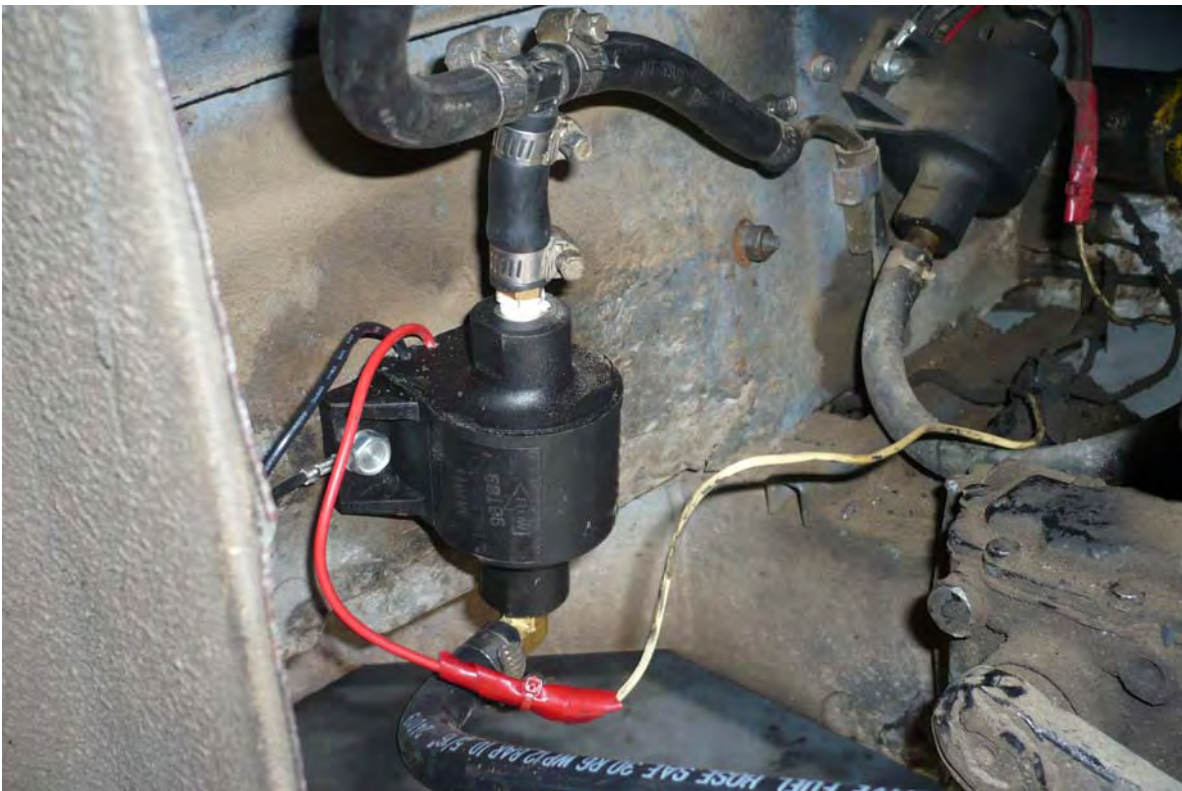
As you can see from the above picture I have two pumps, when I remade the petrol tank I fitted a second outlet pipe beside the original but it stopped it 1" from the bottom of the tank (not the bottom of well) and connected it through the front of the boot to one of the pumps, this became the Main pump and the other the Reserve, also a change over switch is fitted through into the cabin.

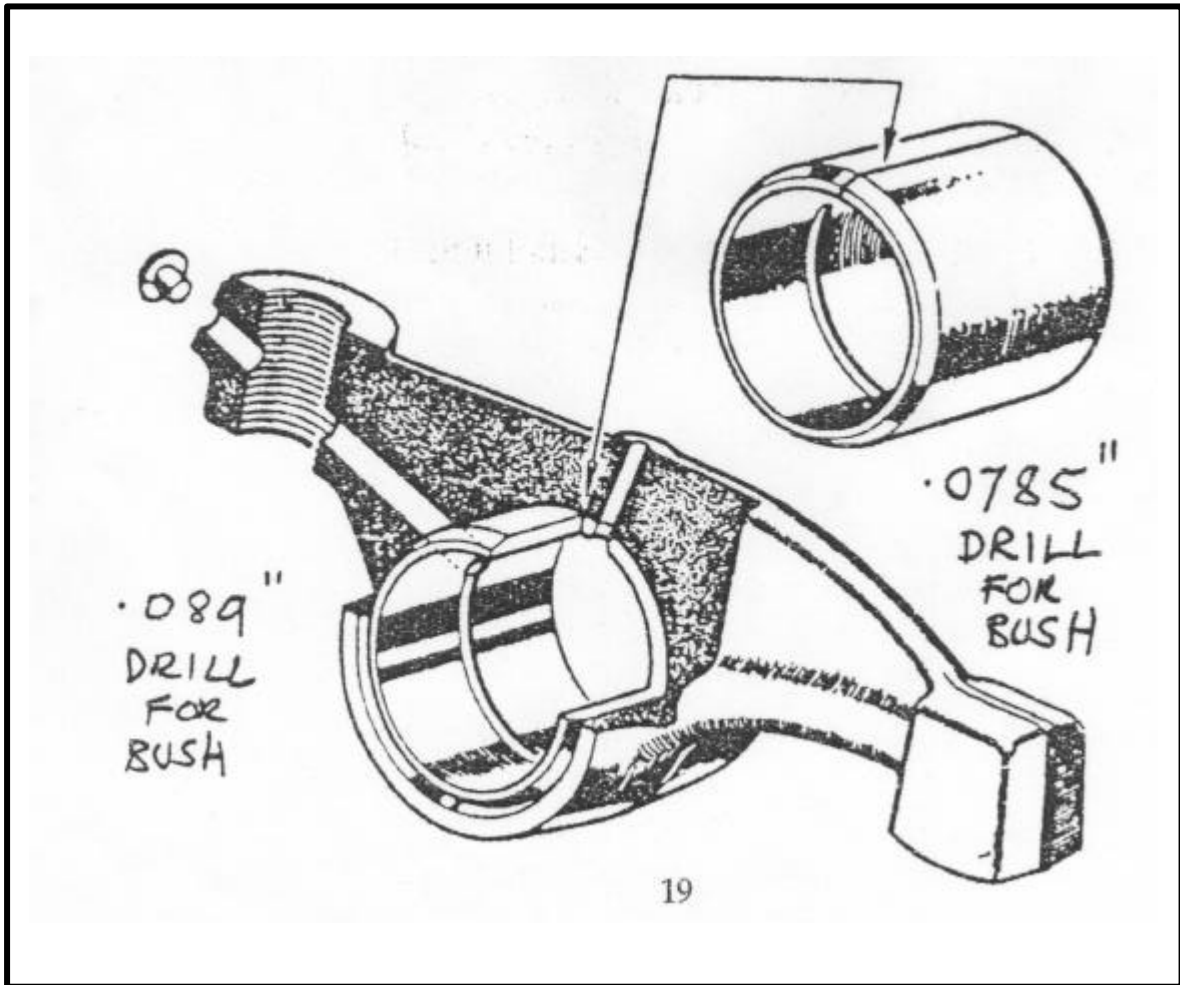
CORRECT POSITIONING OF ROCKER BUSH TO ALIGN OILWAYS.

ARROW SHOWS PROPER LOCATION OF BUSH JOINT

2 Check the rocker arms for wear of the rocker bushes, for wear at the rocker arm face which bears on the valve stem, and for wear of the adjusting ball ended screws. Wear in the rocker arm bush can be checked by gripping the rocker arm tip and holding the rocker arm in place on the shaft, noting if there is any lateral rocker arm shake. If shake is present, and the arm is very loose on the shaft, remedial action must be taken. Forged rocker arms, which have worn bushes, may be taken to your local BLMC agent or engineering works to have the old bush drawn out and a new bush fitted.

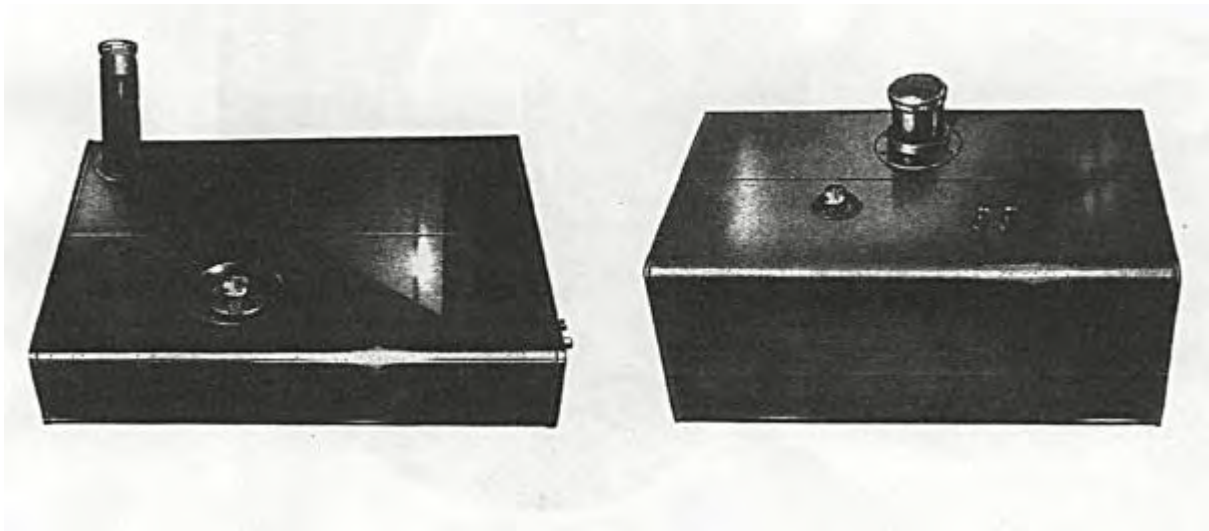
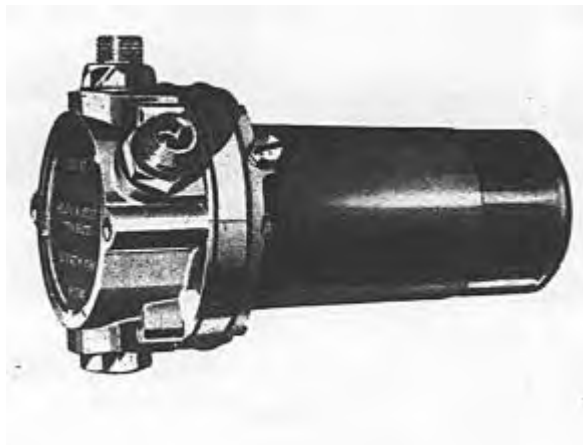
The standard Tank is suitable for most normal purposes. We have developed two alternative petrol tanks. The 15-gallon tank is intended to provide a greater range and a reserve system. The 25-gallon tank is designed for particularly long distance races with a stipulated minimum distance between refueling beyond the capacity of the 15-gallon tank. The 15-gallon tank is about 1 in. deeper and loses very little luggage space. The 25-gallon tank occupies nearly all the available luggage space.

The reserve fuel system is operated by an extra petrol pump and switch.

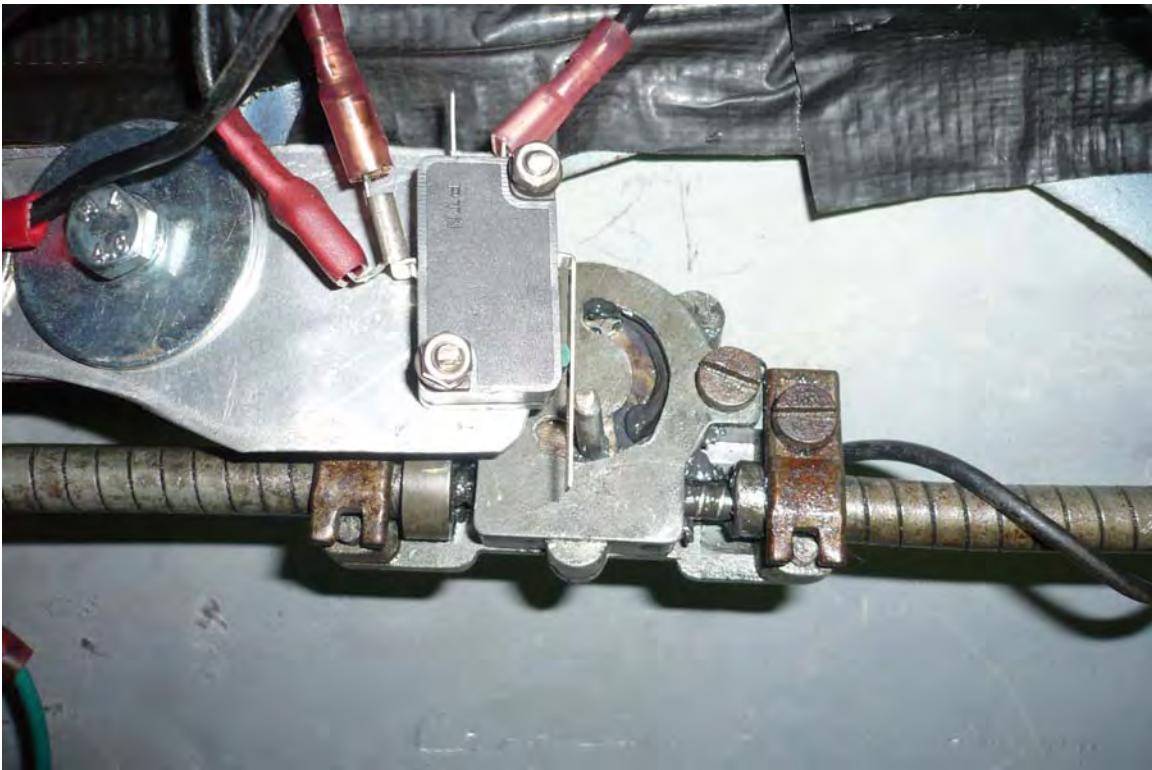
I did some thinking and modified the passenger side wiper wheel and wiper box cover. The wheel and shaft can be taken out by removing the wiper arm then the wiper box cover. The wheel was drilled and tapped 10-32 unf, out near the rack teeth and a 1" length of 5/32" rod with a thread on it's end was Loctited in. The back plate was drilled and filed as shown below to allow the rod to move back and forth as the wipers worked. The wheel and shaft was replaced with the rod at its lowest position when the wipers were parked and the back plate replaced.

The plate holding the micro switch is 4"x 1 1/2" aluminium bolted to the bracket on the body, for the LHD steering column support channel,

First turn off the battery switch or undo a battery terminal, then undo the red and black with green wires to the wiper switch and connect them together along with the lead to terminal 30 on the relay. Run a wire from one of the wiper switch terminals to earth and one from the other one to the micro switch in terminal. Disconnect the black earth wire from the wiper motor terminal and run a wire from the terminal to terminal 85 on the relay.

Adjust the micro switch to click off when the wipers are in the park position. Reconnect the battery and give it a try.

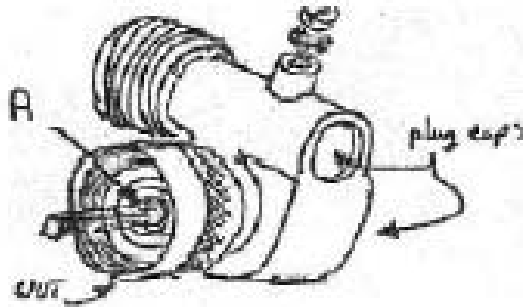
**FIGURE 1
OUTSIDE VIEW**

Figure 1 shows the appearance of a healthy drive unit. The shaft mating with the overdrive is actually a short length of speedo cable. In my case it had sheared at point A. I found that by twisting the stub with my finger, the shaft and gears in the unit turned easily. Thus repair was merely a problem of installing anew piece of speedo cable. But replacement requires disassembly of the right angle drive unit.

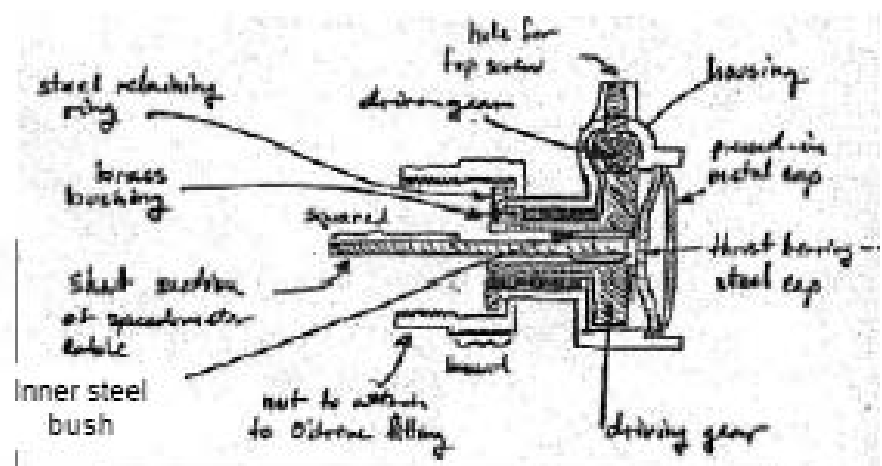
**FIGURE 2
CROSSSECTION OF DRIVING GEAR**

Figure 2 shows a cross section view of the driving gears within the unit. By placing the housing over a recessed support, the end cap can be driven out by using the 1/4" punch against the broken off cable end. Once the gear is free, the 1/8" punch is used to drive the cable out, as shown in **Figure 3**. Chances are that the inner bush will come out with the cable. If it doesn't, use the punch to drive it out too. In my case, I ended up with a short cable length as shown in **Figure 4**. Again the 1/8" punch was used to drive the cable free. The vise jaws can be used to support the gear and bush in these operations, but be careful not to squeeze the gear shaft or cable.

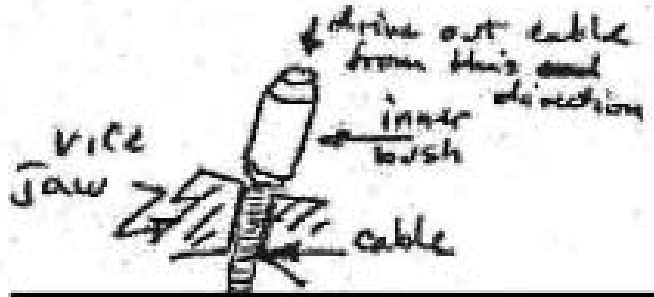
**FIGURE 4
CABLE WITH PRESSED-ON BUSH**

The only tricky part of the repair is insertion of the cable into the bush. Place the cable horizontally into the vise jaws to grip all it's length except for about 5/8" of the round end, which should protrude. To drive the bush onto this end, grip it with the pliers and while hammering on the free end, simultaneously apply a counter clockwise twist. This will tend to wrap the cable's outer wires tighter, thus reducing it's diameter. If you turn the other way, these wires will spread making the job impossible. Drive the bush on until the cable is within 1/16" of its open end.

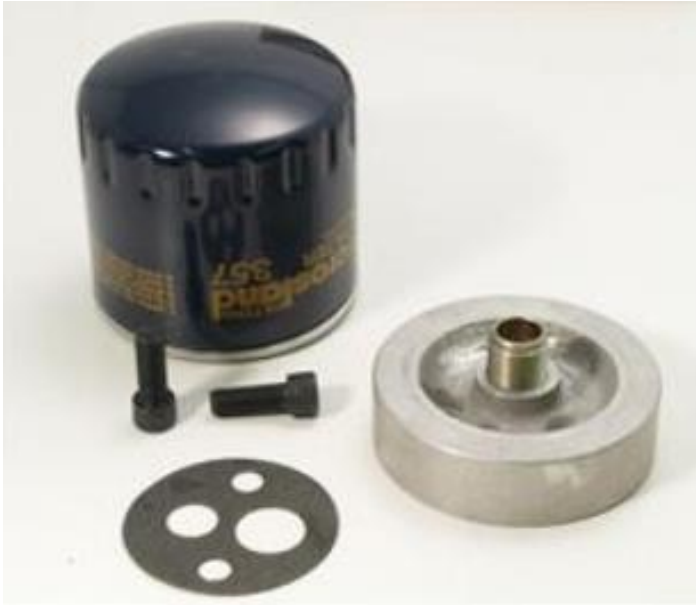
Filter kit

The spin on cartridge filter replaces the original one, is a more modern filter and easier to replace.

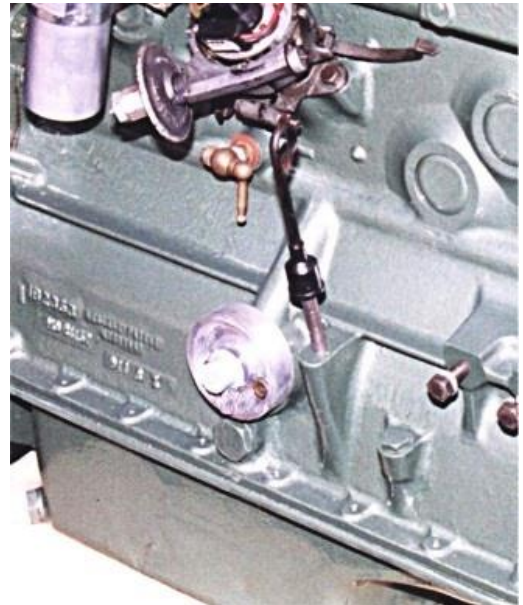
Filter adaptor attached to engine

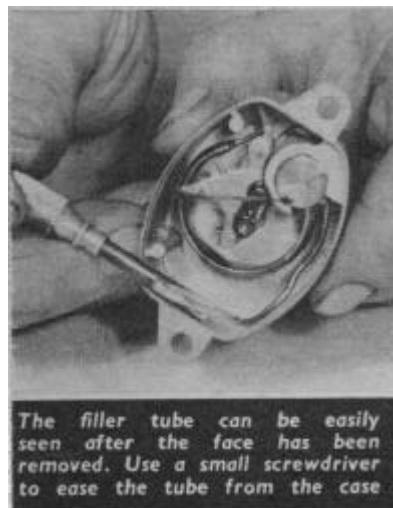
The filler tube can be easily seen after the face has been removed. Use a small screwdriver to ease the tube from the case

Refilling has to be undertaken from the dial end of the instrument. Tucked away around the outside of the gauge unit is a short length of tubing which is used for filling, so I gently prised it out until it was possible to saw off its soldered end with a midget hacksaw. I did not attempt to unsolder the end, as there seemed some risk that the solder might run down inside the tube and cause a blockage.

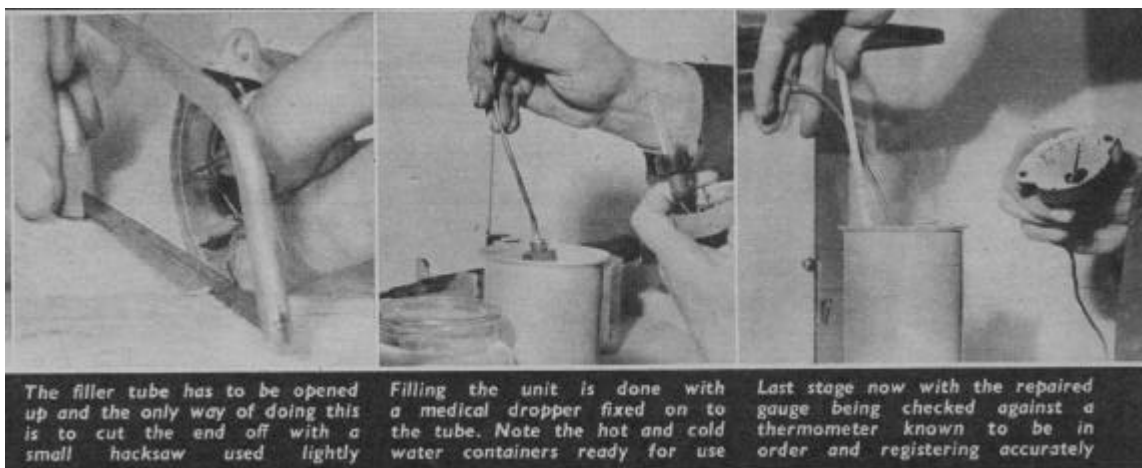
The filler tube has to be opened up and the only way of doing this is to cut the end off with a small hacksaw used lightly

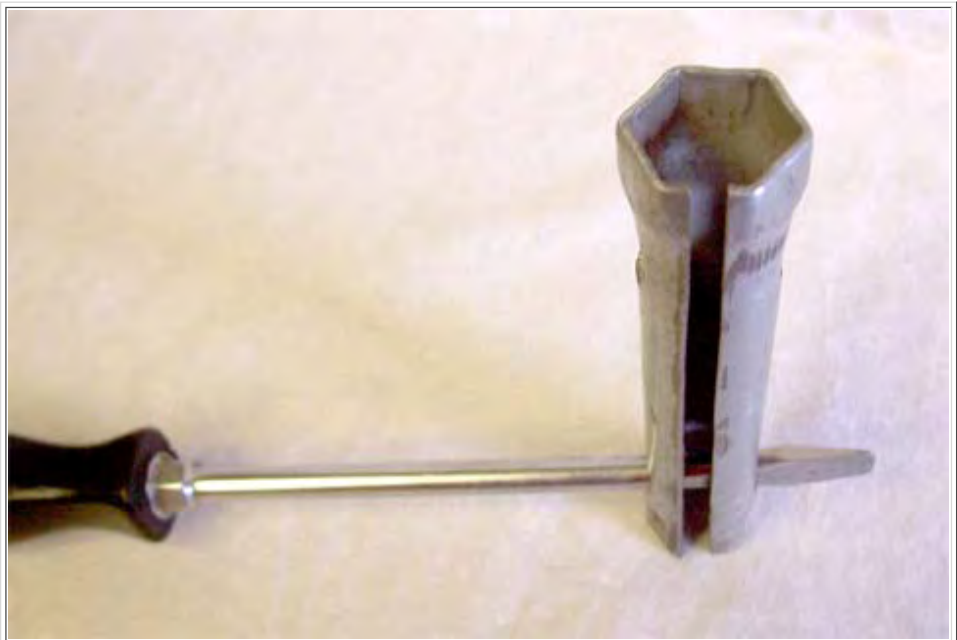
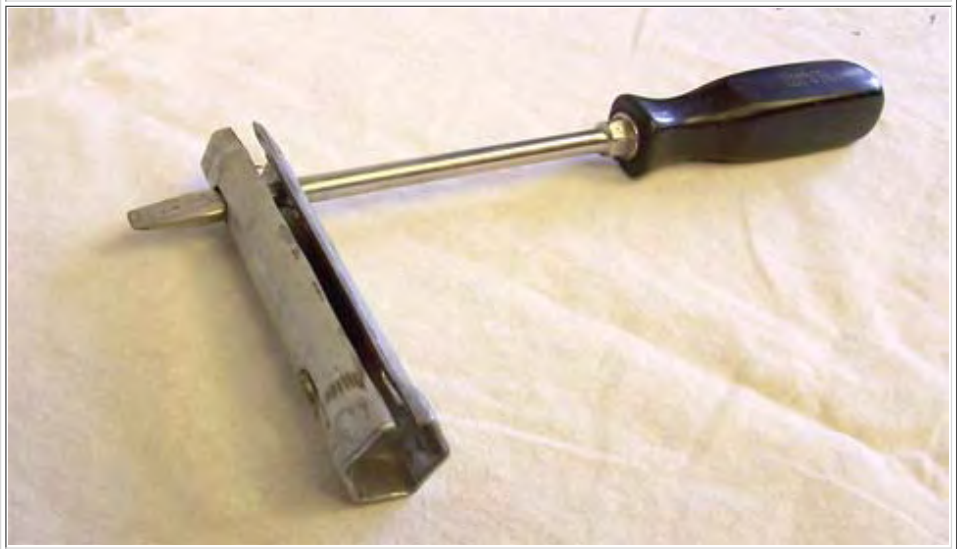
You will need to then cut a slot through the socket, lengthwise

from top to bottom, using a die grinder with a cut off wheel attachment. This will allow the tube to feed through the center of the socket, allowing it to be slid over the capillary tube nut. Use a screwdriver to turn the socket.

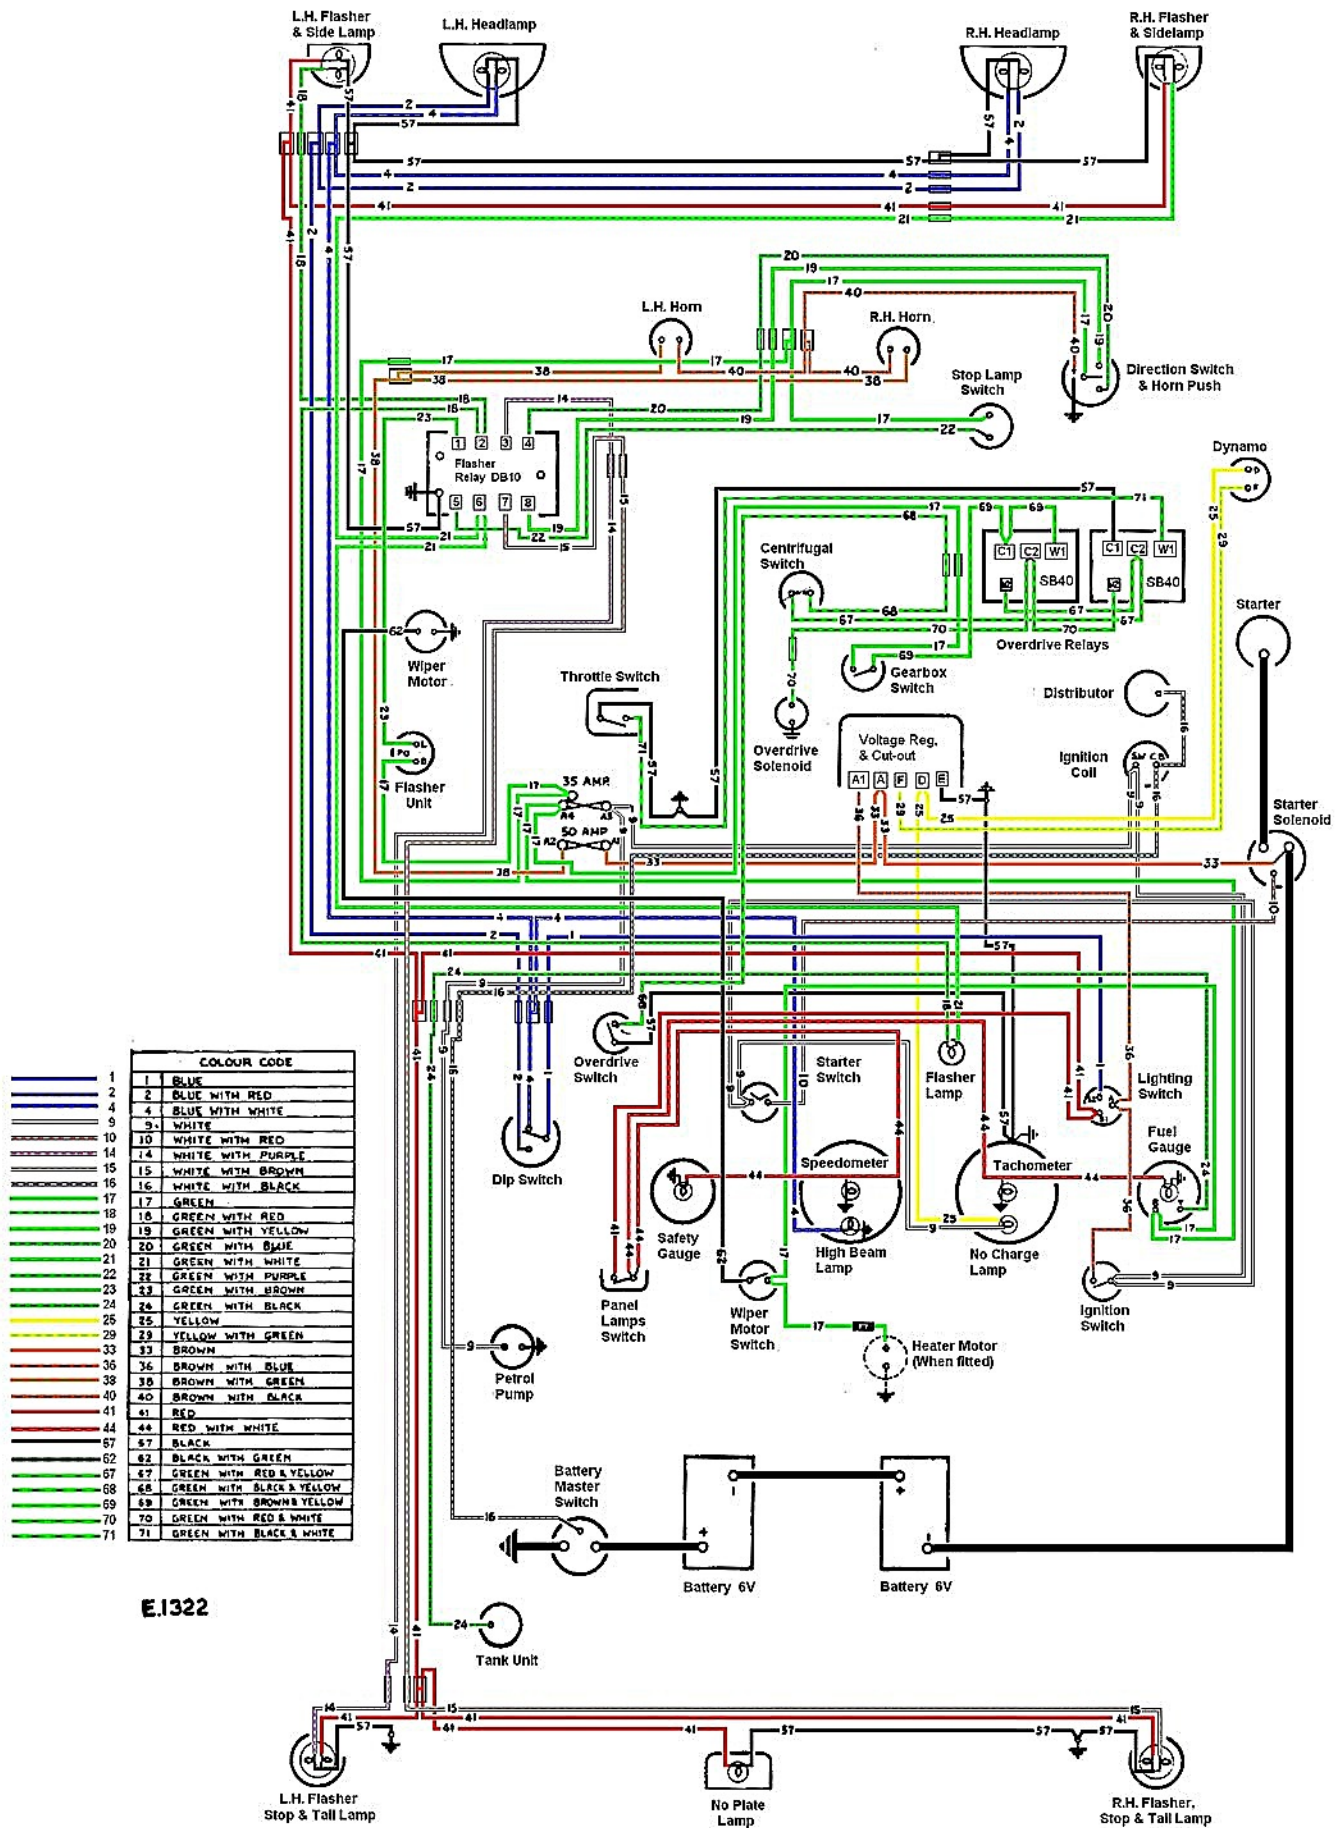
E.1322

Fig. 26. A general arrangement of the electrical circuits together with components in relation to their location on the chassis and bodywork.
